Hənłəmdʒi Məkola Yorke Island Conservancy

As-found Survey and
Condition Assessment

March 2018

HERITAGEWORKS

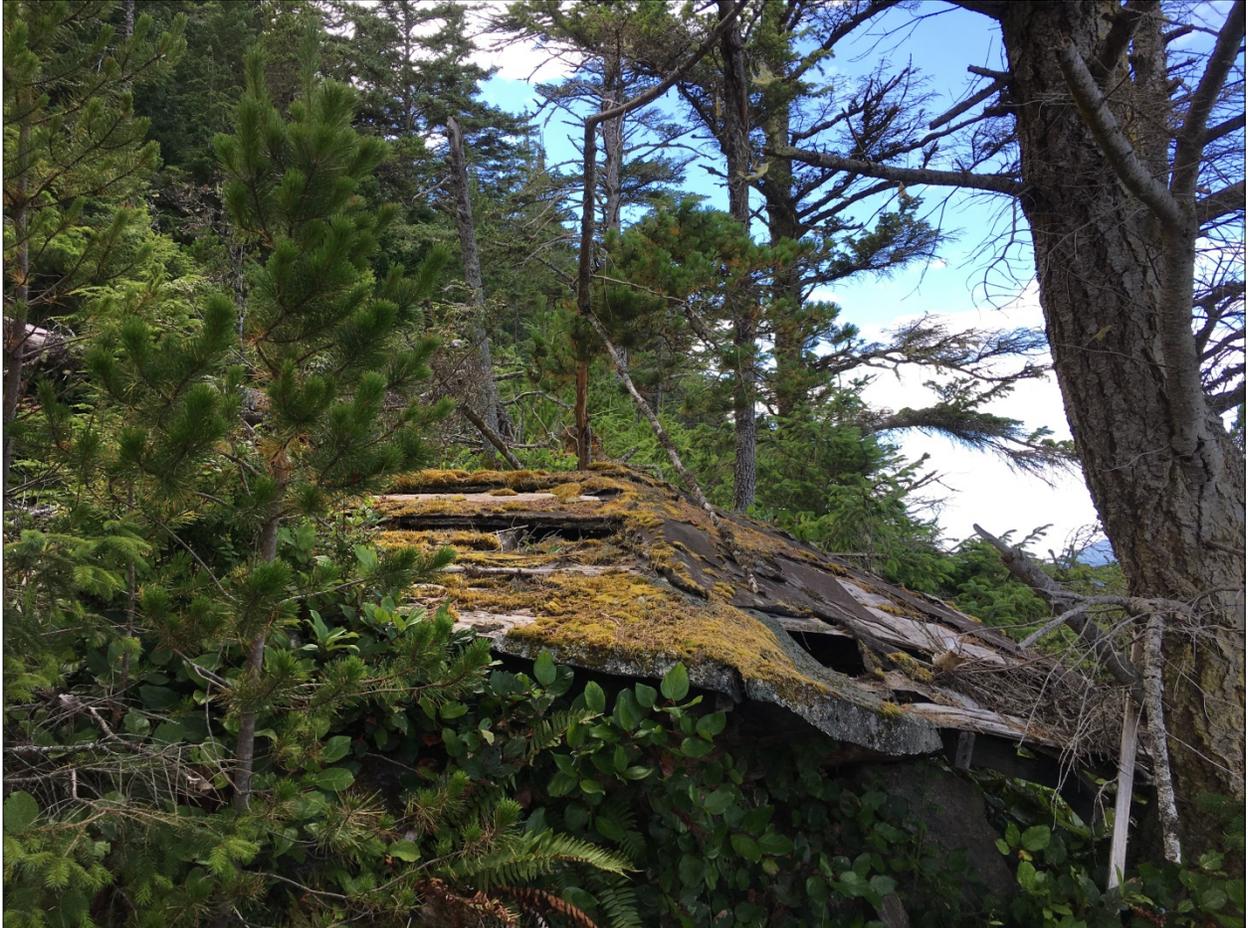
Southern aspect of ruinous building showing the decayed roof
