Yorke Island 2018

Vancouver Artillery Association Yorke Island Project

Yorke Island Battery - Site Plan

YORKE ISLAND
 BATTERY

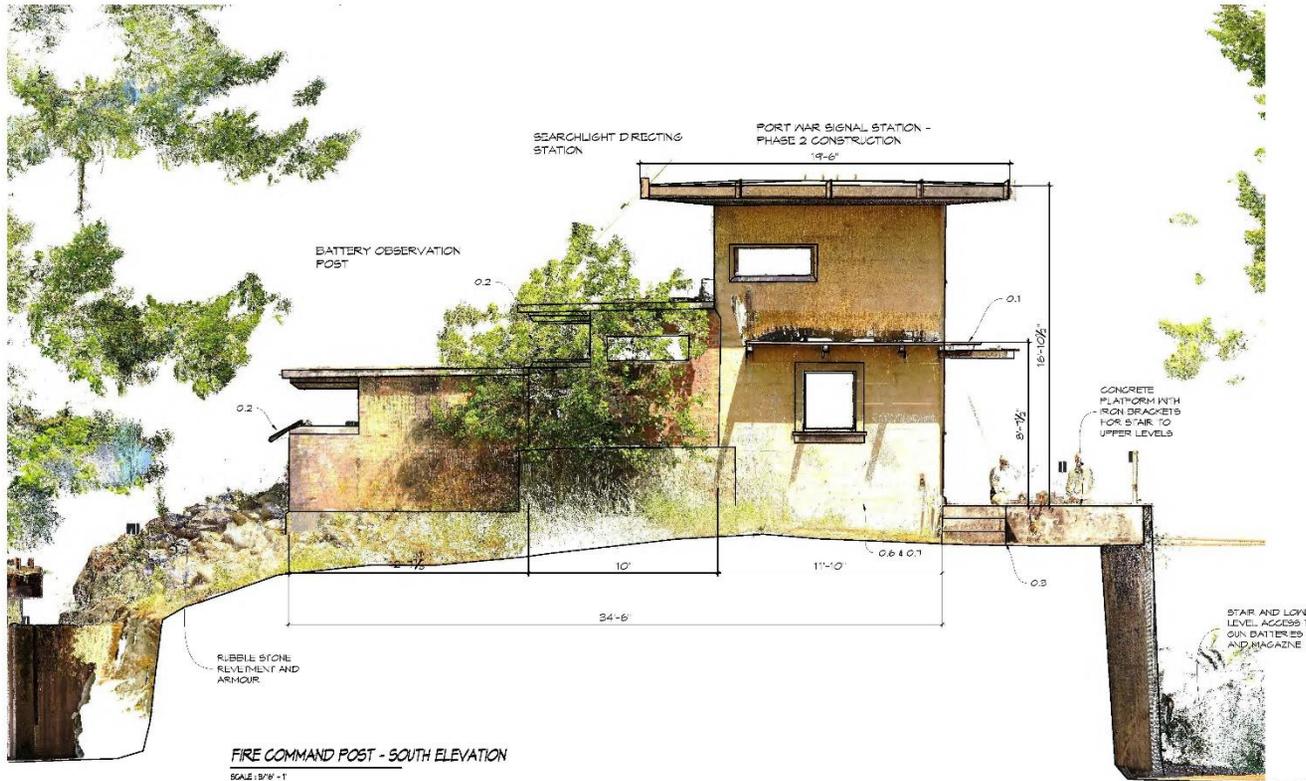
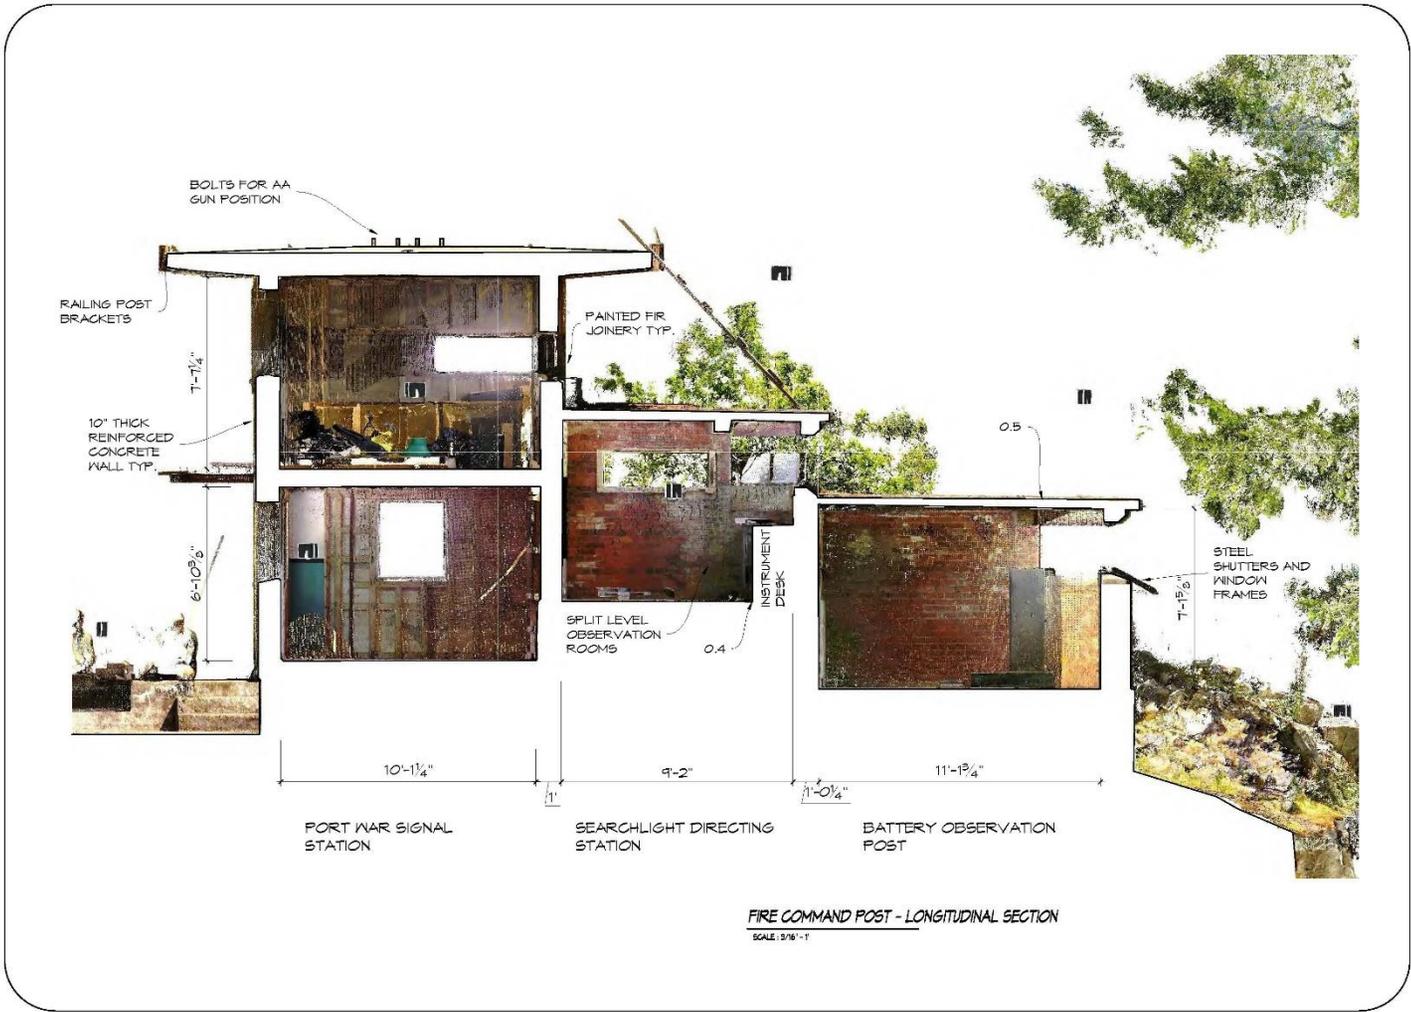
FIRE COMMAND
POST SOUTH
ELEVATION

The core structure of the Fire Command Post is in excellent condition. The roofs are in fair condition, but these have been damaged by visitors trying to access the Naval Signals Station and its rooftop.

Steel shutters enclose the Battery Observation Post and Searchlight Directing Station. These are in poor to moderate condition and some have been disconnected/disassociated from their original locations.

The exterior of the building is camouflage painted, and some of this remains in legible condition, though it has been vandalized recently with paintballs on the east elevation. Some of the exterior walls have also been marked with modern graffiti. The original camouflage paint is highly susceptible to damage.

Guardrails along the concrete apron to the south and east are missing.

The roofs are somewhat accessible, and visitor impacts include damage to the vegetation cover revealing the underlying bitumen, and thus increasing UV damage. In hot summer conditions the roofs warm up and the bitumen become pliable; making it easily damaged by people walking on it. In winter conditions the membranes are brittle.

Proposed scope of work: Reconstruct exterior stairs and balconies to provide safe access to the Naval Signals Post and its roof; Reinstall the metal shutters at the Battery Observation Post and Searchlight Directing Station; Reinstall historic barriers at south and east of apron using the existing, cast-in-place receivers; Consolidate the instrument desk in the Searchlight Directing Station; Strip existing roof and install new bitumen roofing to make all parts of the Fire Command Post watertight.

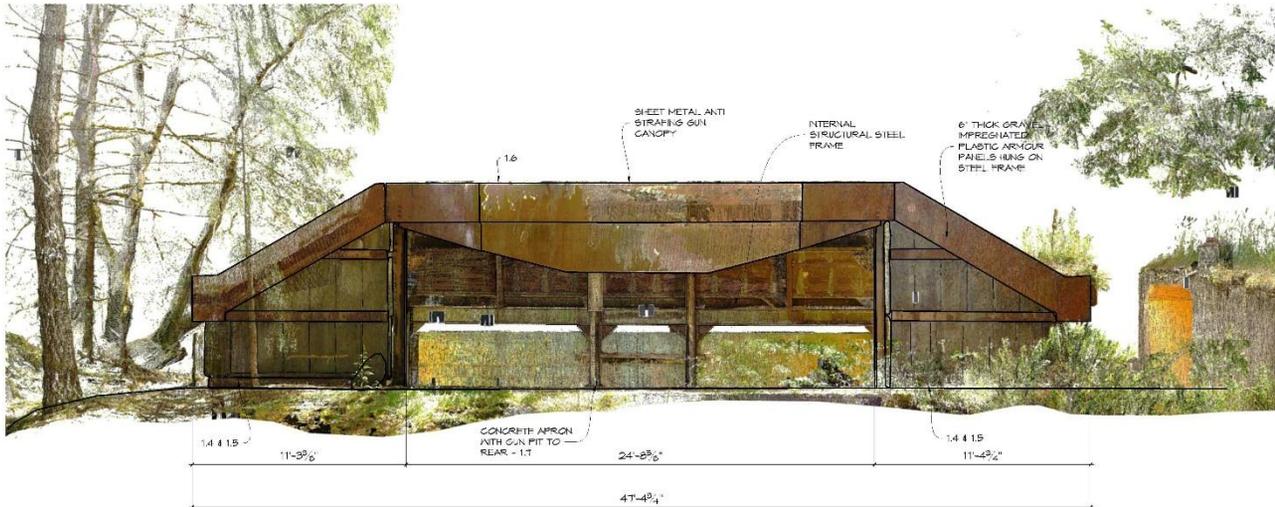
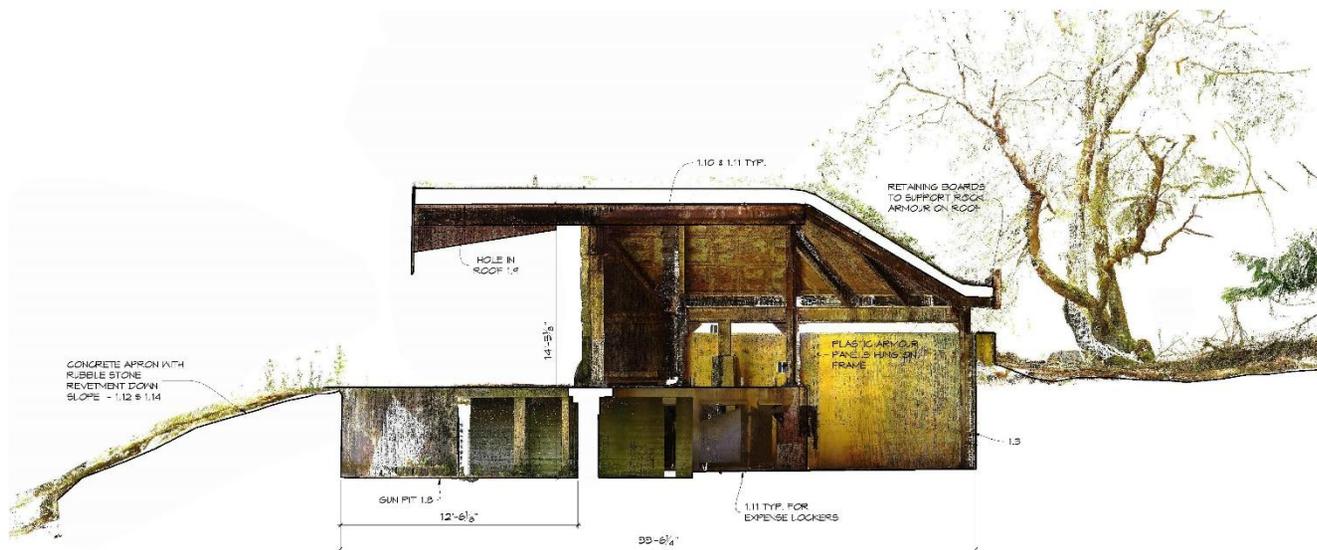
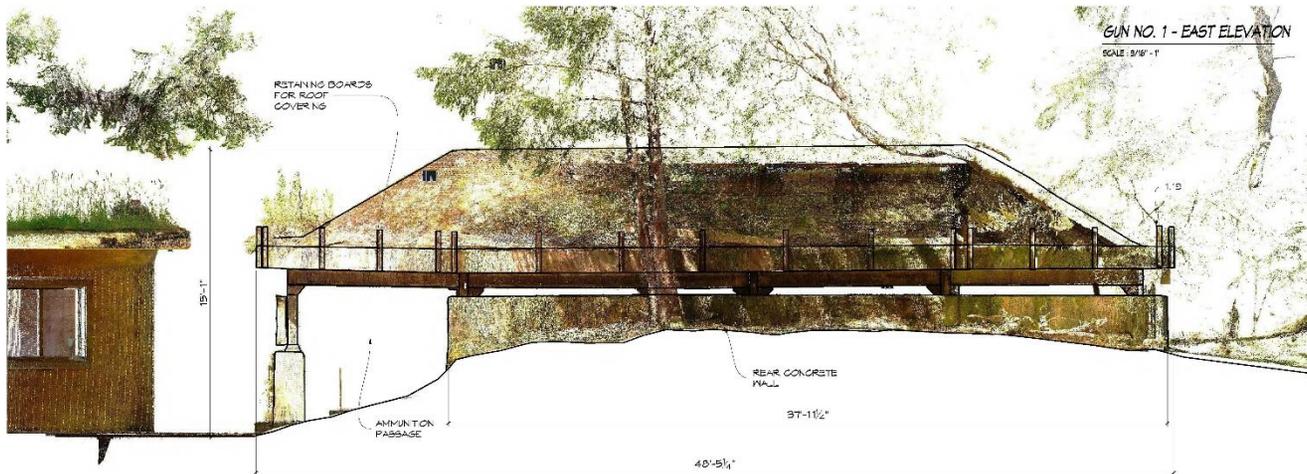
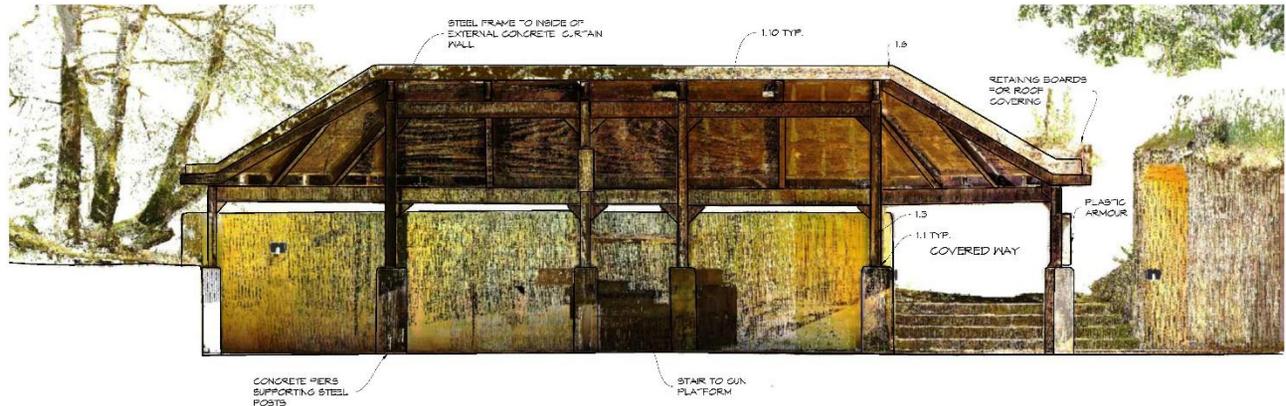
GUN NO. 1-
WEST
ELEVATION

The concrete is in excellent condition, and despite some modest vandalism to exposed surfaces, the plastic armor is as well. The chief weakness of the building is its tar and gravel roof membrane. Seedling trees (wildings) have rooted in the accumulated leaf litter, disturbing the roofs. The roof is somewhat accessible, and visitor impacts include damage to the vegetation cover revealing the underlying bitumen, and thus increasing UV damage. In hot summer conditions the roofs warm up and the bitumen become pliable; making it easily damaged by people walking on it. In winter conditions the membranes are brittle. All the primary seams along the hipped roof are broken, allowing water to run under the roof armor and along structural members, contributing to the corrosion of steel members and their connections.

Proposed scope of work: Make repairs to the corroded steel columns and column base connections of gun shelters; Clear all drains and ensure that they are operating effectively; Make seismic upgrade to gun shelter by securing column heads to concrete wall; Repair lost and badly deteriorated retaining bolts and reinstate retaining flanges of plastic armor; Treat remaining retaining bolts and flanges to inhibit corrosion; Strip existing roof and install new bitumen roofing to make gun shelter watertight. Reinststate historic barriers at some of the unguarded edges around gun pit using the existing, cast-in-place receivers; Install nuts and oversized washers on holdfast studs in gun pit; Treat loose armor panel (originally from roof above gun pit) in-situ and support to minimize corrosion.

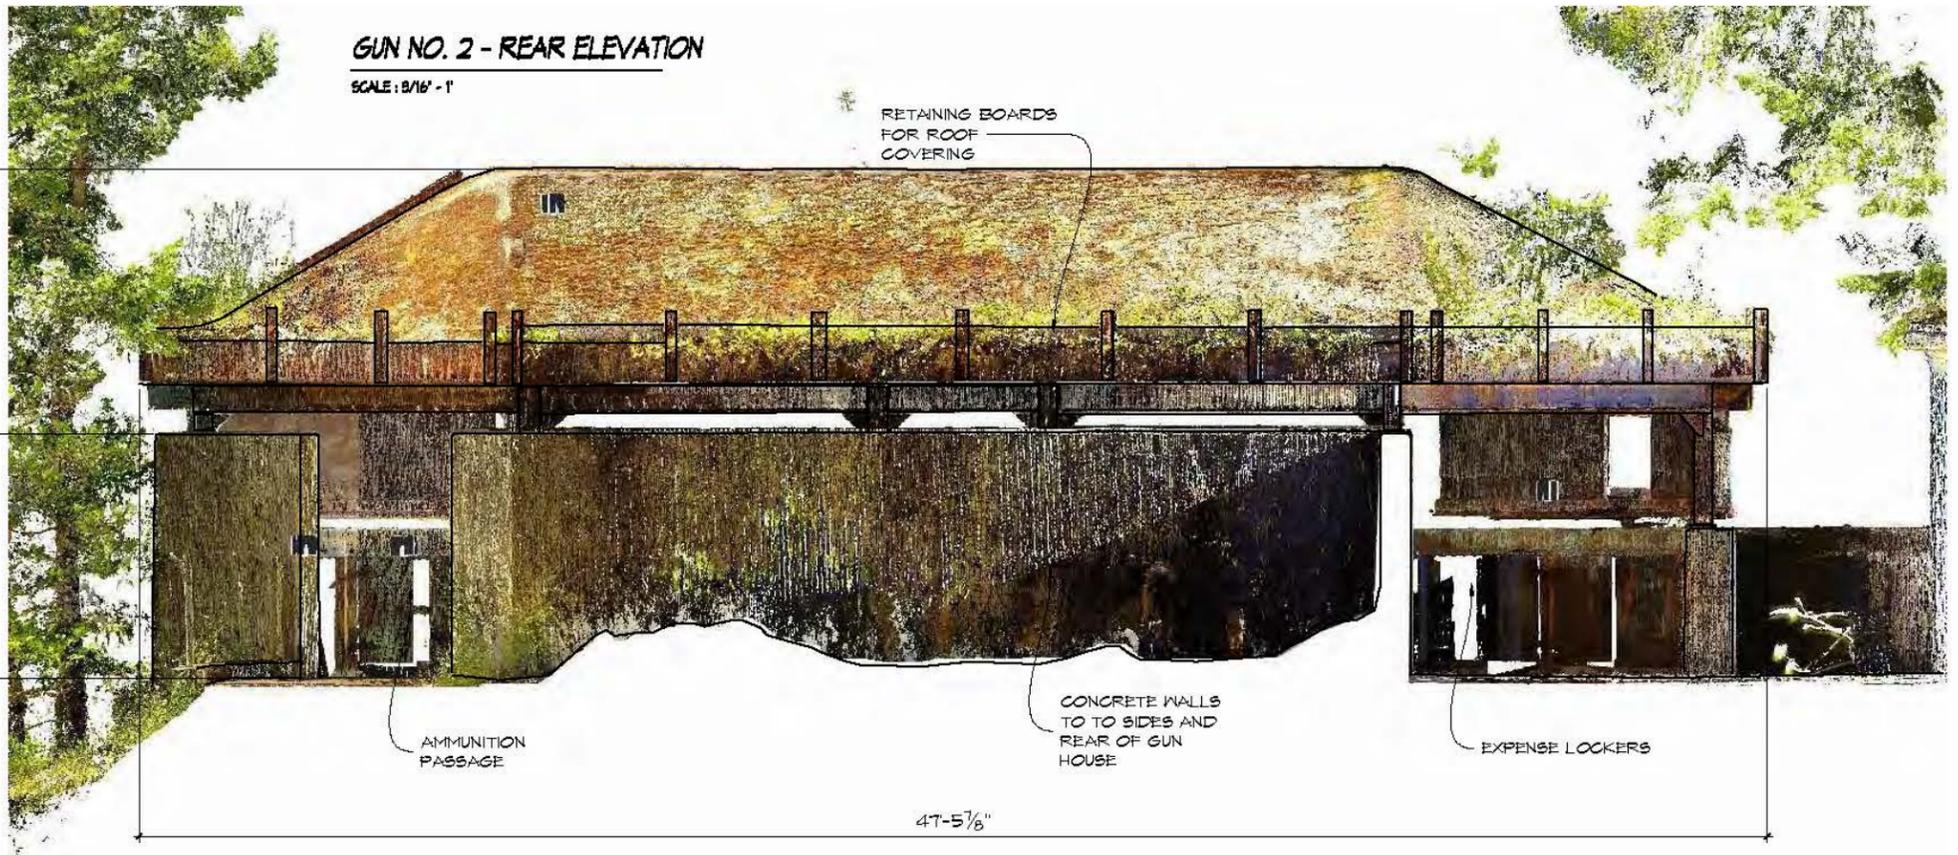
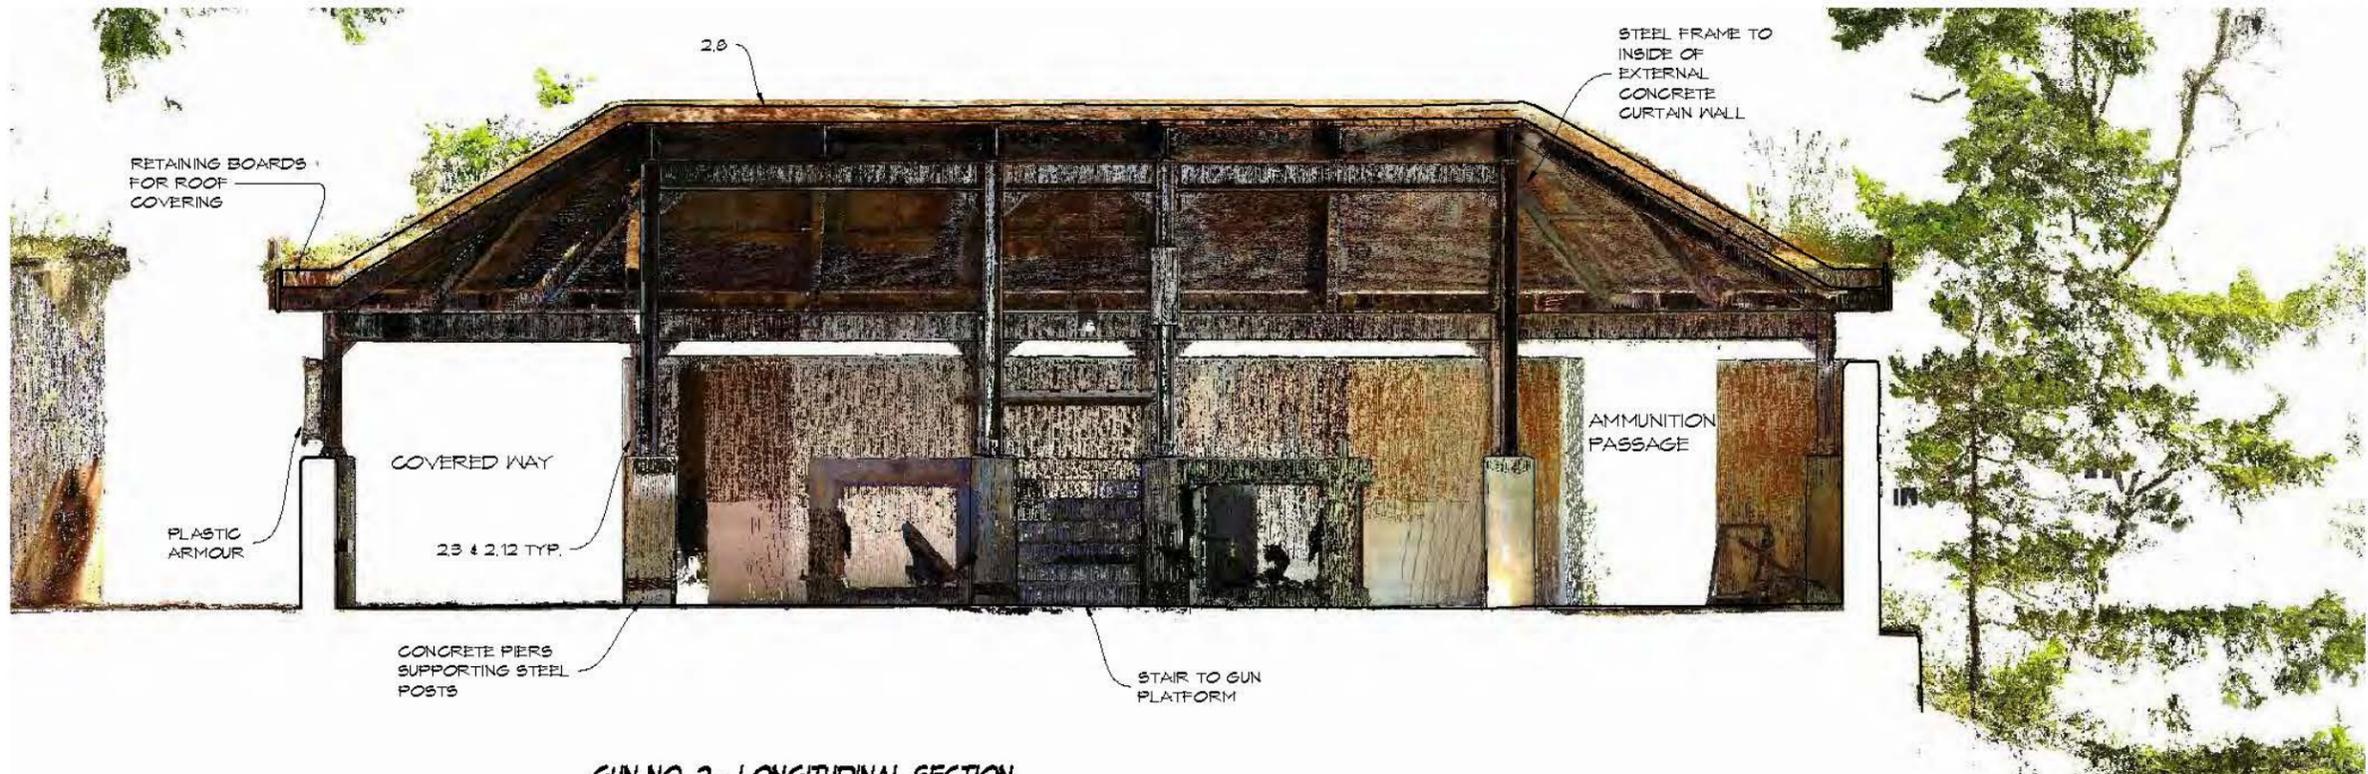
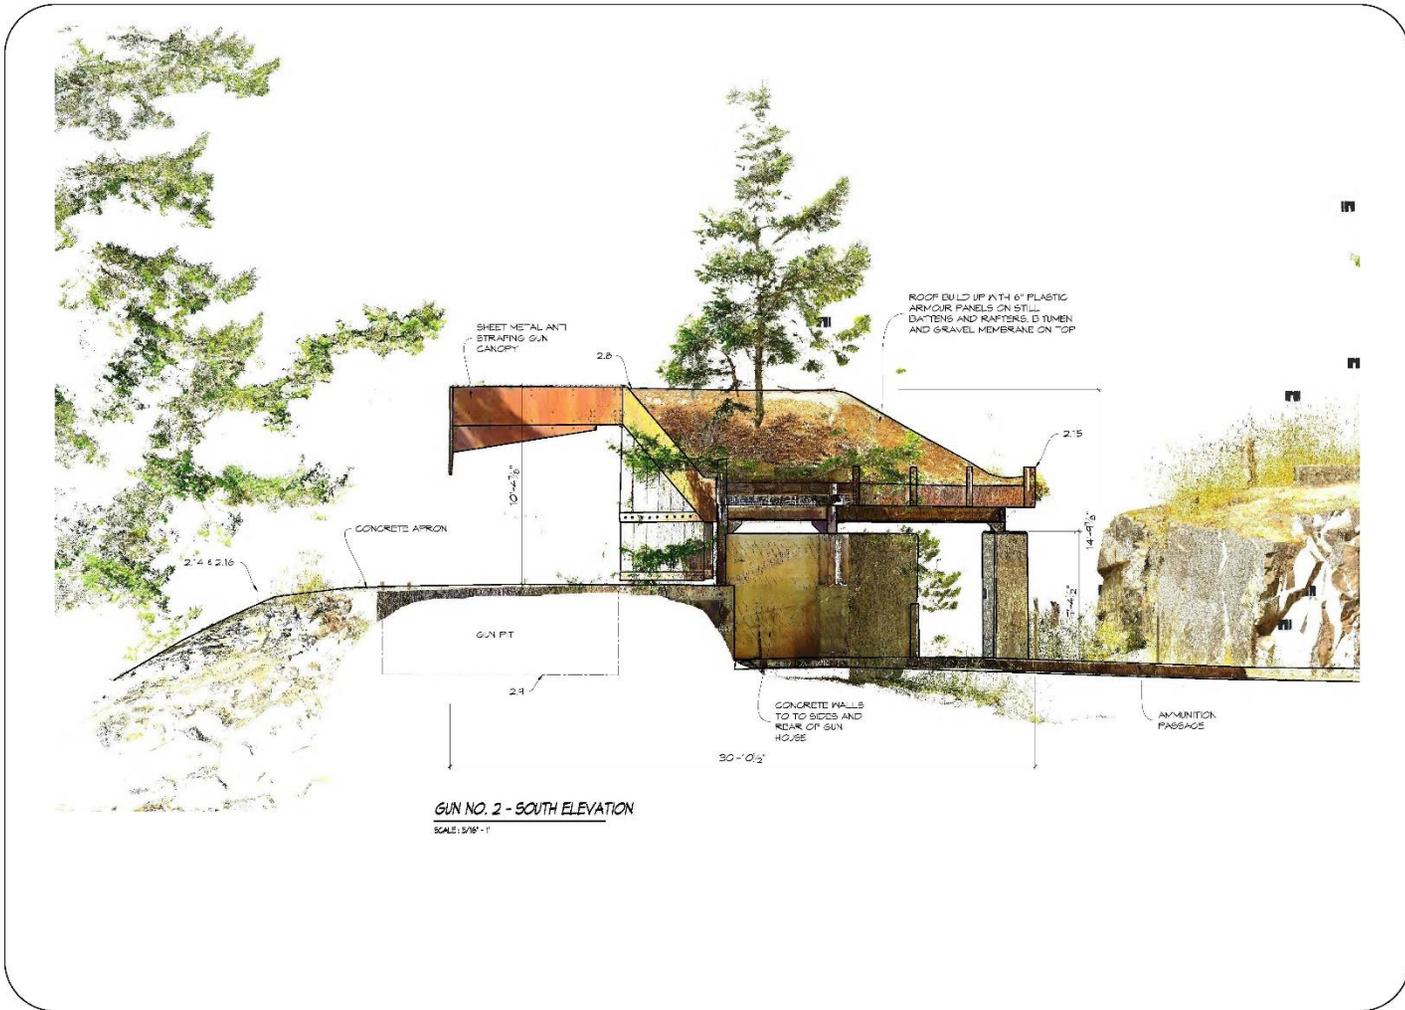
GUN NO. 2 -
REAR ELEVATION
AND LONGITUDINAL
SECTION

The concrete is in excellent condition, and despite some modest vandalism to exposed surfaces, the plastic armor is as well. The chief weakness of the building is its tar and gravel roof membrane. Seedling trees (wildings) have rooted in the accumulated leaf litter, disturbing the roofs. The roof is somewhat accessible, and visitor impacts include damage to the vegetation cover revealing the underlying bitumen, and thus increasing UV damage. In hot summer conditions the roofs warm up and the bitumen become pliable; making it easily damaged by people walking on it. In winter conditions the membranes are brittle. All the primary seams along the hipped roof are broken, allowing water to run under the roof armor and along structural members, contributing to the corrosion of steel members and their connections.

Proposed scope of work: Make repairs to the corroded steel columns and column base connections of gun shelters; Clear all drains and ensure that they are operating effectively; Make seismic upgrade to gun shelter by securing column heads to concrete wall; Repair lost and badly deteriorated retaining bolts and reinstate retaining flanges of plastic armor; Treat remaining retaining bolts and flanges to inhibit corrosion; Strip existing roof and install new bitumen roofing to make gun shelter watertight. Reinststate historic barriers at some of the unguarded edges around gun pit using the existing, cast-in-place receivers; Install nuts and oversized washers on holdfast studs in gun pit; Treat loose armor panel (originally from roof above gun pit) in-situ and support to minimize corrosion.

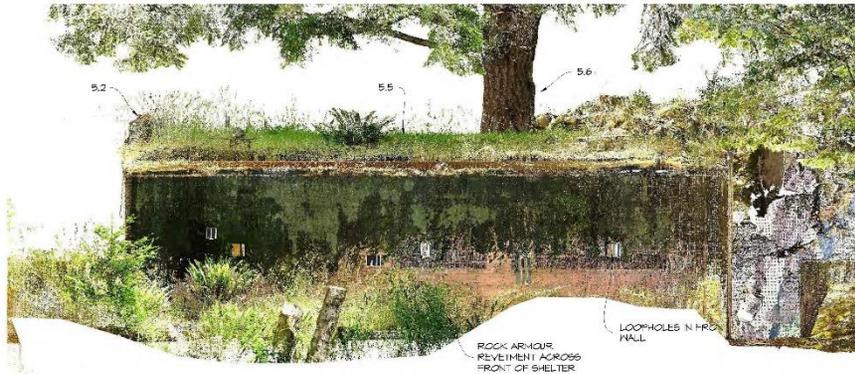
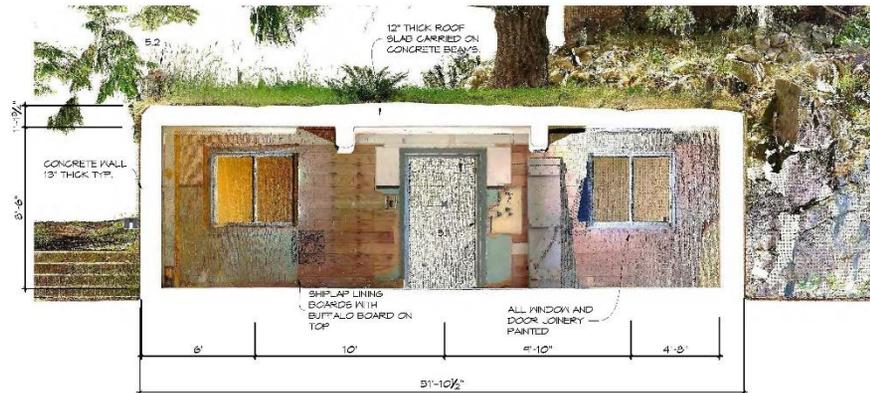
WAR SHELTER - WEST
ELEVATION AND
LONGITUDINAL
SECTION

The roof is in poor condition, and visitor impacts include damage to the vegetation cover revealing the underlying bitumen, and thus increasing UV damage. In some places the roofing membrane is missing entirely. In hot summer conditions the roofs warm up and the bitumen become pliable; making it easily damaged by people walking on it. In winter conditions the membrane is brittle.

There is extensive modern graffiti along both interior walls of the Ammunition Passage. The exterior of the building was camouflage painted, but it is no longer legible.

The stone retaining wall that borders the path to the Stopping Gun is in poor condition and the stones are loose. Similarly, the rock armor/camouflage forward of the Stopping Gun platform is separating from the concrete.

Proposed scope of work: Reinstate the door on hardware to match original configuration; Make and install a new cap flashing for the flu; Repair the modern damage to interior walls of Ammunition Shelter with multiple coats of lime wash to match historic colors; Repair the stone retaining wall that borders the path to the Stopping Gun platform.

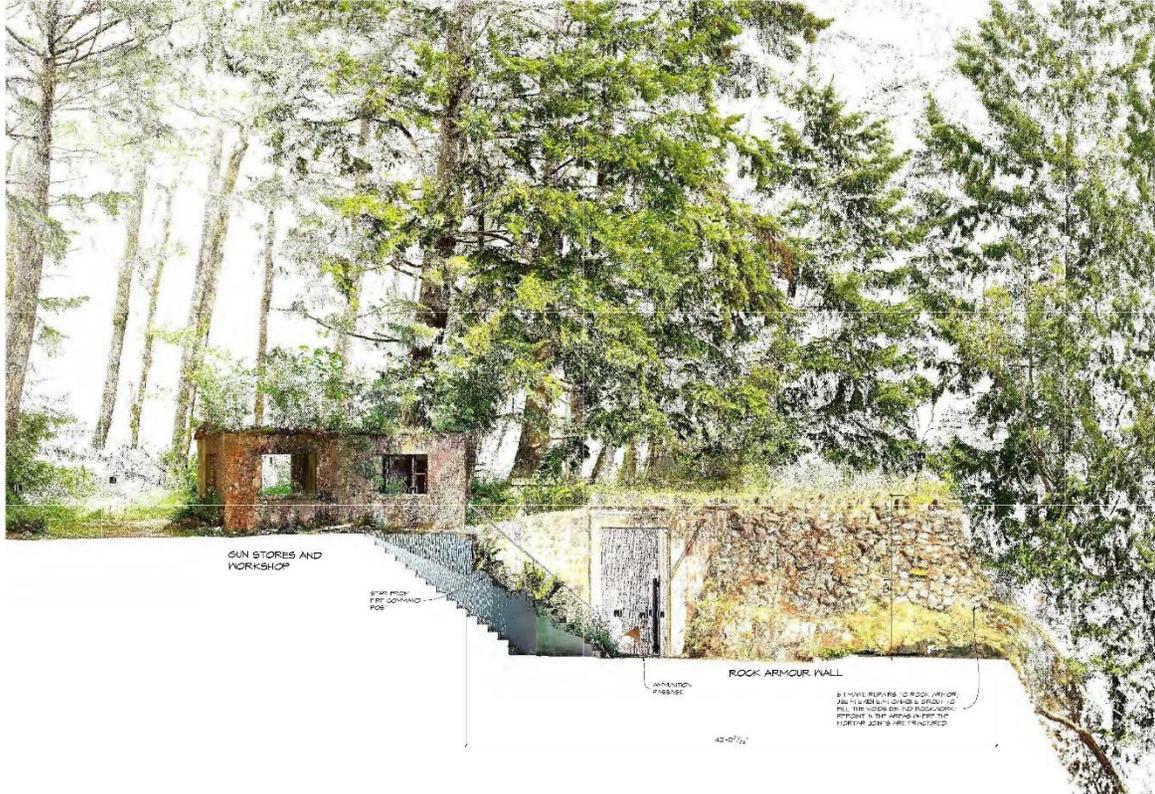
NEW MAGAZINE -
WEST ELEVATION

Like the Guns and the War Shelter, the high-quality of materials and workmanship in the New Magazine is character-defining. The thoughtful design and careful construction are also the main reasons that the building survives in such good condition. The concrete is in excellent condition throughout, with just one area of modest calcification at the Passage near the south entrance.

The chief weakness of the building is its tar and gravel roof. Seedling trees (wildings) have rooted in the accumulated leaf litter, disturbing the roofs. The roof is easily accessible, and visitor impacts include disruption of the rock armor/camouflage and damage to the vegetation cover revealing the underlying bitumen, and thus increasing UV damage. In hot summer conditions the roofs warm up and the bitumen become pliable; making it easily damaged by people walking on it. In winter conditions the membranes are brittle.

The rock armor/camouflage is delaminating from the structure at many locations and is in poor condition. Additionally, the stiff mortar joints have failed and large cracks have opened up in the rockwork allowing water to run freely between the rock and the concrete walls. Seasonal frost-jacking will soon cause this rockwork to fail.

The floor on one of the Shell Stores has been damaged by fire, presumably lit by vandals.

The metal ventilators are missing from all of the flues. The damaged original ventilators are lying down-slope on the forest below the New Magazine. One of the flues above the Laundry/Boiler is brick-made, and in poor condition with an open top.

The original metal covers to the Ammunition Wells are lying on the roof and partially buried beneath vegetation. They are in poor condition and the tracks that they originally ran on are badly decayed.

Proposed scope of work: Make repairs to rock armor; Repair and reinstate the tracks and covers for the Ammunition Wells; Make and install a new cap flashing for the flu above Laundry / Boiler; Reinststate original ventilators on flues above Shell Stores; Windsafe surrounding forest including removal of over-mature alder; 6.6 Treat metal doors and frames and make all hardware operable.

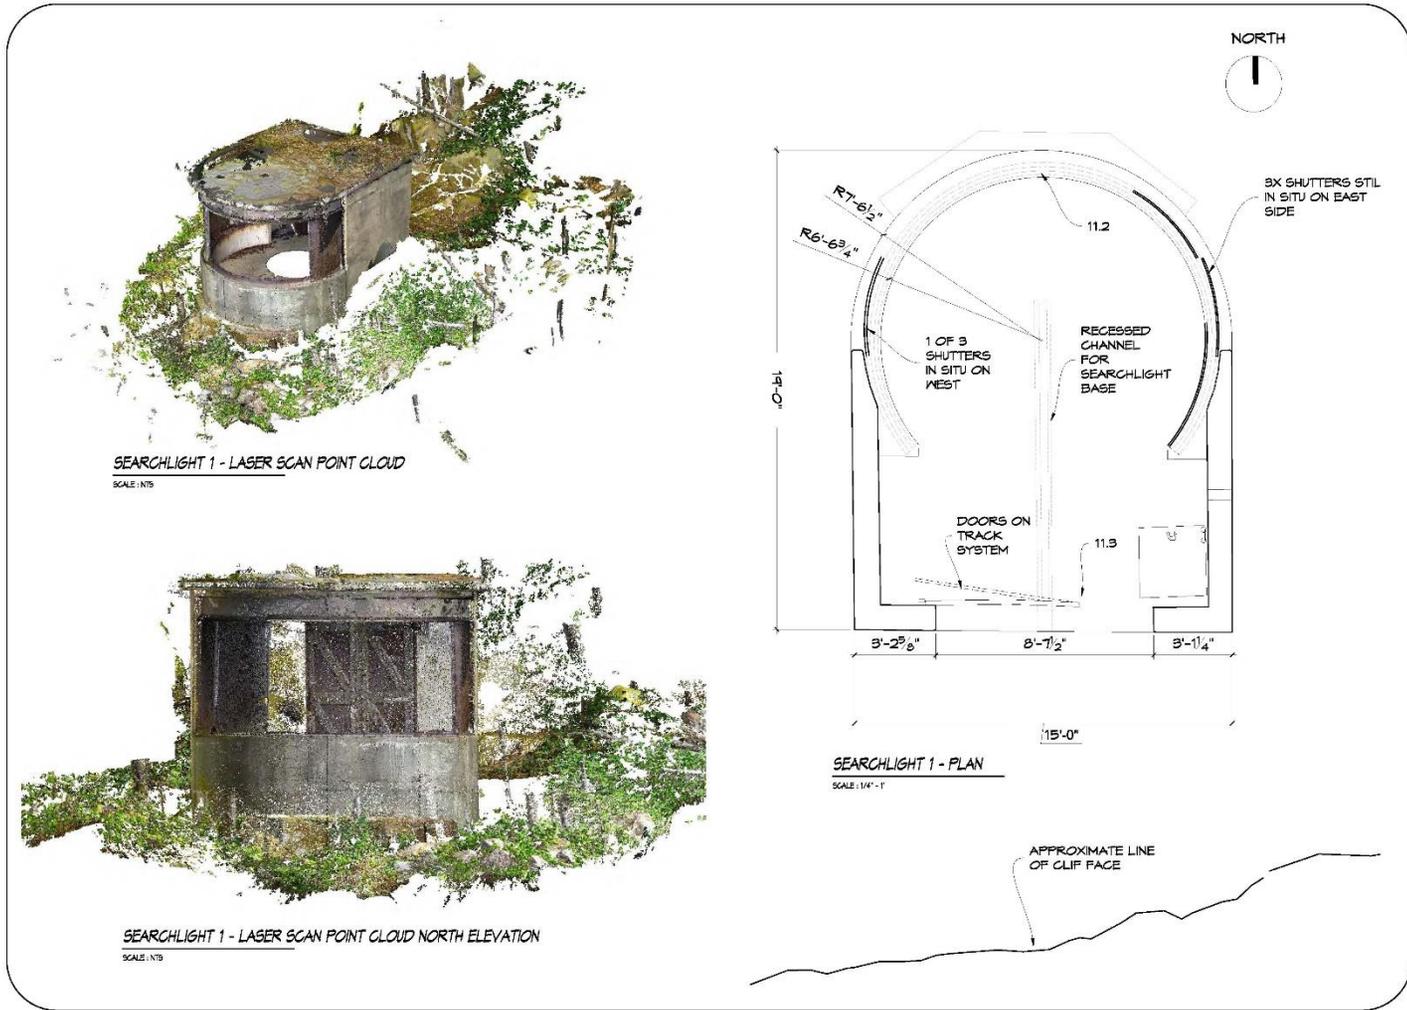
S 1.1

The structure is in very good condition despite its harsh marine environment. The curved-section steel beam that supports the cantilevered roof slab is very important to the structural integrity of the building. This beam is currently in good condition but it is essential that this is maintained in order to ensure the buildings longevity.

The metal tracks (cast in place) that support the steel shutters are badly corroded and continuing to decay. These are in extremely poor condition. Six of the 6 original steel shutters are still in place. Three of the 3 original wood and steel doors are still in place and 2 of them are still mounted. The tracks are in poor condition and badly corroded.

The exterior of the building was originally painted in a camouflage pattern and this is still legible in some places. The roof is in fair condition.

Proposed scope of work: Descale exposed metal surfaces of cantilevered beam above shutters with needle gun; Stabilize the tracks for shutters; Repair the doors and make operable; Restore historic sightlines to ocean by selectively pruning/clearing shoreline trees.

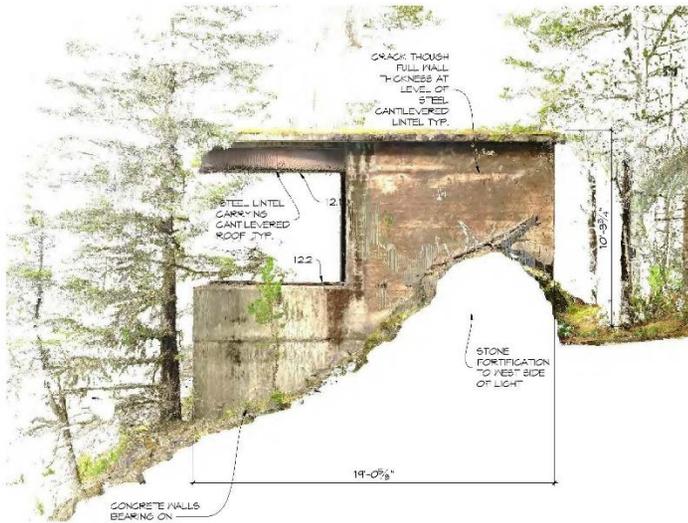
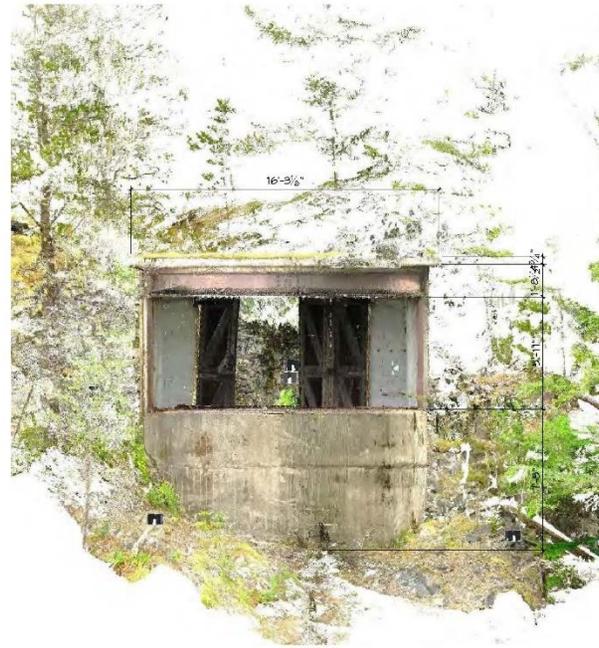
S2.2

The structure is in very good condition despite its harsh marine environment. The curved-section steel beam that supports the cantilevered roof slab is very important to the structural integrity of the building. This beam is currently in good condition but it is essential that this is maintained in order to ensure the buildings longevity.

The metal tracks (cast in place) that support the steel shutters are badly corroded and continuing to decay. These are in extremely poor condition. None of the 6 original steel shutters are still in place. Three of the 3 original wood and steel doors are still in place. This is the best surviving example of the doors. The tracks are in poor condition and corroded. The exterior of the building was originally painted in a camouflage pattern and this is still legible in some places. The roof is in fair condition.

Proposed scope of work: Descale exposed metal surfaces of cantilevered beam above shutters with needle gun; Stabilize the tracks for shutters; Repair the doors and make operable; Restore historic sightlines to ocean by selectively pruning/clearing shoreline trees.

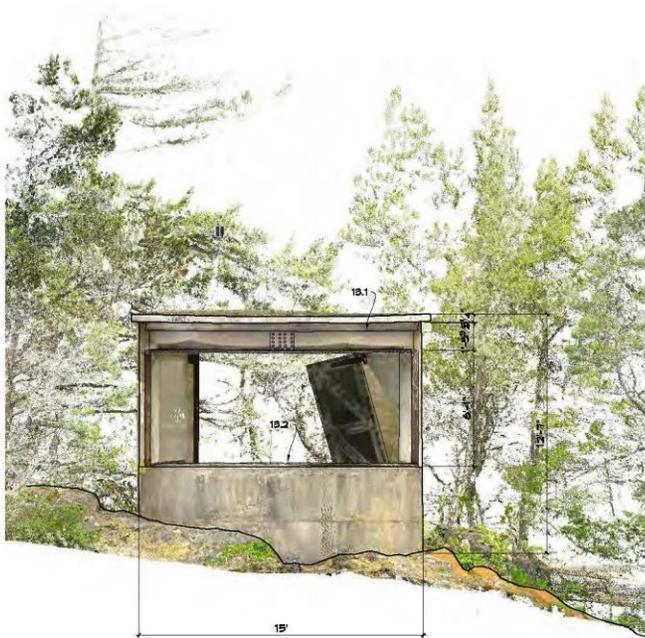
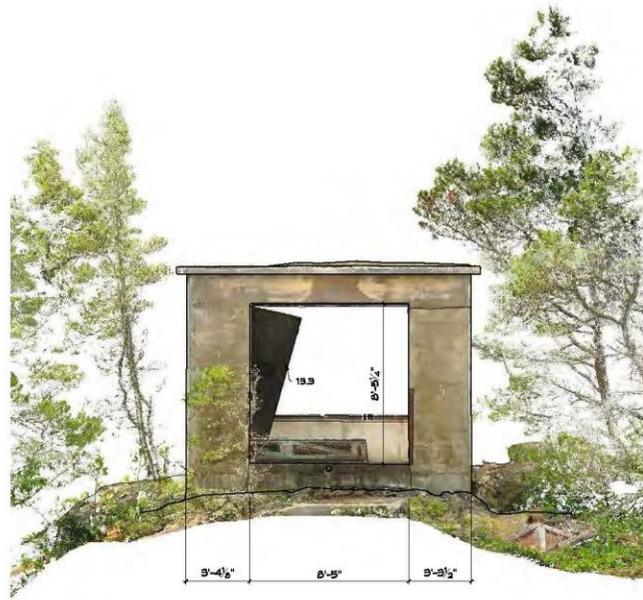
The structure is in very good condition despite its harsh marine environment. The curved-section steel beam that supports the cantilevered roof slab is very important to the structural integrity of the building. This beam is currently in good condition but it is essential that this is maintained in order to ensure the buildings longevity.

The metal tracks (cast in place) that support the steel shutters are badly corroded and continuing to decay. These are in extremely poor condition. None of the 6 original steel shutters are still in place. Two of the 3 original wood and steel doors are still inside the building and partially attached while the third panel is lying in the environs nearby. The tracks are in poor condition and badly corroded.

The exterior of the building was originally painted in a camouflage pattern and this is still legible in some places. The roof is in fair condition.

Proposed scope of work: Descal exposed metal surfaces of cantilevered beam above shutters with needle gun; Stabilize the tracks for shutters; Repair the doors and fix in open position.

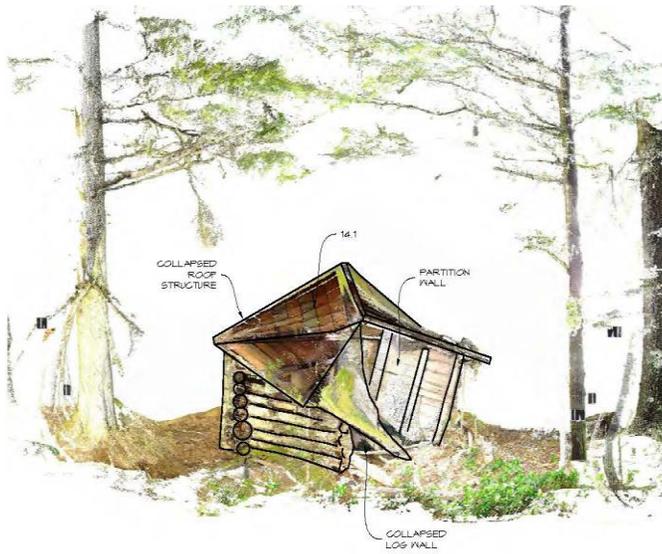
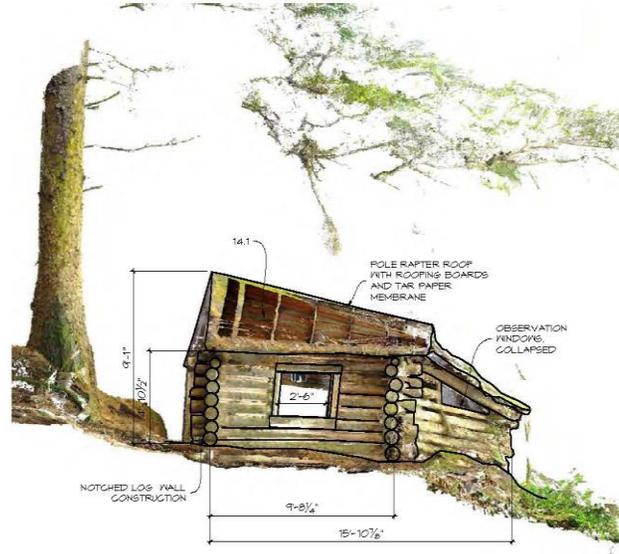
The building was partially-collapsed and hazardous. Some remedial work has now been completed.

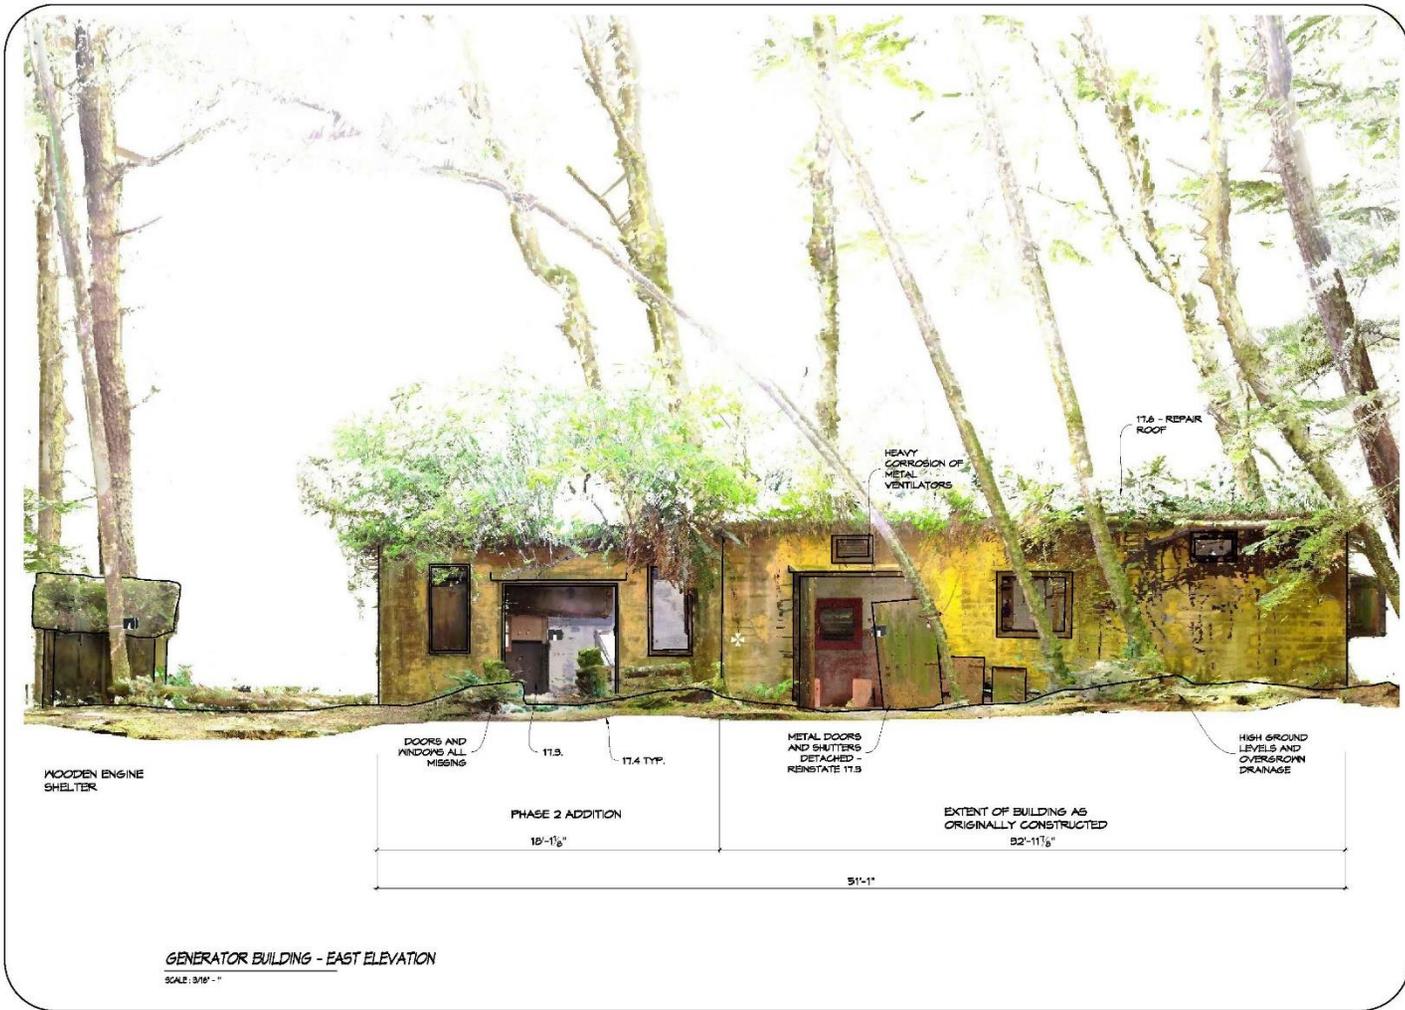
The structure is generally in very good condition though several trees have fallen against it. The large steel doors are still in place (or nearby) and they are in fair/good condition. The interior of the southern space has been damaged by vandals, and there is a lot of debris on the floor in this area.

The camouflage paint is in fair condition on the west elevation, but remains vulnerable to damage. Soils and forest debris have accumulated along the east elevation to the extent that groundwater can now enter the generator hall. A distinct smell of oil hangs over the entire building and immediate surrounding environs suggesting the that adjacent soils are probably contaminated.

Proposed scope of work: Explore ways to protect the historic camouflage; Remove deadfall; Repair the doors and fix in open position; Alter/lower grades along east elevation to encourage drainage away from building; Windsafe surrounding forest including removal of over-mature alder.

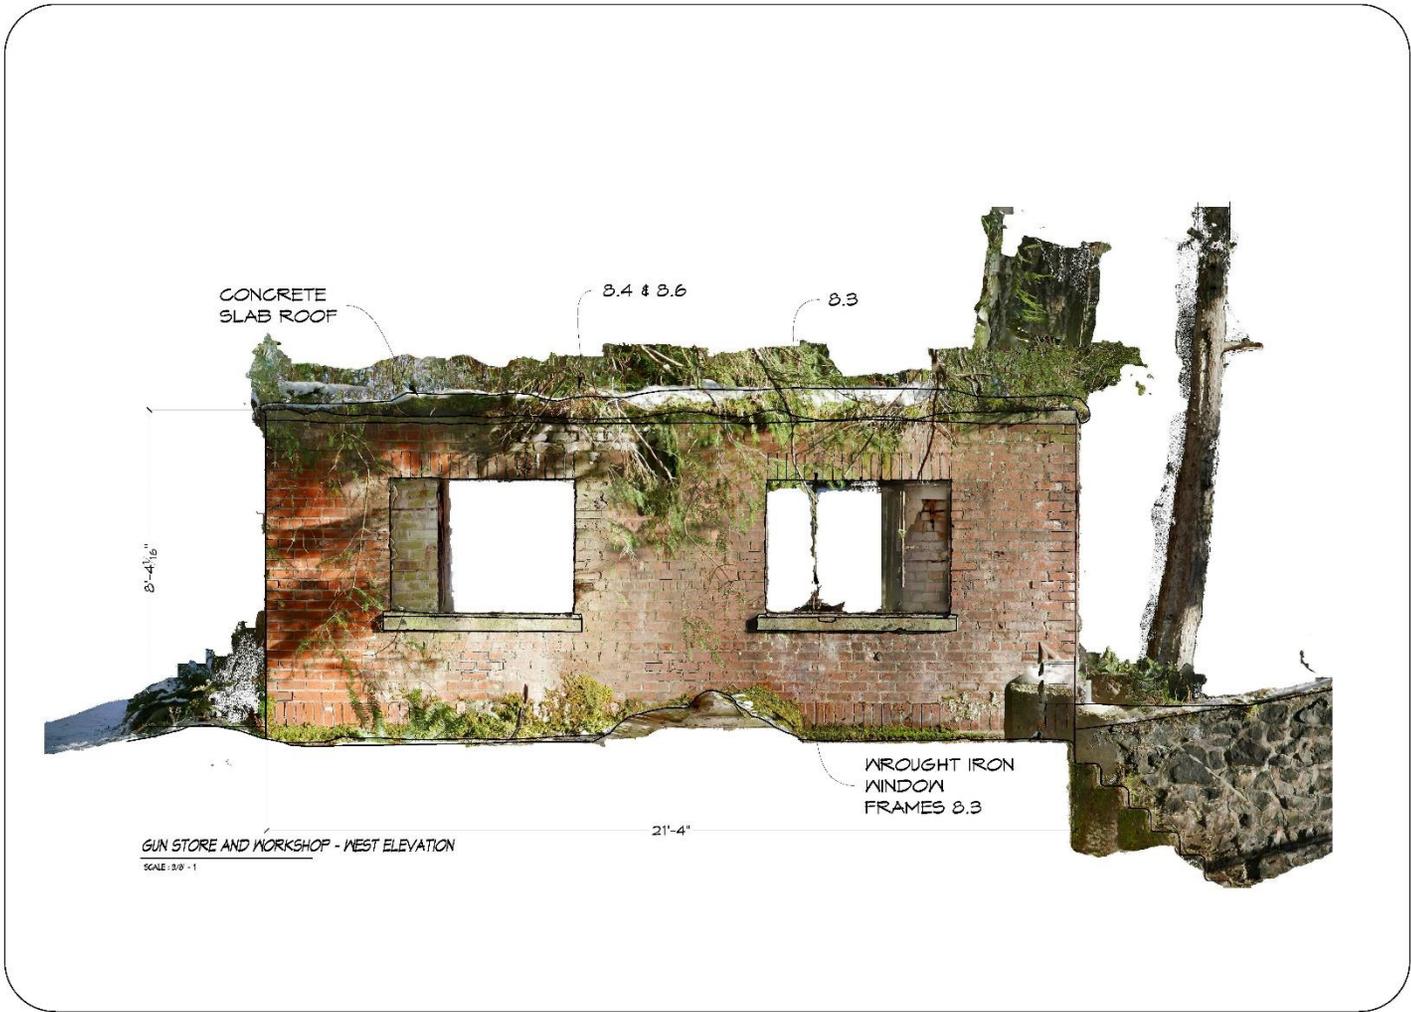
There is a large Douglas-fir tree growing at (and probably under) the southeast corner of the building that is causing some minor deformation of the structure, but the brickwork is otherwise in good condition. Because of its location the building is subject to a lot of leaf litter from the surrounding forest, and the roof has a correspondingly large amount of vegetation including some seedling trees growing on it. Soils have accumulated along the east elevation to such an extent that groundwater now flows into the building during wet conditions and the bottoms of the door jambs are partially buried.

Evidence in the form of charred timbers suggests that the building had a fire at one time, and was then re-finished to conceal the damage.

Proposed scope of work: Alter/lower grades along east elevation to encourage drainage away from building; Remove Douglas-fir tree from southeast corner; Consolidate and re-associate loose parts of window sashes; Treat corrosion of metal parts and secure in place; Remove all trees from roof; Windsafe surrounding forest including removal of over-mature alder.
