Vancouver Artillery Association

Yorke Island Docent Package

The Docent Package is intended as a resource for those volunteering at the Hanlamd'i Makola/Yorke Island Conservancy. This role is a part of the Volunteer Partnership Agreement that is in effect between BC Parks and the Vancouver Artillery Association that allows for the delivering of educational workshops and seminars, which may include guided walks or interpretive tours.

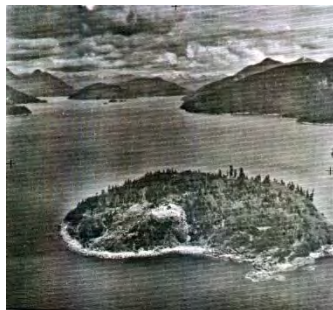
1C – Yorke Island Aerial Photo. This photo was taken 15 May 1943, from 1000' looking East 125°58'30"W-50°26'45". It clearly shows the island's 39 hectares (96 acres) and its elevation of 72 meters (236 feet). The fort area, gymnasium, generator building and dock can be seen.

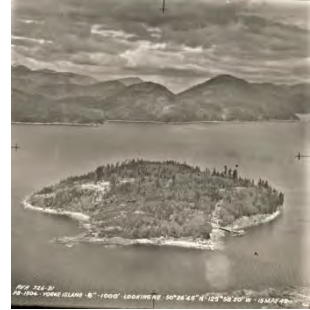
1D - Yorke Island Aerial Photo. Another aerial photo taken 15 May 1943. It was also taken from 1000' looking NE 50°26'45"W-125°58'30"W. This view provides a clearer picture of the dock and the road leading up to the Fort area. *15FdMuseum985.59.08*

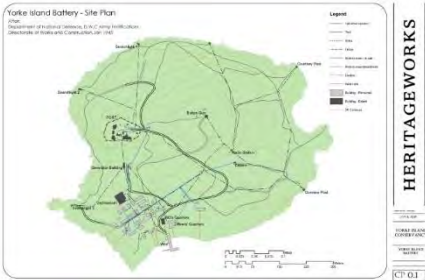
1E - Yorke Island 2018. This map was produced from a 1945 National Defense Army Fortifications and enhanced to portray the existing buildings. Comparison with the aerial photograph provides a view of the construction efforts that had taken place during the Second World War.

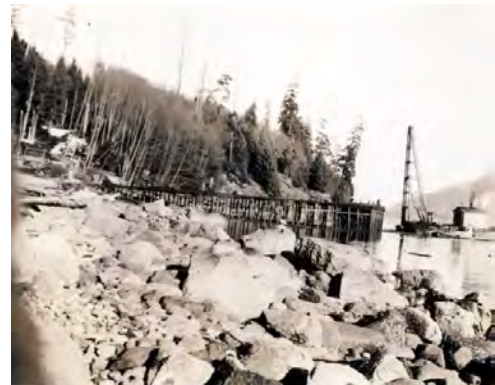
2A – Dock Construction. The pile driver barge is in position and working on the construction of the dock in 1938/39. *15FdMuseum989.154.57*

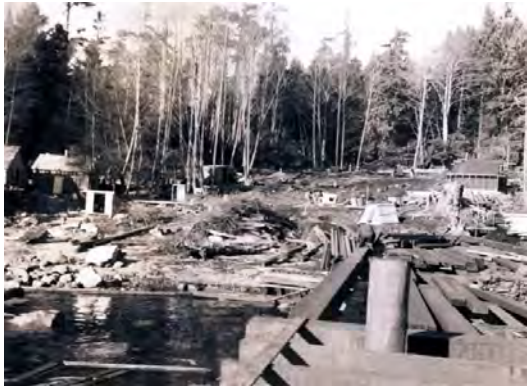
2B – Dock Construction. This photo provides a view of the dock area circa 1938/39. The dock boards have yet to be installed and it appears that the ground is being prepared for the Officers’ Quarters. The existing buildings appear to be short term construction sheds. *15FdMuseum989.154.56*

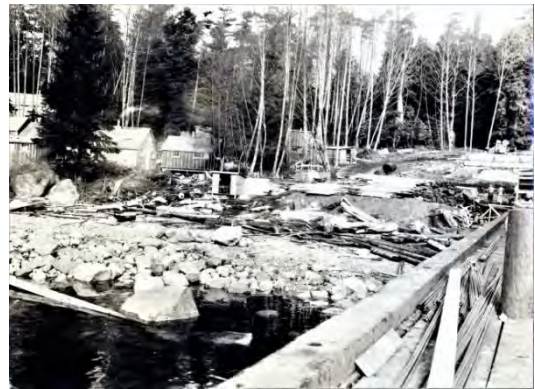
2C – Dock Area. The dock floorboards have been completed and there is a quantity of rebar ready to be used on the next concrete job. The Officers’ Quarters foundation is being worked on. *15FdMuseum989.154.55*

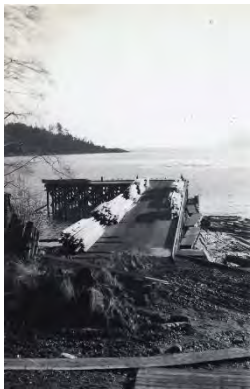
2D – Dock. The photo is dated January 1940 and the dock has lumber stacked ready to be moved onto the island for the next building project. *15FDMuseum997.15.1.993F*

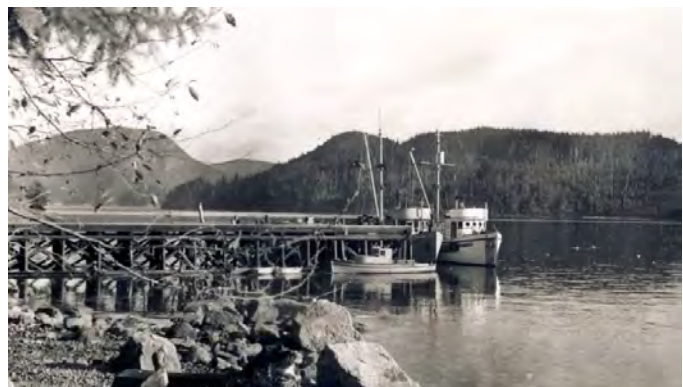
2E – Completed Dock. The view looking south towards Hardwicke Island. *15FdMuseum985.88.133*

The main feature of the Yorke Island Fort was the dock on the southern (predominantly leeward) side of the island. It was from here that men, construction materials, ammunition and other supplies could be transferred from boats onto shore, and then distributed to various parts of the island by truck and tractor. Remnants of the pilings and the wooden supports at the foreshore remain.

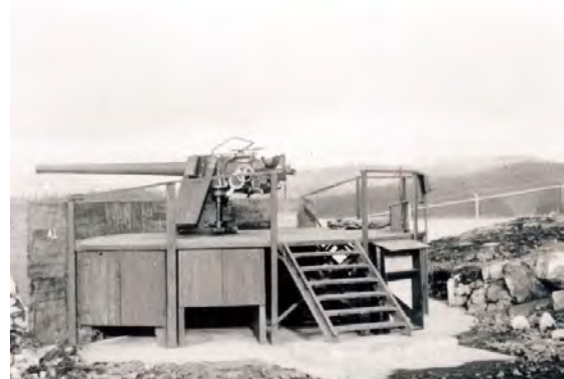
5A - 4.7-Inch Quick Firing Mark IV "B" Gun. This photo shows the #1 gun mounted on a Mark III Garrison Carriage. The gun is protected by a concrete wall and the ammunition under the platform is protected with doors.

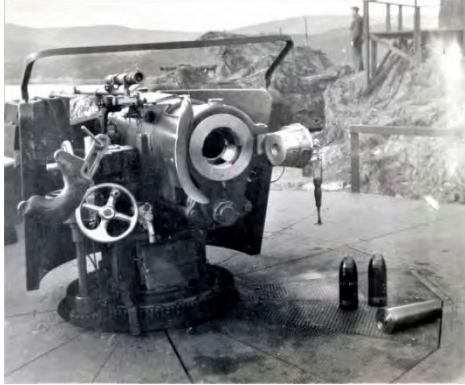
5B - 4.7-Inch Quick Firing Mark IV "B" Gun. This photo shows the #2 gun with 2 projectiles and a casing ready. The #1 gun is hidden under a camouflage net. *15FdMuseum985.88.185, 984.73.9n, 994.25.12*

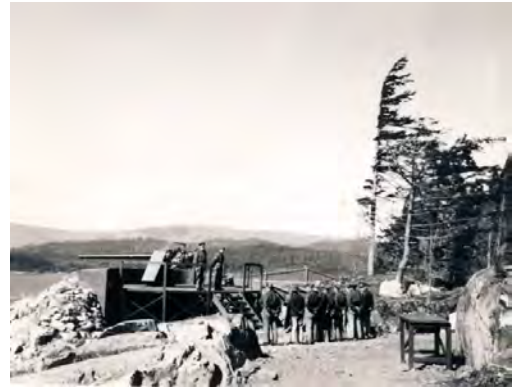
5C - 4.7-Inch Quick Firing Mark IV "B" Gun. This photo appears to show the detachment receiving a lesson on gun drill on the #1 gun. There are no covers visible under the platform.

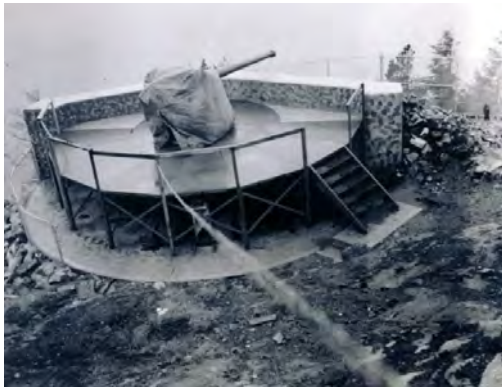
5D - 4.7-Inch Quick Firing Mark IV "B" Gun. This photo appears to show the #2 gun. There are no covers visible under the platform. The gun is covered with a gun tarp due to the inclement weather.

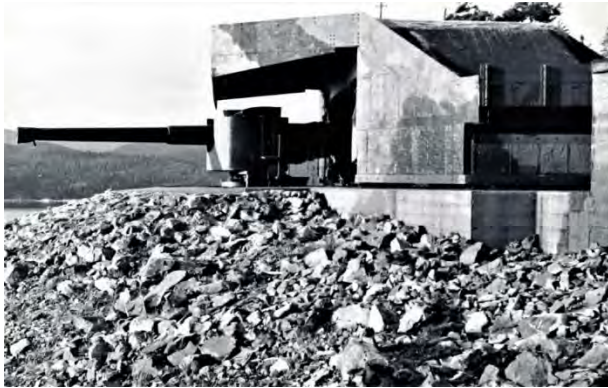
6A - 6-Inch Breech Loading Mark VII Gun. The photo appears to depict the period when the 4.7" guns were replaced by the 6" guns that had previously been mounted in the Stanley Park Fort. This dates the photo as June/July 1942

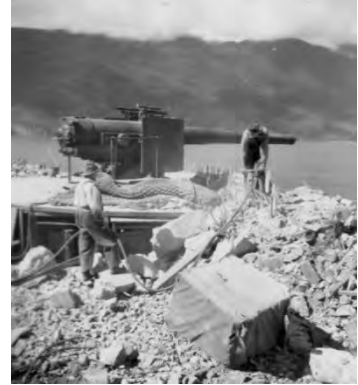
6B - 6-Inch Breech Loading Mark VII Gun. The #1 gun is shown sometime after the overhead protective cover has been installed. The cover was a steel structure with large blocks of plastic armour added on. Note the camouflage paint.

The maximum range was 12,000 yards (10,970 meters) and the weight of the shell was 100 lbs (45.4 kg). The protection consists of modular panels of plastic armor composed of precast bitumen and aggregate slabs (plates) and retained by metal flanges that are bolted to the steel frame.

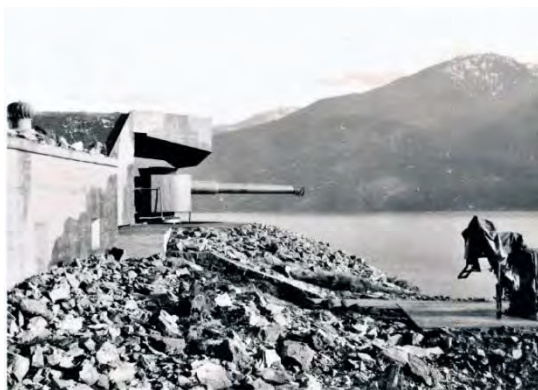
6C - 6-Inch Breech Loading Mark VII Gun. The #2 gun. It appears to have been photographed at the same time as the 6B photo. Note the camouflage painted on the overhead cover. *15FdMuseumRE.84.1113*

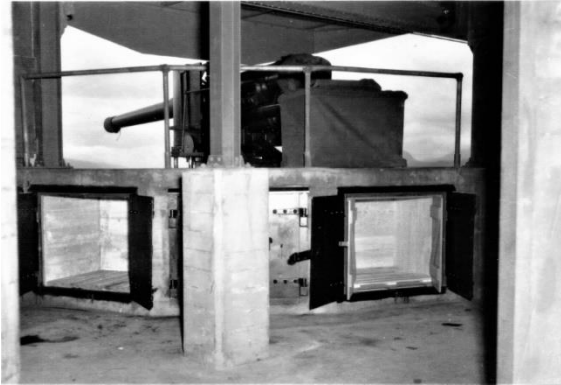
6G - 6-Inch Breech Loading Mark VII Gun. Interior view shows two rounds ready plus some detail on the communications speaker and phone system. *15FdMuseumRE.84.1110*

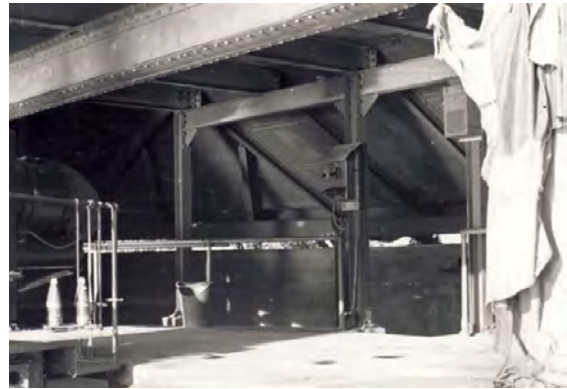
6H - 6-Inch Breech Loading Mark VII Gun. Interior view of #2 gun shows additional detail on the ammunition storage recesses and the support structure for the plastic armour system. *15FdMuseumRE.84.1081*

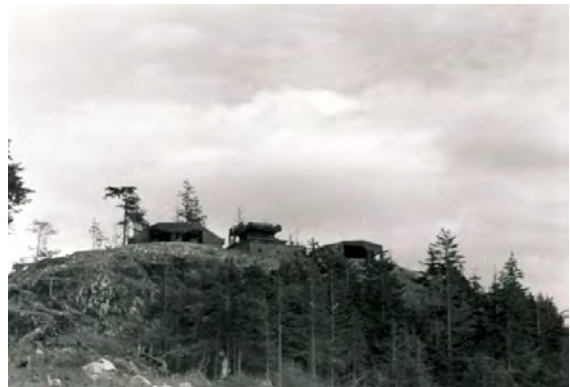
7A – 6 Pounder, 8 hundredweight Hotchkiss Gun. This gun was the standard examination service enforcer in the Coast Artillery Forts. It could fire 25 rounds per minute with a muzzle velocity of 1,818 feet per second (554 m/s) and an effective firing range of 4,000 yards (3,700 m).

The mounting plates for the 6-pounder Hotchkiss can be found between the two 6-inch emplacements. The 6-pounder was used as a more economical means of firing bring-to rounds to assist the examination vessels.

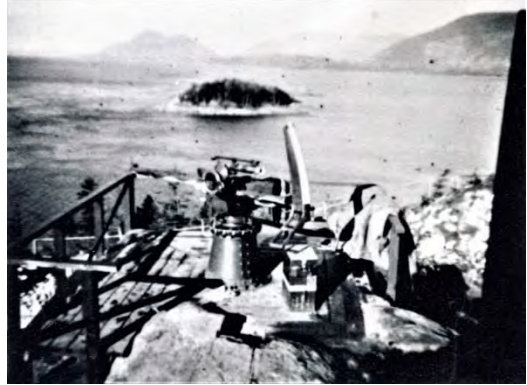
7B – 6 Pounder, 8 hundredweight Hotchkiss Gun. The Yorke Island examination gun was mounted on a concrete pad forward and between the two main guns. Clarence Island can be clearly seen from this vantage point.

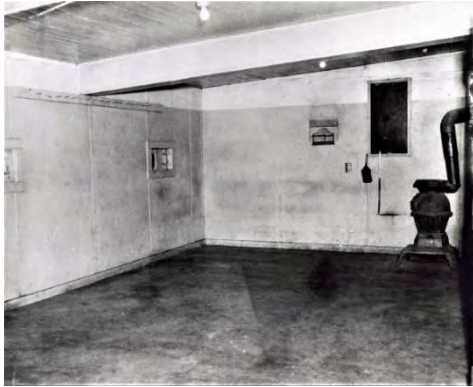
8A - War Shelter

The War Shelter, often referred to as Crew Shelter, offered protection for the detachment replacements that were waiting to relieve the on-duty detachment should they be wounded or killed. *15FdMuseum997.001.083A*

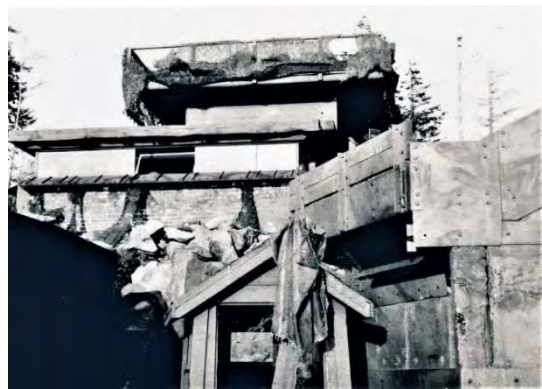
9A – Battery Observation Post. The Battery Observation Post was also referred to as the Fire Command Post or Searchlight Directing and Battery Observation Post or simply as the BOP. The Yorke Island BOP This photo is from the end of the war and features a 40mm anti-aircraft position on the rooftop.

The Fire Command Post, also referred to as the Searchlight Directing and Battery Observation Post, or simply the 'BOP', went through several upgrades through the war. The current structure was constructed with the arrival of the 6" guns and consists of the Port War Signal Station to communicate with the examination vessels in the strait which intercepted passing ships. The Searchlight Directing Station in the BOP coordinated the beams of the three searchlights to illuminate the passage at night. Officers in the BOP directed the guns and a Naval Signals Station monitored maritime traffic. A Bofors 40-mm anti-aircraft gun was later placed on the BOP's roof.

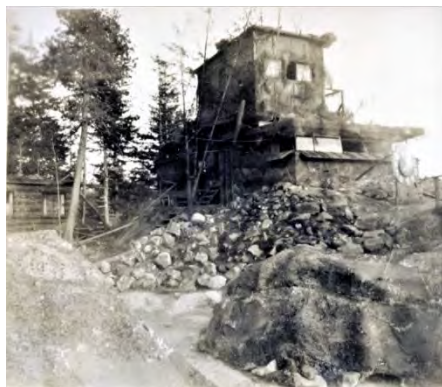
Observation Post. This iteration of the BOP was the result of constructing a communications room on the top level. *15FdMuseum985.88.184*

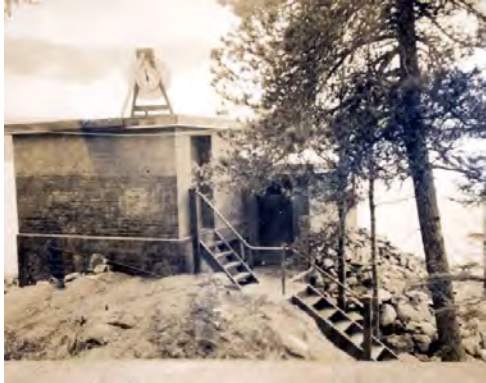
9C – Battery Observation Post. The original BOP, constructed in 1938, is shown in this photo.

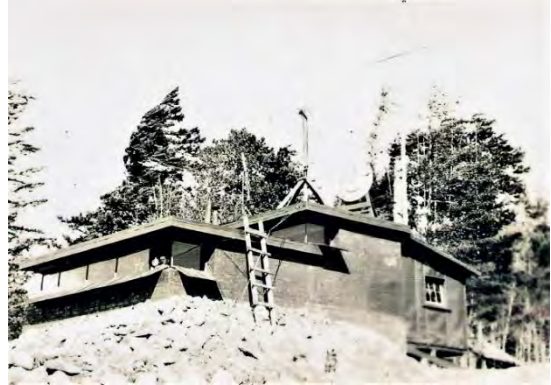
9D – Battery Observation Post. The original BOP featured a manual, visual signaling device to coordinate the fire of the guns should communication fail. *15FdMuseum985.88.012*

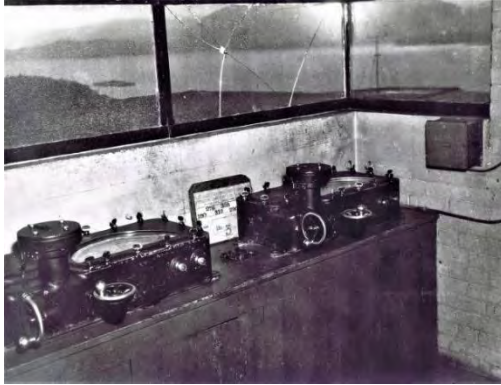
9H – Searchlight Controls. The direction and elevations of the searchlights were controlled from the BOP circa 1943 and later. *15FdMuseum997.001.082A*

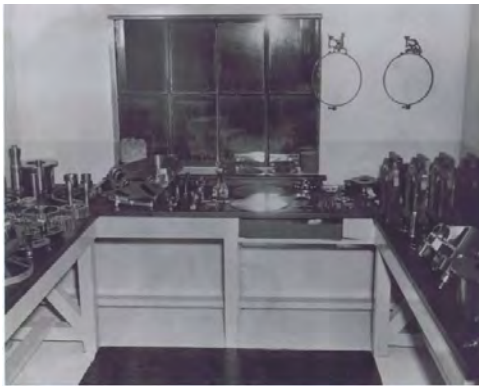
10A – Gun Stores and Workshop – The unique tools and parts required to maintain the guns can be seen laid out on the workbenches. *15FdMuseum997_002_004A*

The Gun Stores and Workshop also dates from the earliest phase of the battery. It is a simple, brick-made building consisting of two interconnected rooms with a suspended wood floor. It was used to repair and maintain the coastal guns. A team of artificers held sufficient spare parts to ensure that the guns could remain in action. This was critical for a fort far from its support base..

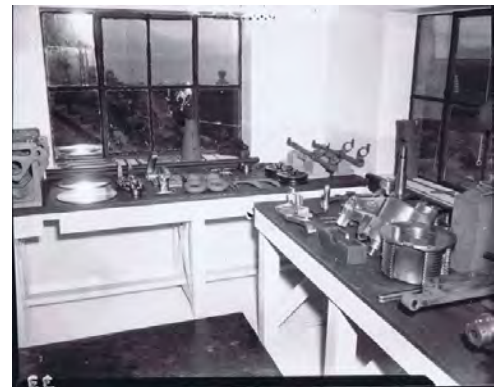
10B – Gun Stores and Workshop – The workshop was well stocked with tools and equipment as it was a considerable distance to the nearest supply depot. *15FdMuseum997_001_095A*

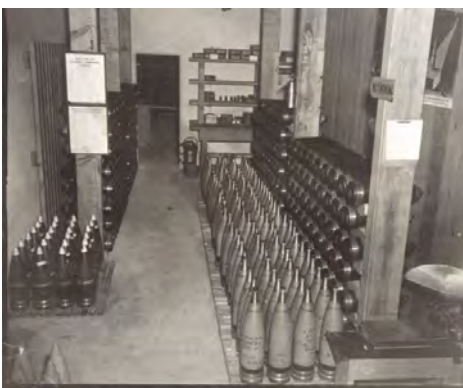
11A- New Ammunition Magazine

The New Magazine is a substantial engineering work that was constructed from concrete in 1943 when the guns were exchanged. It consists of two ammunition wells that originally held mechanical lifts plus two shell storerooms. Some of the original heavy steel doors are still in place and operable. The shell stores contain some of the timber columns that formed the original structure of the shell storage system.

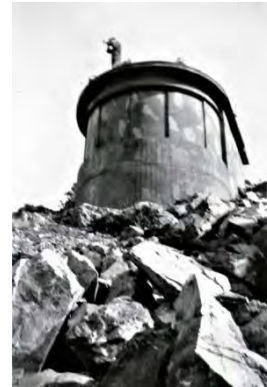
12A – Searchlight Emplacement. Three searchlights were installed on Yorke Island. The enclosures had sliding metal shutters at the front and large wooden doors at the rear.

There were three searchlight towers on Yorke Island. A curved, concrete enclosure and roof sheltered the 5-foot (1.5 meters) diameter searchlights. These structures had wooden sliding doors at the rear and sliding, metal shutters on the front. The lights have been removed but the service conduit and holdfasts remain in the concrete floor.

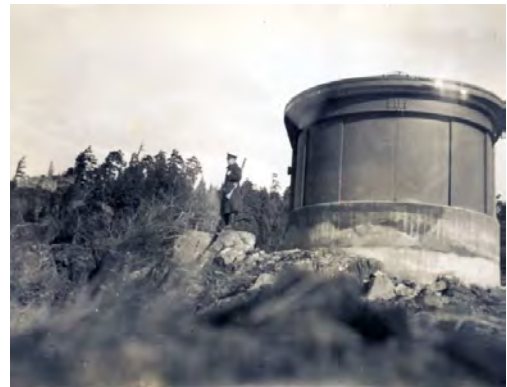
12B – Searchlight Emplacement. The intent of the searchlights was to highlight enemy vessels for the guns to range in on. They were also used as defence outposts with sandbagged positions on the roof such as this .50 cal machine gun position on #2 searchlight.

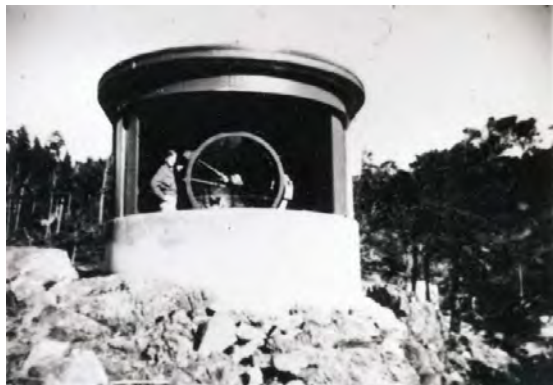
12D – Searchlight Emplacement. Each emplacement was equipped with a 60-inch Canadian General Electric Type B searchlight with 800, 000 candlepower each.
15FdMuseum994.25.07

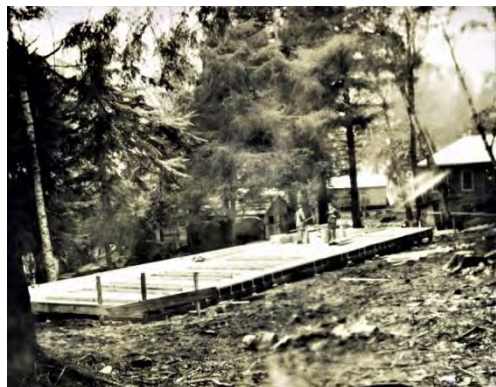
13A – Camp Area Construction. Civilian contractors and military personnel were employed in the construction of the wooden buildings in the camp area. *15FdMuseum985.88.114*

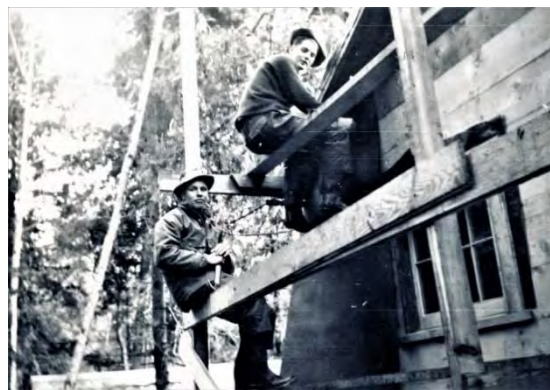
13B – Camp Area. The camp buildings were simply-made from locally-available materials, with very few specially imported components such as door hardware, window sashes and woodstoves. Typically, these were clad in either shiplap or tar-paper with battens, and fitted with site-made joinery and doors.
15FdMuseum985.88.010

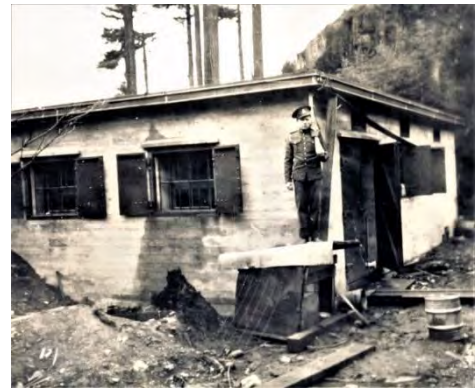
14B – Generator Building. The original generator was considerably smaller. *15FdMuseum985.88.018*

This two-room concrete structure contained the electrical power plant. It was built in two phases. The larger of the two rooms (and the first to be constructed) housed four, diesel-powered, electrical generators on concrete foundations with service channels cast into the concrete slab floor. One was a standby engine to maintain the flow of electricity whenever another engine was being serviced or had failed.

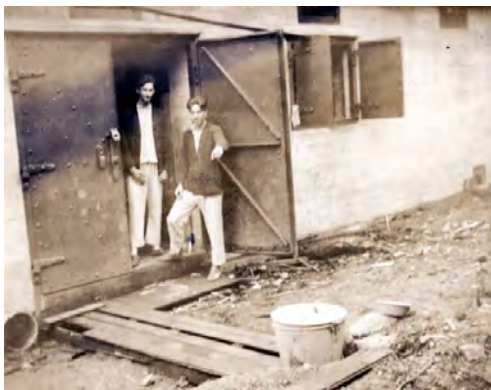
14C – Generator Building. Another early view of the generator building. *15FdMuseum985.88.056*

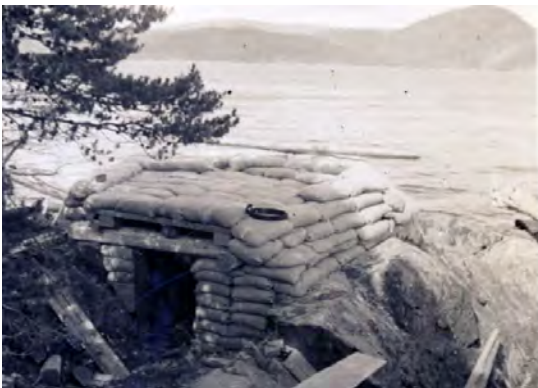
16A – Listening Post. One of the sandbagged positions located at either Gunners Post or Courtenay Bay Post.
RossKellerDJ01

Courtenay Bay Post was the northeastern most listening post. The original Courtenay Bay Post was located on the southern side of the bay and appears to have been a fortification in the form of a low pillbox constructed from sand bags and logs. Courtenay Bay post controls the northeastern approach to the island and was connected to the other perimeter posts by an inland trail. Like the other coastal observation posts and lights, electricity was provided to these posts and some remains of the network survive on site.

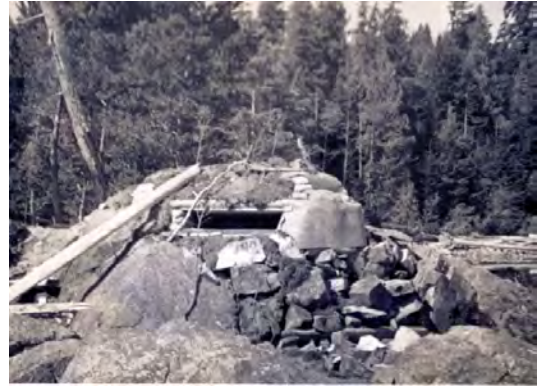
16B – Listening Post. Another view of one of the sandbagged positions located at either Gunners Post or Courtenay Bay Post. *RossKellerDJ02*

Gunners Post was the southeastern most listening post. Gunners Post controlled this approach to the island and was connected to the other perimeter posts by an inland trail. Like the other coastal observation posts and lights, electricity was provided to these posts and some remains of the network survive on site.
