Yorke Island 2018

Vancouver Artillery Association Yorke Island Project

Yorke Island Battery - Site Plan

YORKE ISLAND
 BATTERY

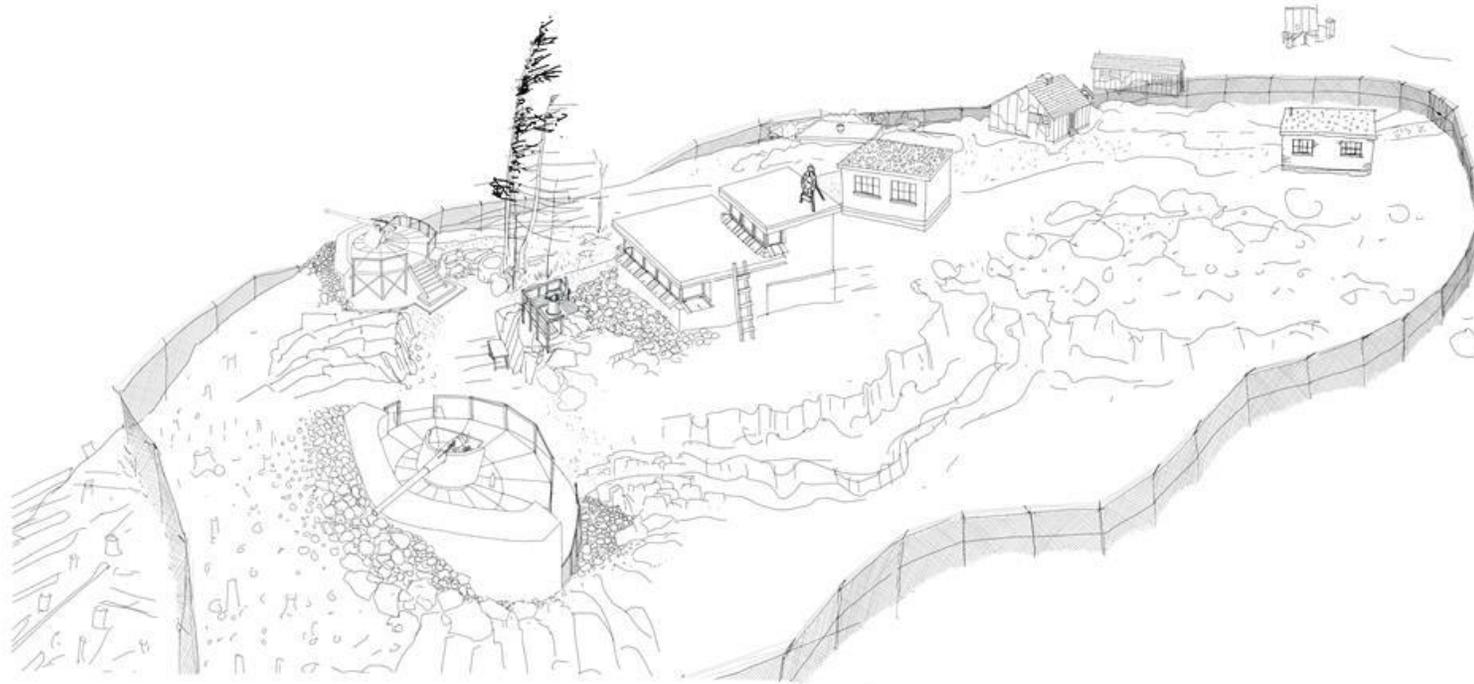
1938 Fort Layout, Sketch by R. Linzey.

Two 4.7-inch Quick Firing (QF) Mark IV guns on Mk III Garrison Carriages were installed in 1937.

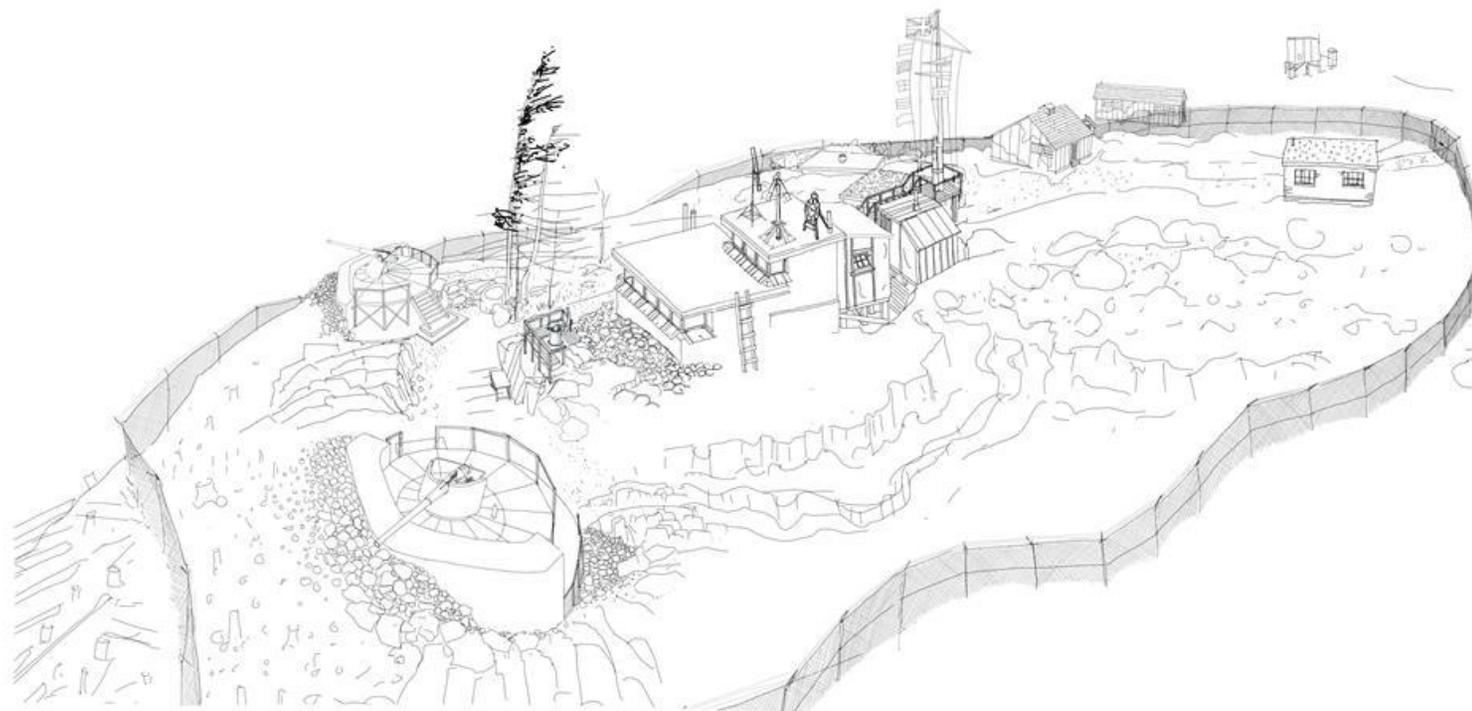
1939 Fort Layout, Sketch by R. Linzey

Semaphore and antennas mounted on roof of Battery Observation Post (BOP).

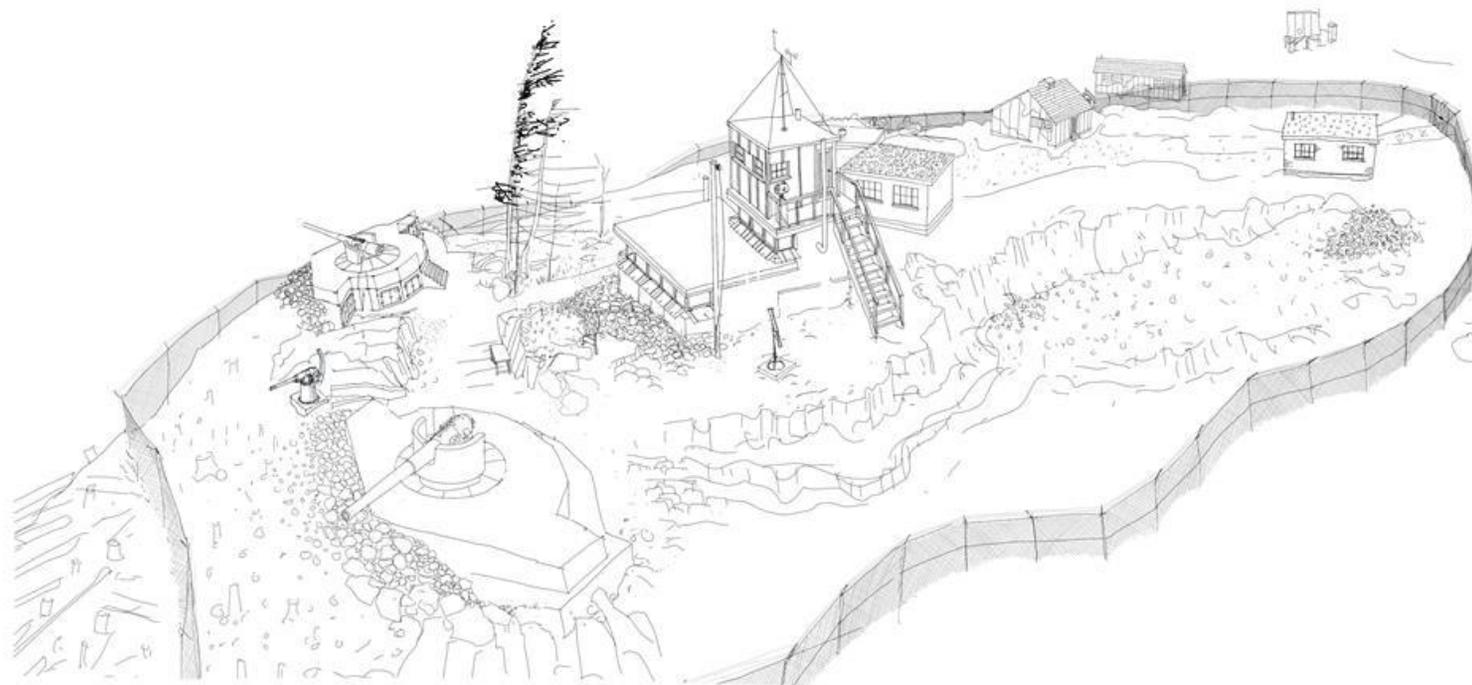
1943A Fort Layout, Sketch by R. Linzey

Two 6-inch Breech loading Mark VII guns on Mark II (L) CP Garrison Mounting
Guns traded from Stanley Park Fort – originally installed at the Citadel in Quebec City.

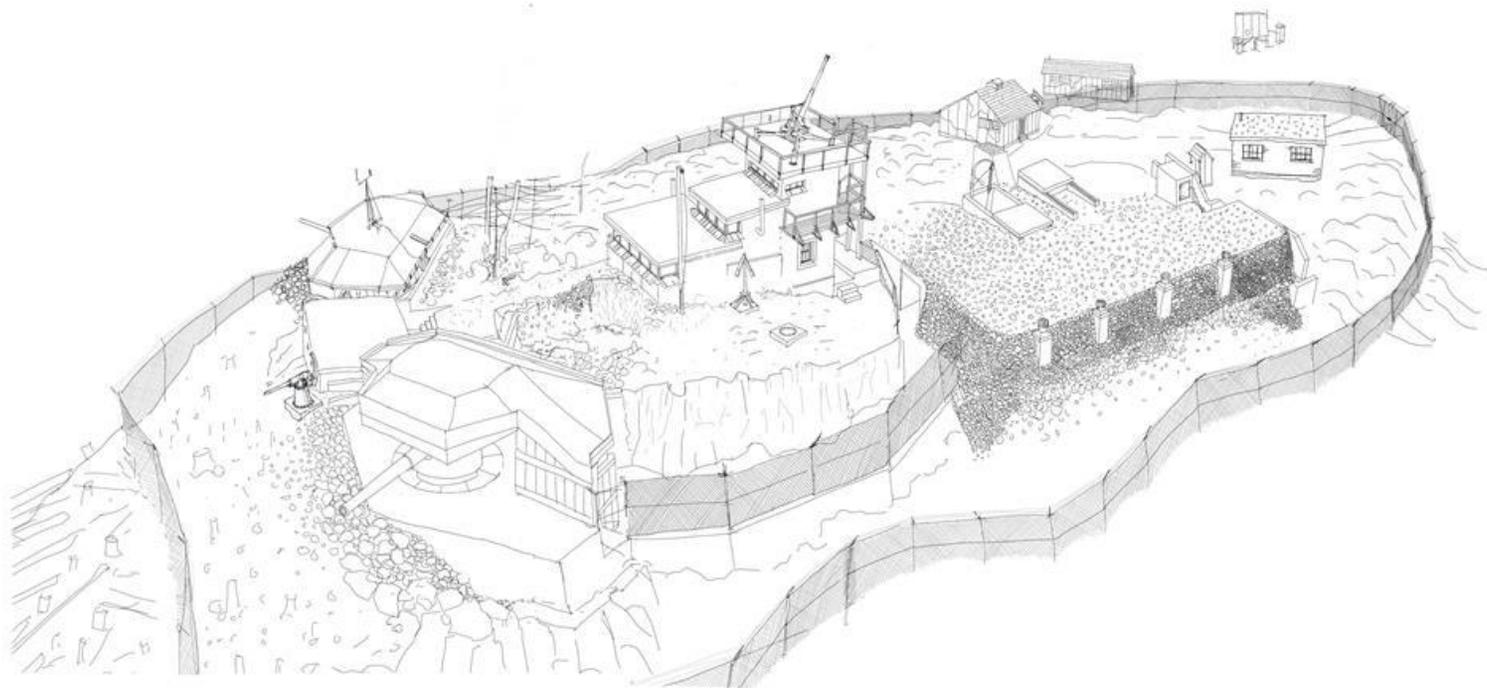
1943B Fort Layout, Sketch by R. Linzey

Overhead plastic armour cover on both guns installed.
