Hənłəmdʒi Məkola Yorke Island Conservancy

As-found Survey and
Condition Assessment

March 2018

HERITAGEWORKS

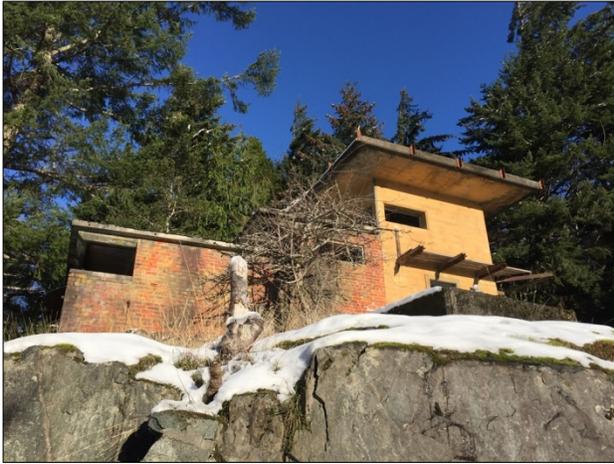
Left - South Elevation

The core structure of the Fire Command Post is in excellent condition. The roofs are in fair condition, but these have been damaged by visitors trying to access the Naval Signal Station and its rooftop.

Steel shutters enclose the Battery Observation Post and Searchlight Directing Station. These are in poor to moderate condition and some have been disconnected/disassociated from their original locations.

The exterior of the building is camouflage painted, and some of this remains in legible condition, though it has been vandalized recently with paintballs on the east elevation. Some of the exterior walls have also been marked with modern graffiti. The original camouflage paint is highly susceptible to damage.

Guardrails along the concrete apron to the south and east are missing.

0.2	<ul style="list-style-type: none"> Reinstate the metal shutters at the Battery Observation Post and Searchlight Directing Station; Stabilize the metalwork; Secure the shutters in place to prevent damage and/or injury to visitors. 	High

0.5	<ul style="list-style-type: none"> Strip existing roof, record camouflage paint scheme, and install new bitumen roofing to make all parts of the Fire Command Post watertight. 	Med

0.6	<ul style="list-style-type: none"> Remove paintball damage. 	Low
	0.7	<ul style="list-style-type: none"> Remove modern graffiti. 	Low

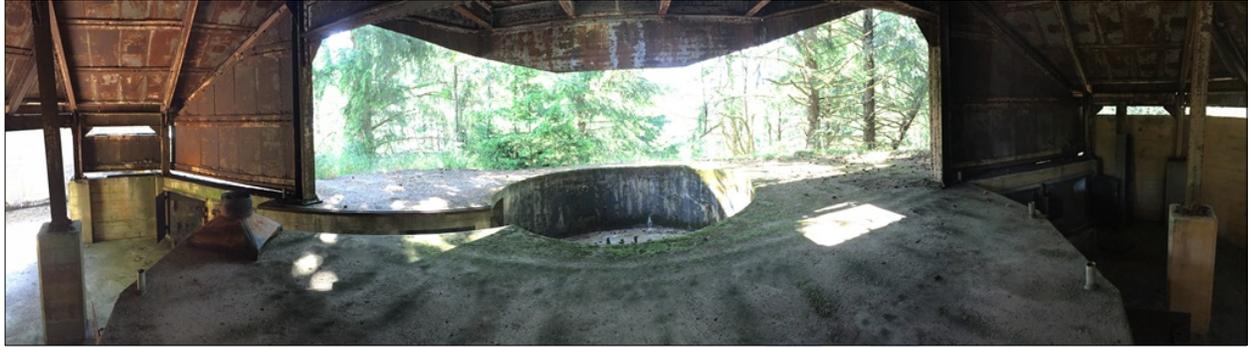
The high-quality of materials and workmanship of No. 1 Gun are character-defining elements of the structure. It is precisely because the building was so carefully designed and constructed, that it remains in such good condition today despite 60-years of abandonment. The concrete is in excellent condition, and despite some modest vandalism to exposed surfaces, the plastic armor is as well. The lower roof edges (at sides and rear) have wooden guards supported on metal posts to permit the installation of rock, brushwood and other natural camouflage over the Gun Shelter, though it doesn’t appear this was ever implemented. These are in variable condition depending on the roof aspect, with many of the boards lost or badly perished. The chief weakness of the building is its tar and gravel roof membrane. Seedling trees (wildings) have rooted in the accumulated leaf litter, disturbing the roofs. The roof is somewhat accessible, and visitor impacts include damage to the vegetation cover revealing the underlying bitumen, and thus increasing UV damage. In hot summer conditions the roofs warm up and the bitumen become pliable; making it easily damaged by people walking on it. In winter conditions the membranes are brittle. All the primary seams along the hipped roof are broken, allowing water to run under the roof armor and along structural members, contributing to the corrosion of steel members and their connections.

Interior of No 1 Gun showing apron and gun pit

Building	Scope Ref	Action Required	Priority
No 1 Gun & Shelter	I.1	<ul style="list-style-type: none"> Make repairs to the corroded steel columns and column base connections of gun shelters. 	High
	I.2	<ul style="list-style-type: none"> Clear all drains and ensure that they are operating effectively. 	High
	I.3	<ul style="list-style-type: none"> Make seismic upgrade to gun shelter by securing column heads to concrete wall; Add new bolts at empty connections of metal frame. 	High
	I.4	<ul style="list-style-type: none"> Repair lost and badly deteriorated retaining bolts and reinstate retaining flanges of plastic armor. 	High
	I.5	<ul style="list-style-type: none"> Treat remaining retaining bolts and flanges to inhibit corrosion. 	Medium
	I.6	<ul style="list-style-type: none"> Strip existing roof and install new bitumen roofing to make gun shelter watertight. 	Medium
	I.7	<ul style="list-style-type: none"> Reinstate historic barriers at some of the unguarded edges around gun pit. 	Medium

I.8	<ul style="list-style-type: none"> Install nuts and oversized washers on holdfast studs in gun pit. 	Medium
	I.9	<ul style="list-style-type: none"> Treat loose armor panel (originally from roof above gun pit) in-situ and support to minimize corrosion. 	Low
	I.10	<ul style="list-style-type: none"> Perform lead-abatement work to structural frame; Descale all exposed metal surfaces with needle gun; Treat all exposed metal surfaces with rust inhibitor; Treat all exposed metal surfaces with polyurethane. 	Low
	I.11	<ul style="list-style-type: none"> Treat expense lockers and make all hardware operable; Repaint locker doors while preserving original signage. 	Low
	I.12	<ul style="list-style-type: none"> Reestablish historic views forward of the gun, and northwest up Johnstone Straight (field of fire). 	Low
	I.13	<ul style="list-style-type: none"> Replace new wood perimeter around gun shelter roof. 	Low

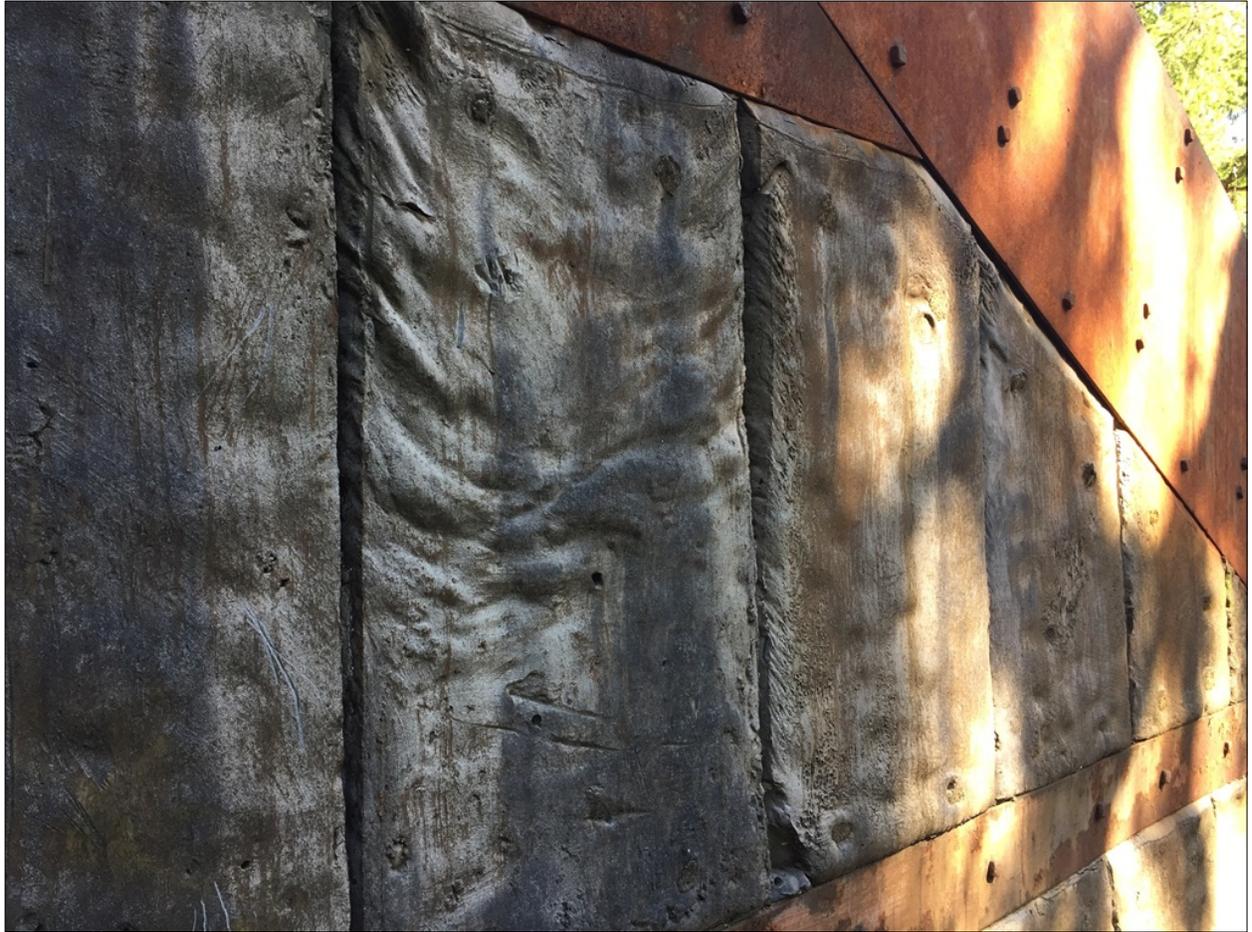
Detail of plastic armor on the north elevation of the gun shelter.

2.4	<ul style="list-style-type: none"> Repair lost and badly deteriorated retaining bolts and reinstate retaining flanges of plastic armor. 	High
	2.5	<ul style="list-style-type: none"> Reinstate historic barriers at west of apron using the existing, cast-in-place receivers. 	High

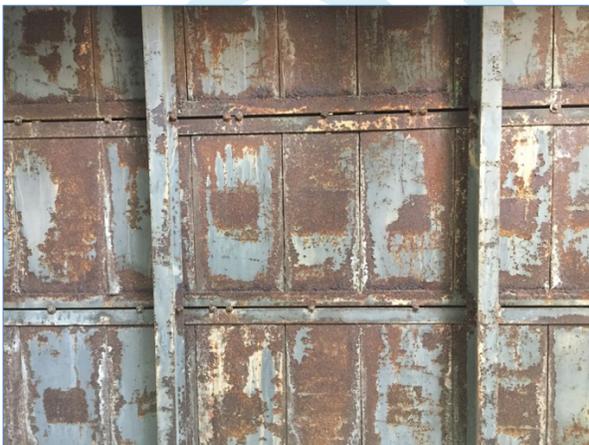
Left – Underside of plastic armor in the roof showing blue-grey paint scheme likely intended to resemble the sky when seen from the water below.

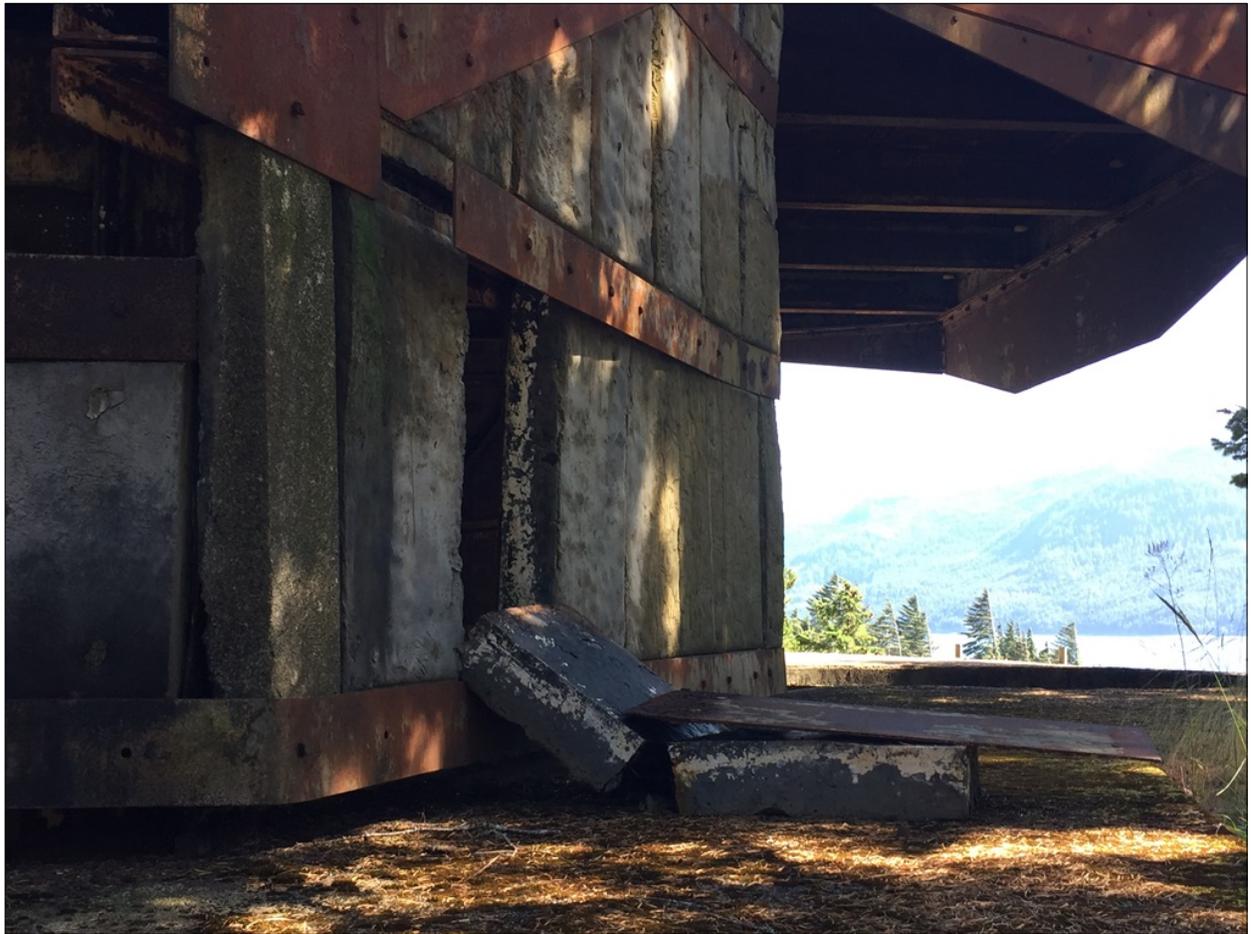
Collapsed panel of plastic armor at northeast corner of gun shelter

2.6	<ul style="list-style-type: none"> Reinstate the collapsed plastic armor panel. 	High
	2.7	<ul style="list-style-type: none"> Treat remaining retaining bolts and flanges to inhibit corrosion. 	Medium

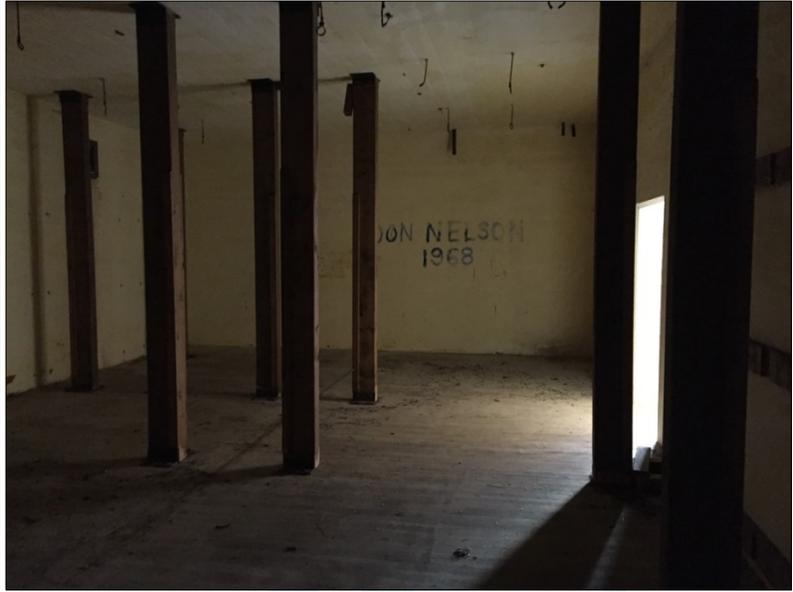
The floor on one of the Shell Stores has been damaged by fire, presumably lit by vandals.

Right – Interior of shell store

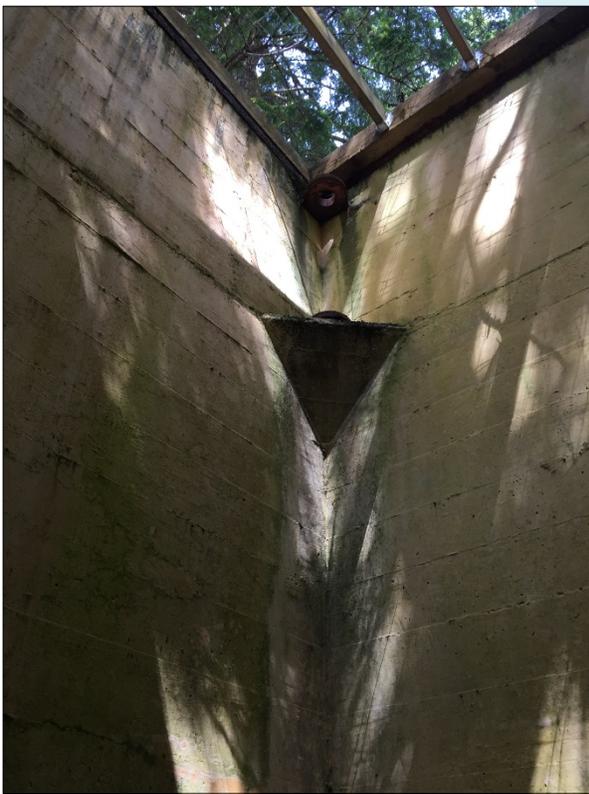
Left – Interior of ammunition well

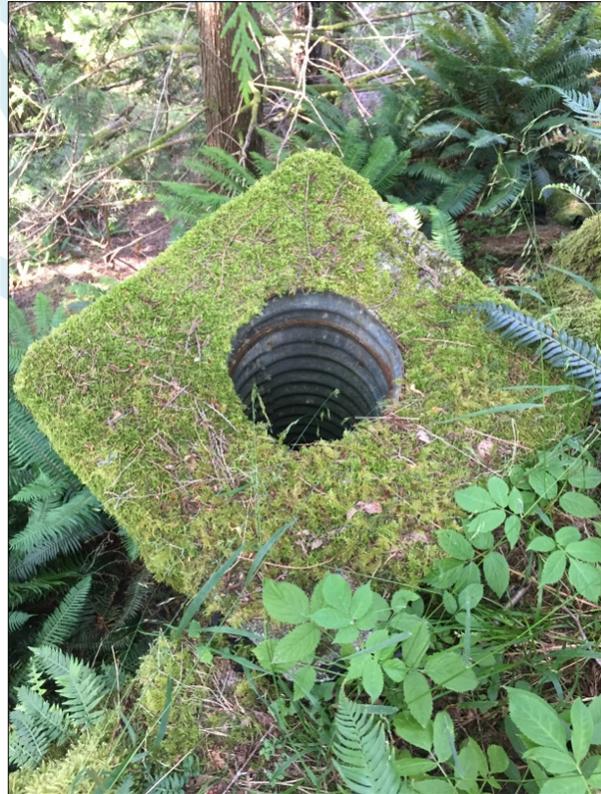
Right – Exterior top of ventilator flue

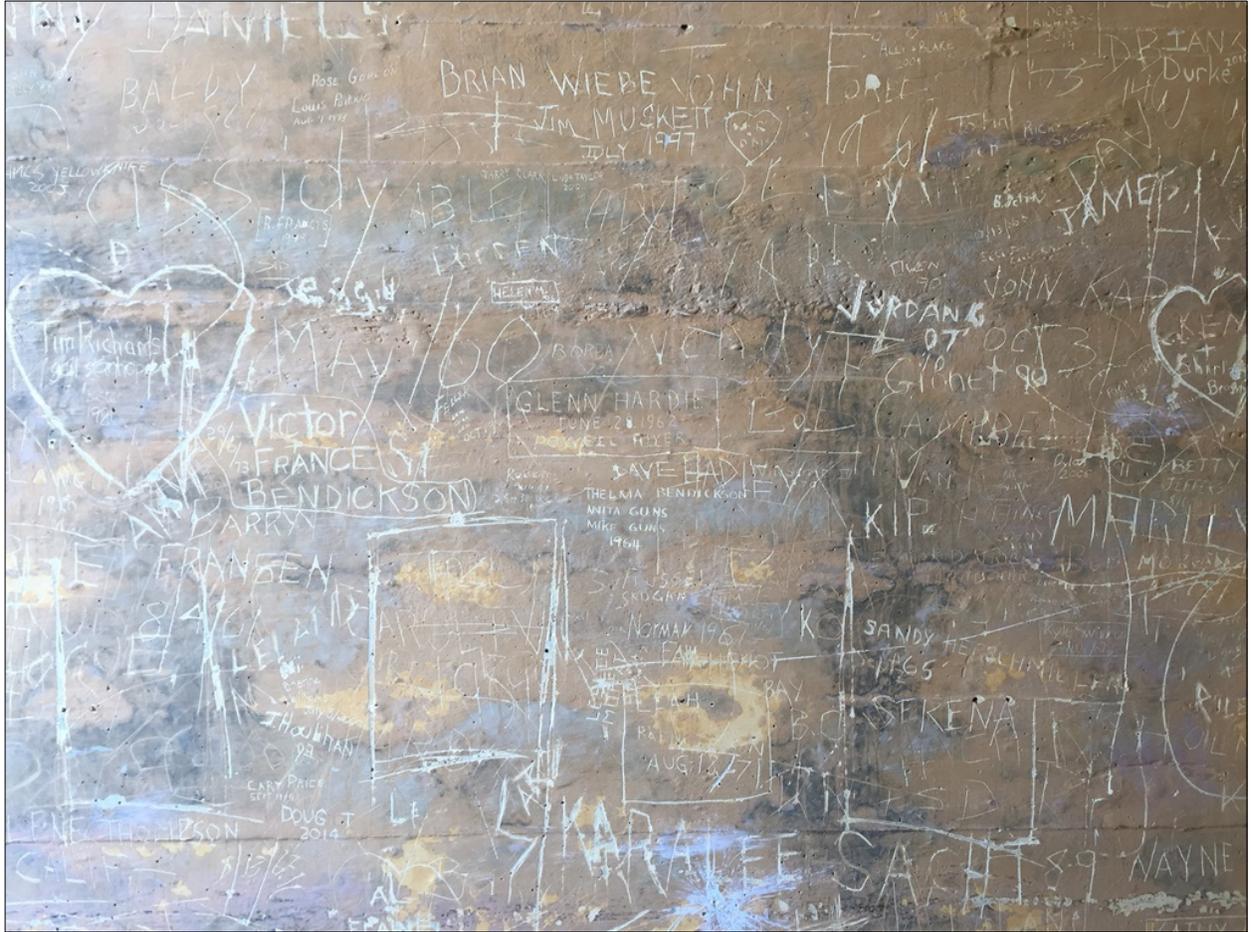
The passageway contains an extensive collection of modern graffiti that is scratched into the soft, rendered surfaces on both sides. There is modern painted graffiti within the shell stores.

Modern graffiti on wall of passage near west entrance

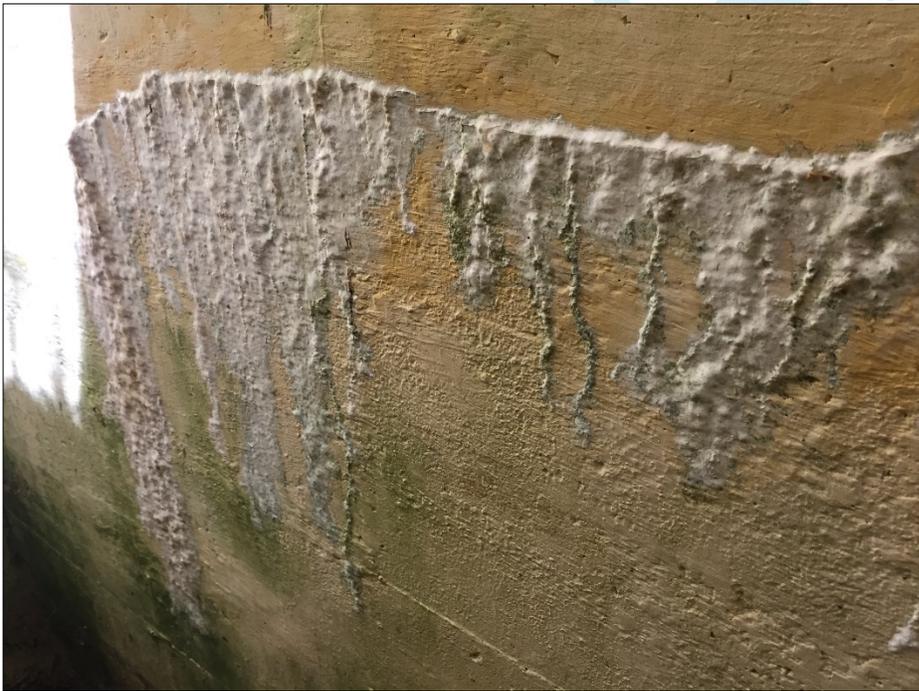
Like the Guns and the War Shelter, the high-quality of materials and workmanship in the New Magazine is character-defining. The thoughtful design and careful construction are also the main reasons that the building survives in such good condition. The concrete is in excellent condition throughout, with just one area of modest calcification at the Passage near the south entrance.

Calcification of concrete in the magazine

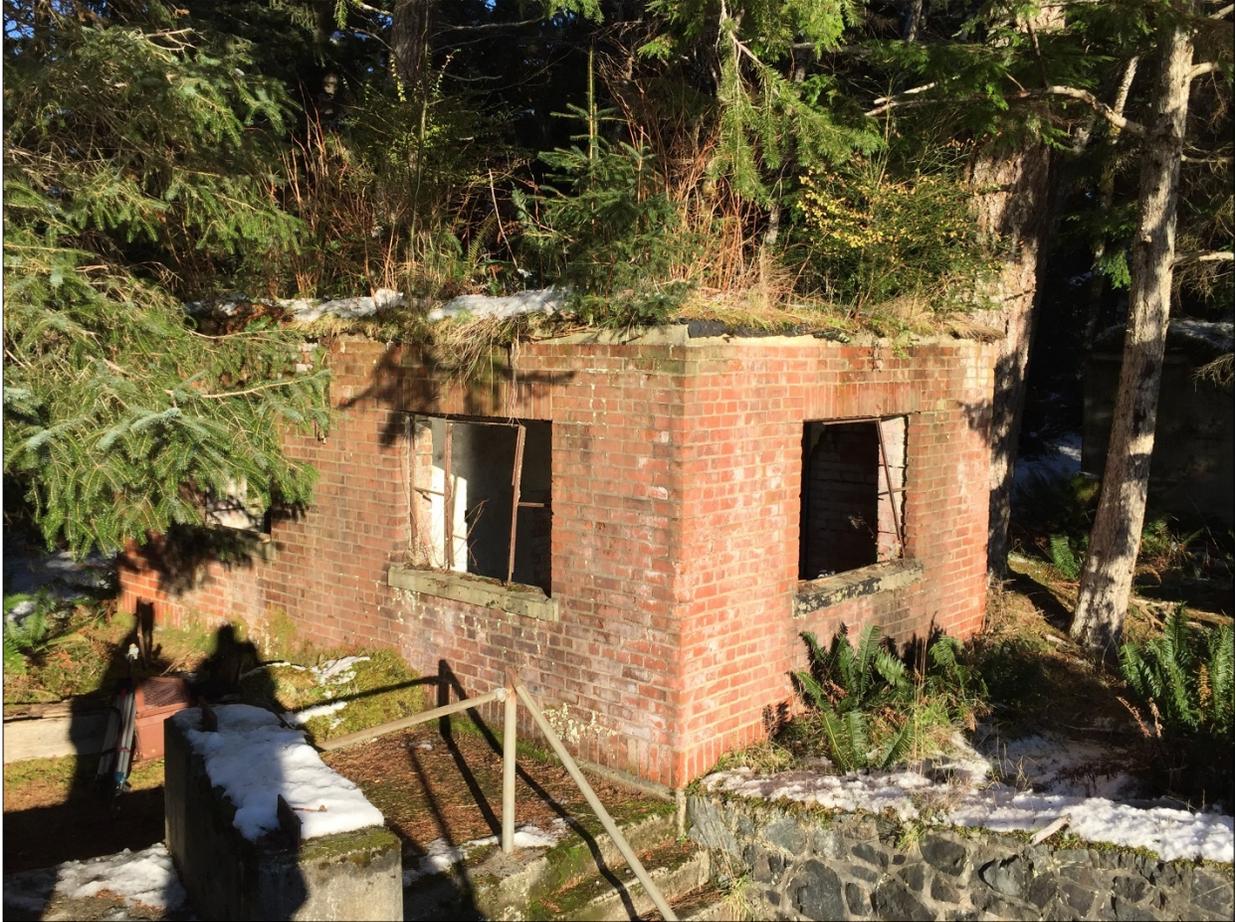
Northwest corner showing the extensive vegetation on roof

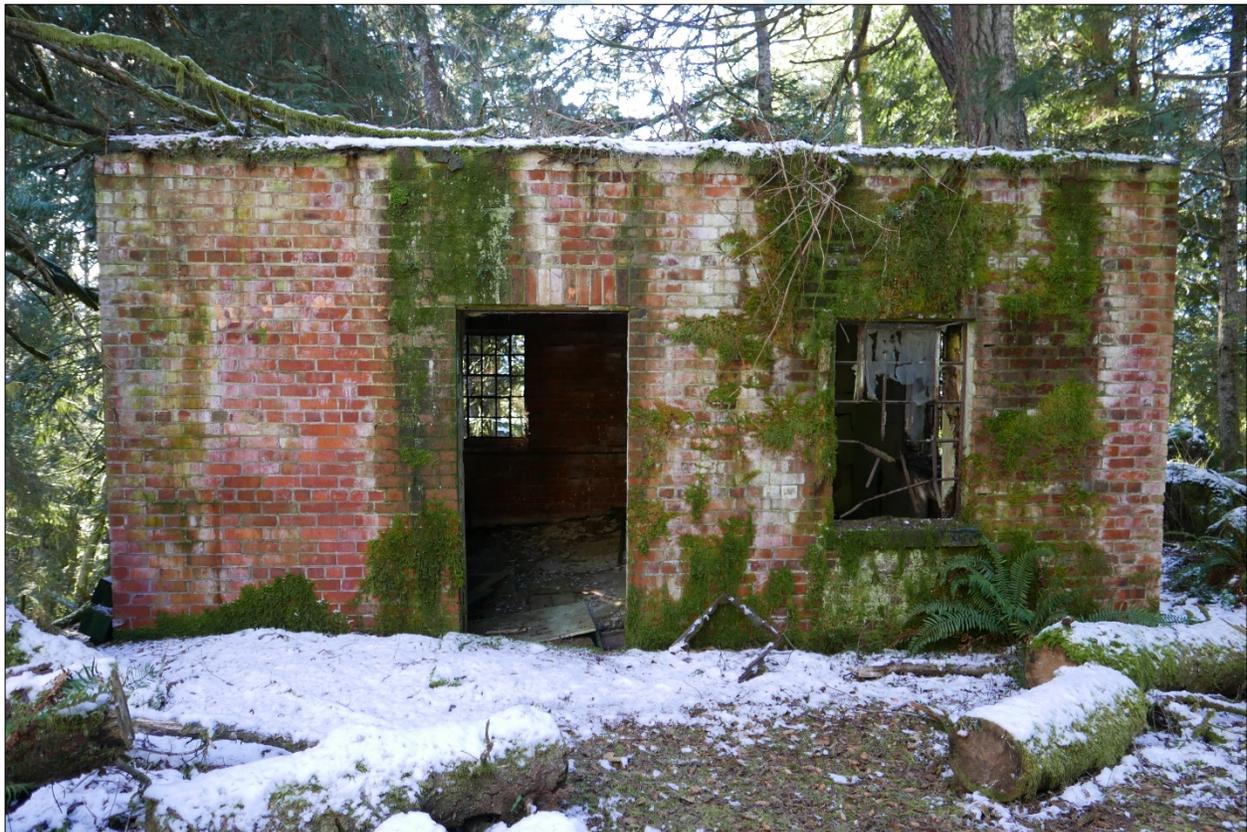
North elevation

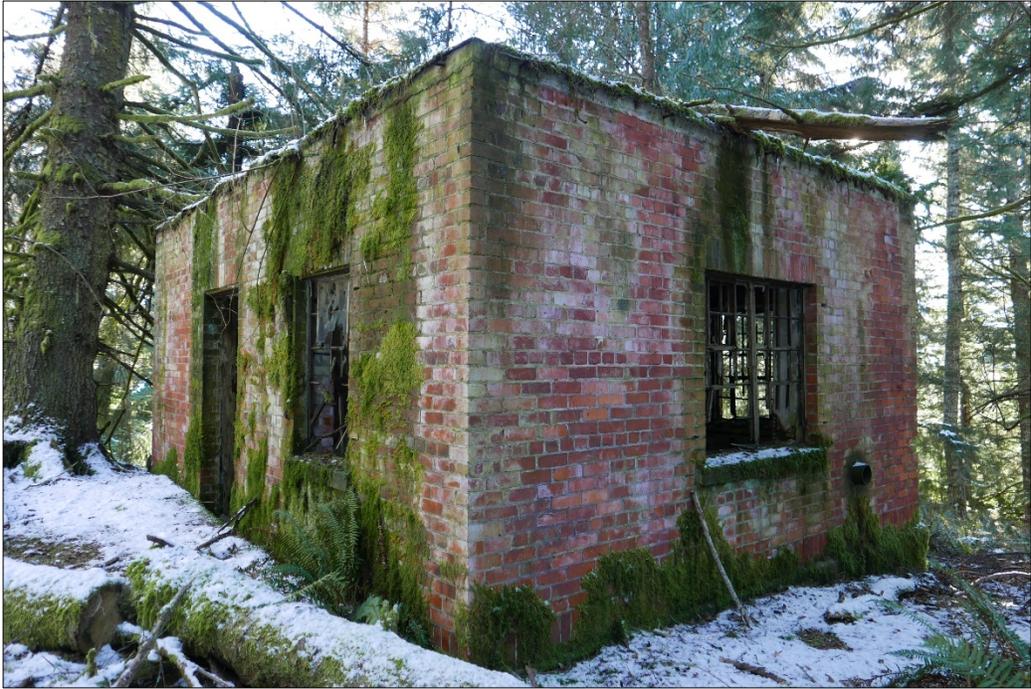
Exterior northwest corner

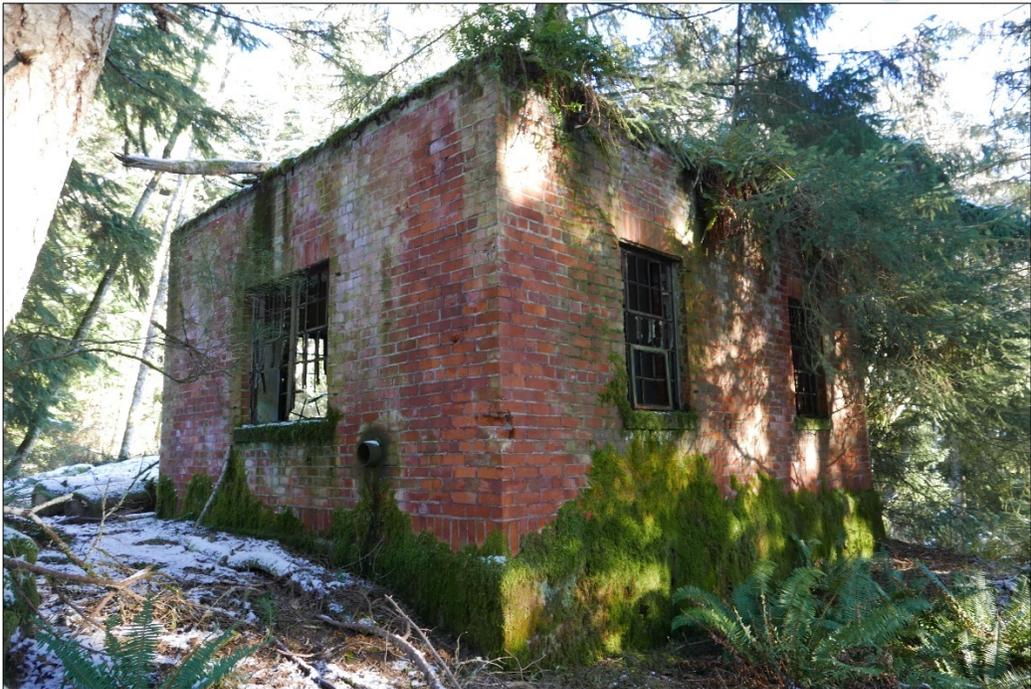
Exterior southwest corner

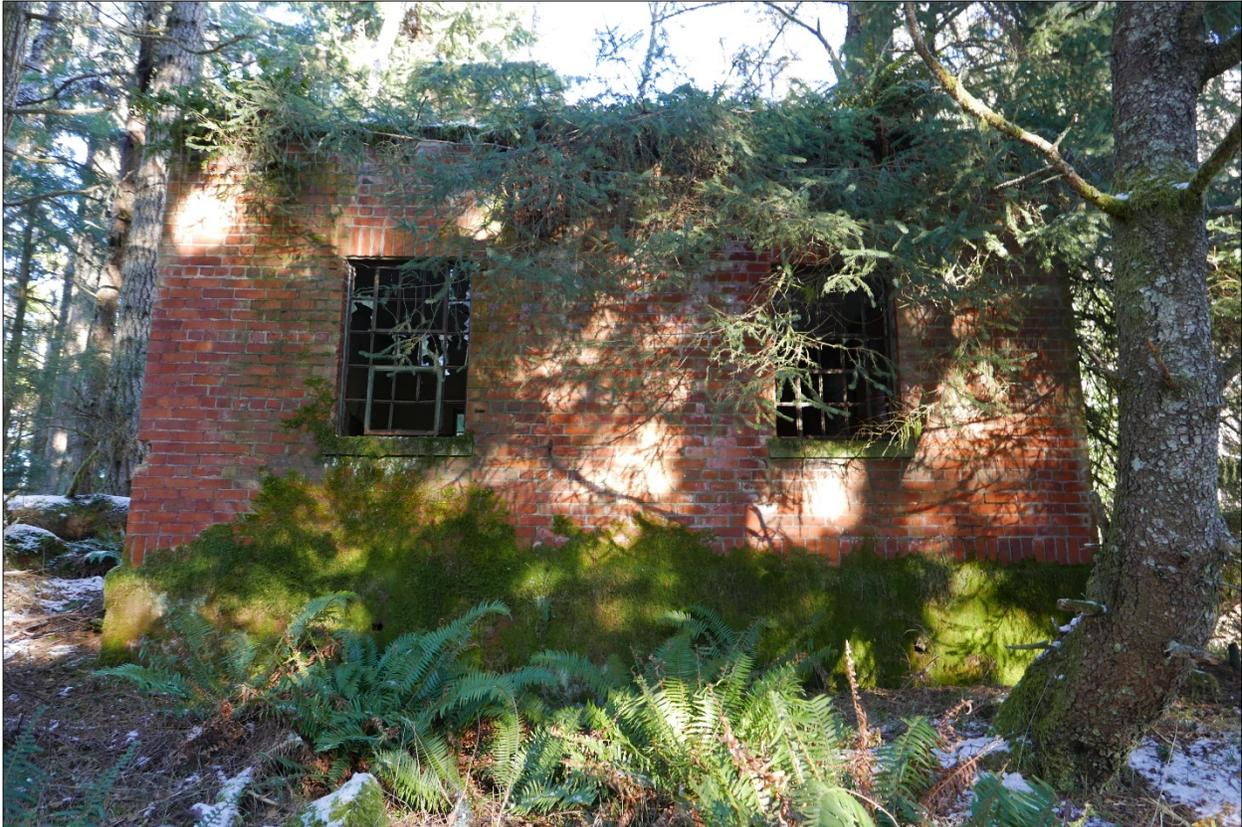
South elevation

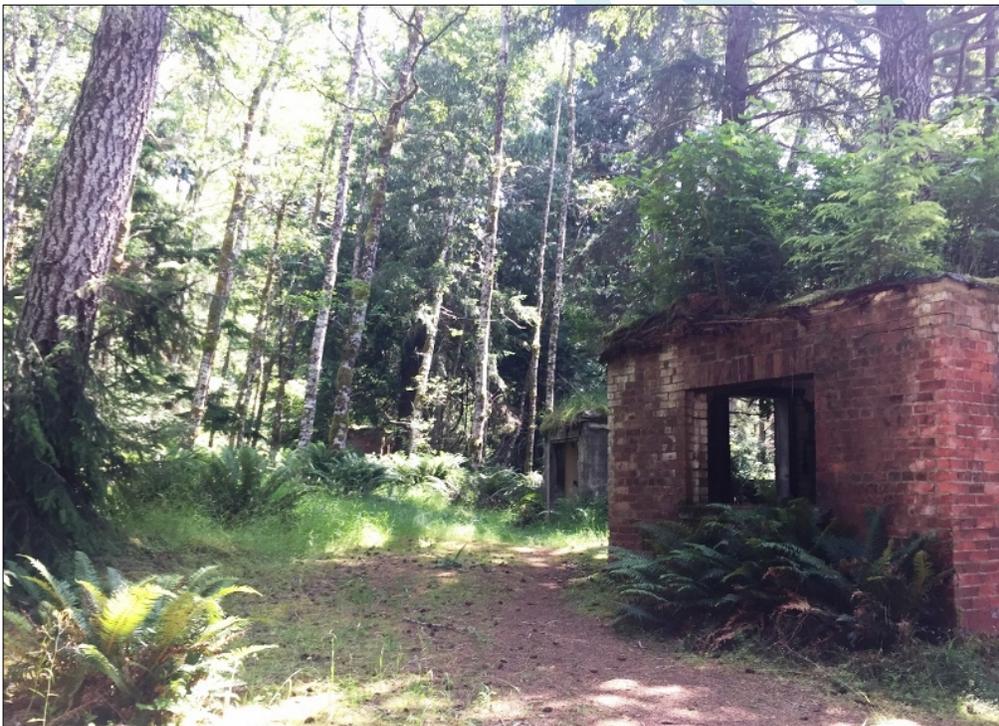
Modern view of the same landscape

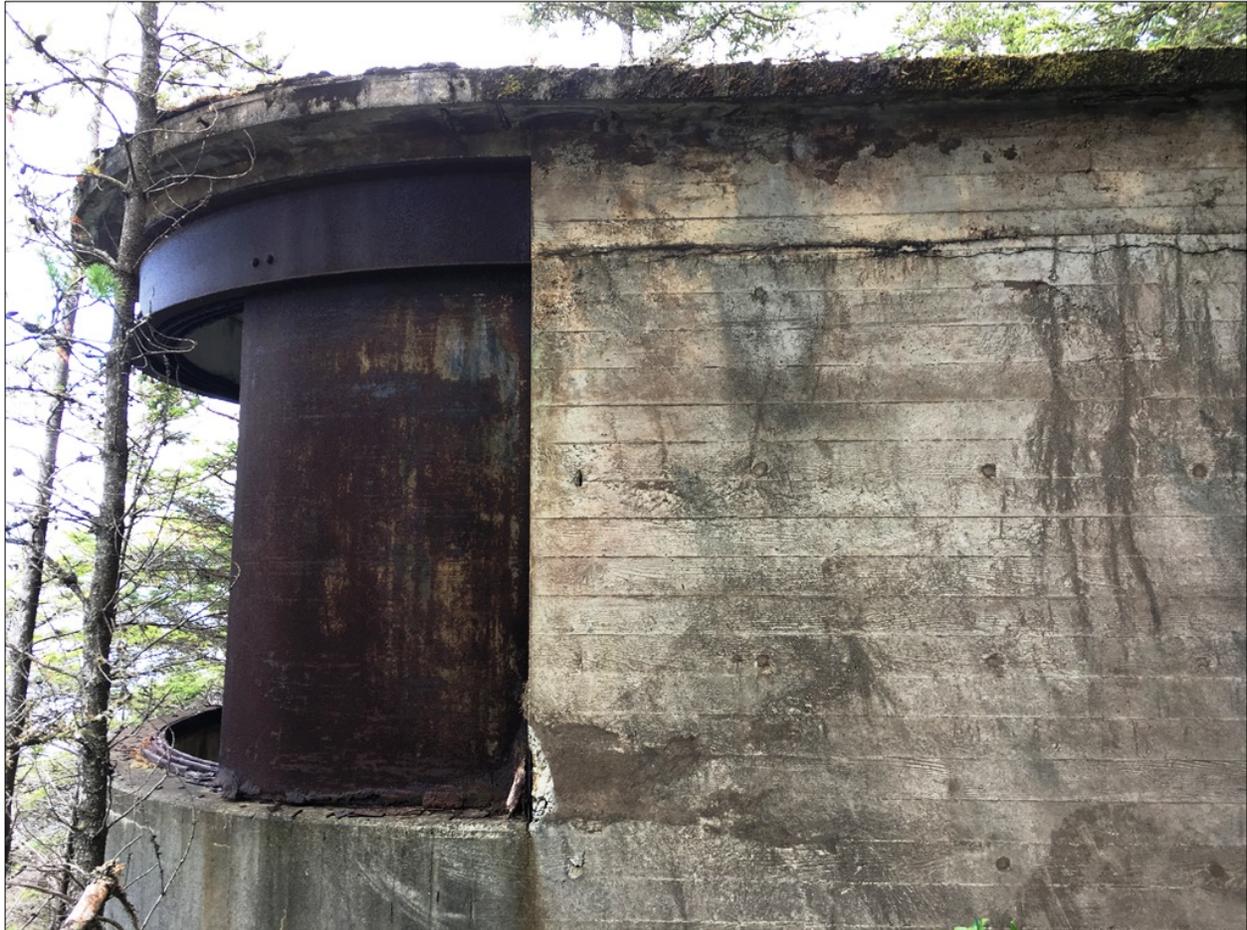
North elevation

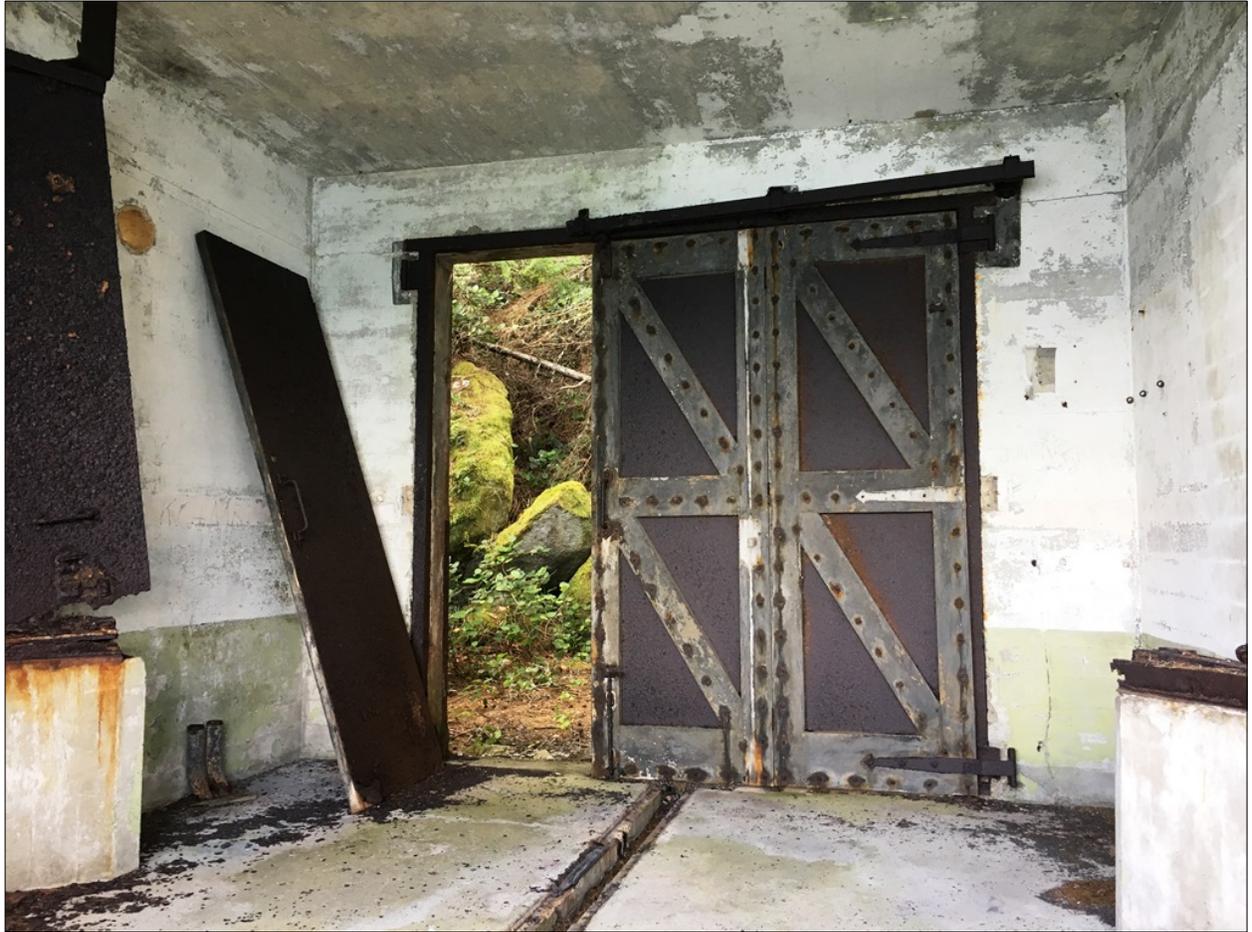
3 of the 3 original wood and steel doors are still in place and 2 of them are still mounted. The tracks are in poor condition and badly corroded.

Interior showing doors at east end of building and service trench in floor

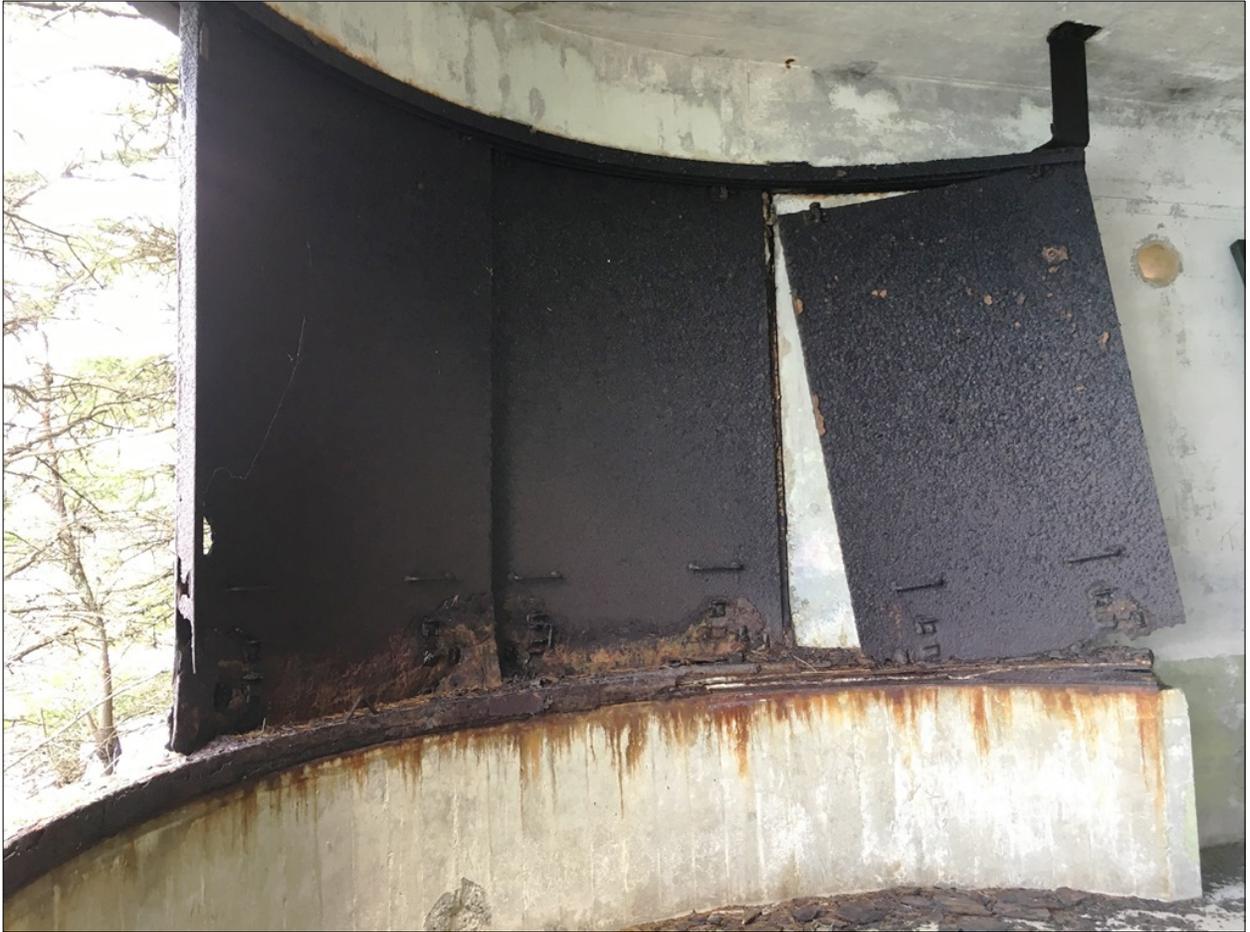
The metal tracks (cast in place) that support the steel shutters are badly corroded and continuing to decay. These are in poor condition.

Interior, showing shutters and tracks at northeast

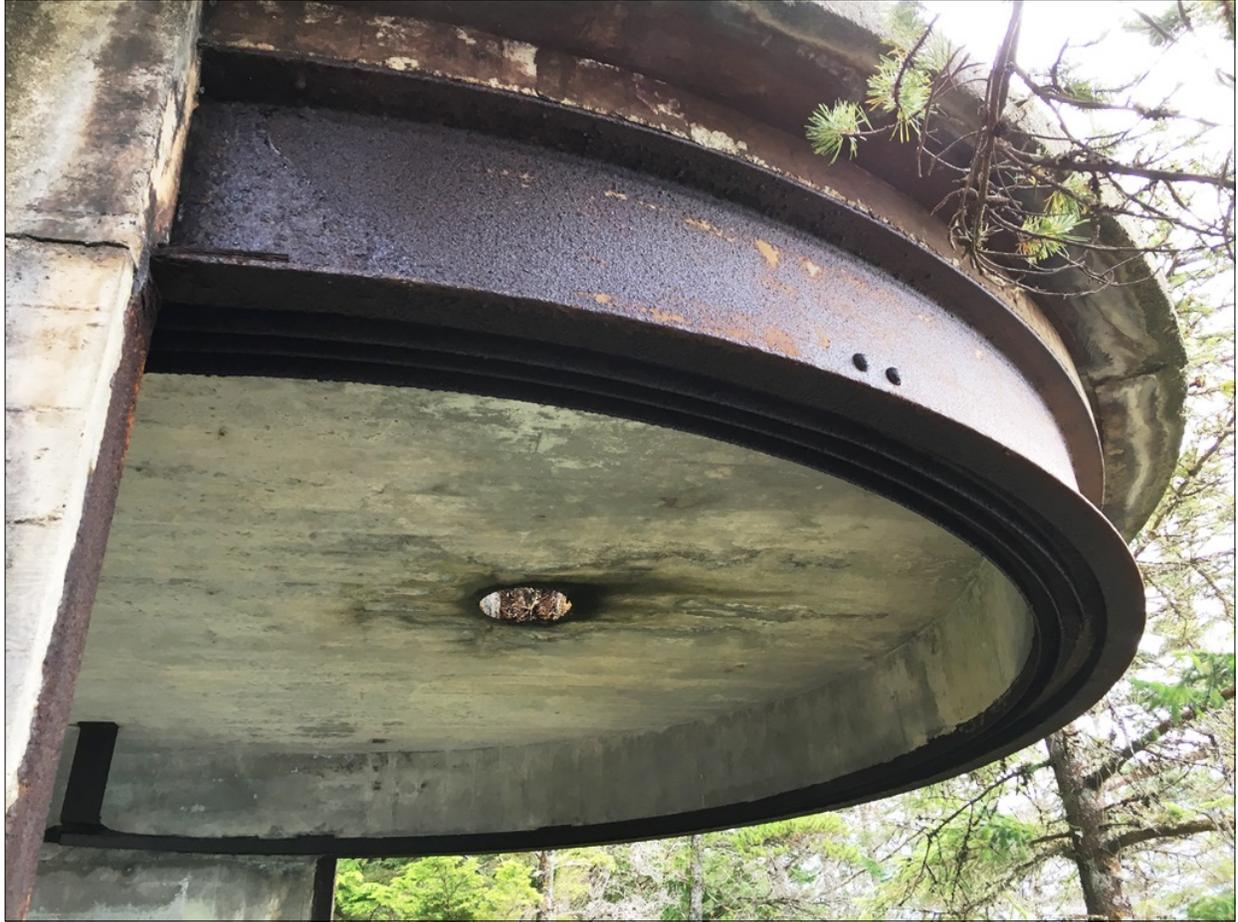
The structure is in very good condition despite its harsh marine environment. The curved-section steel beam that supports the cantilevered roof slab is very important to the structural integrity of the building. This beam is currently on good condition but it is essential that this is maintained in order to ensure the buildings longevity.

Building	Hazard	Likelihood	Severity	Priority
No 2 Searchlight	Continued corrosion of the curved and cantilevered metal beam that supports the roof slab, ultimately resulting in collapse of the roof.	High	High	High
	Damage to painted surfaces caused by visitors	Low	Med	Low
	Loss or damage to building features such as parts of the doors and shutters that have become dissociated	Med	Med	Med
	Continued corrosion of the metal parts resulting in loss of historic features	High	High	High

Iron beam supporting cantilevered roof slab at north end of the light

Building	Scope Ref	Action Required	Priority
No 2 Searchlight	12.1	<ul style="list-style-type: none"> • Descale exposed metal surfaces of cantilevered beam above shutters with needle gun; • Treat with rust inhibitor; • Treat with polyurethane. 	High
	12.2	<ul style="list-style-type: none"> • Stabilize the shutters and tracks; • Treat all exposed metal parts. 	High
	12.3	<ul style="list-style-type: none"> • Repair the doors and make operable; • Treat all exposed metal parts. 	Med
	12.4	<ul style="list-style-type: none"> • Restore historic sightlines to ocean by selectively pruning/clearing shoreline trees. 	Med

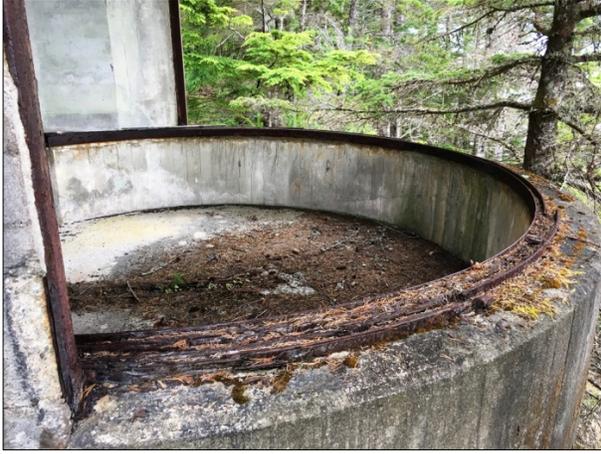
The metal tracks (cast in place) that support the steel shutters are badly corroded and continuing to decay. These are in poor condition.

Left – Tracks for shutters

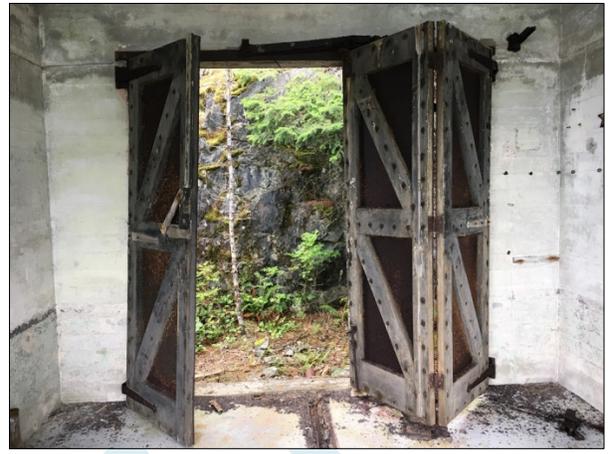
3 of the 3 original wood and steel doors are still in place. This is the best surviving example of the doors. The tracks are in poor condition and corroded.

Right – Interior showing doors at east end

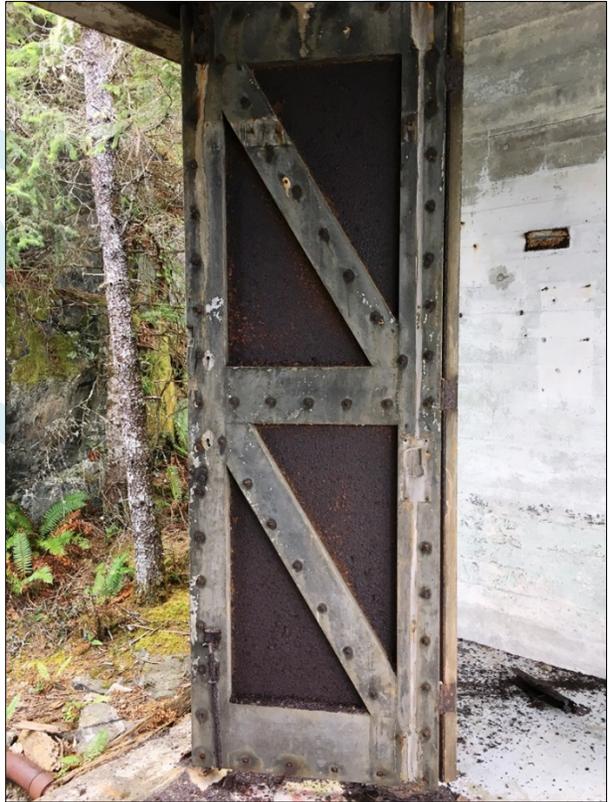
Right – Interior of doors at east elevation

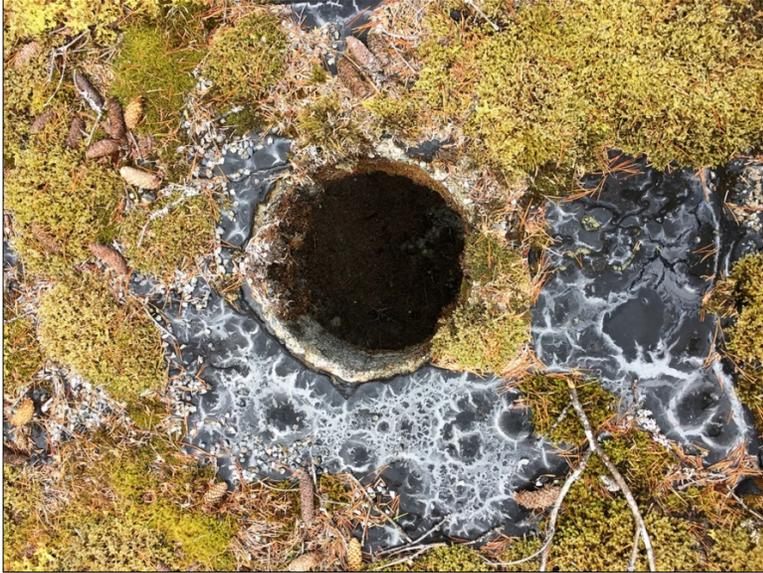
Left – Detail of ventilation hole at roof (from above)

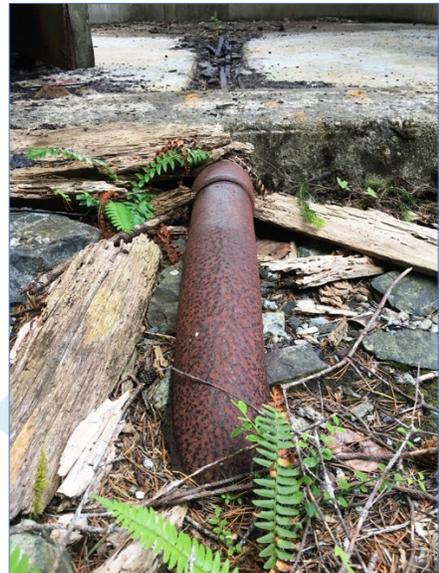
Right – Service conduit at entrance

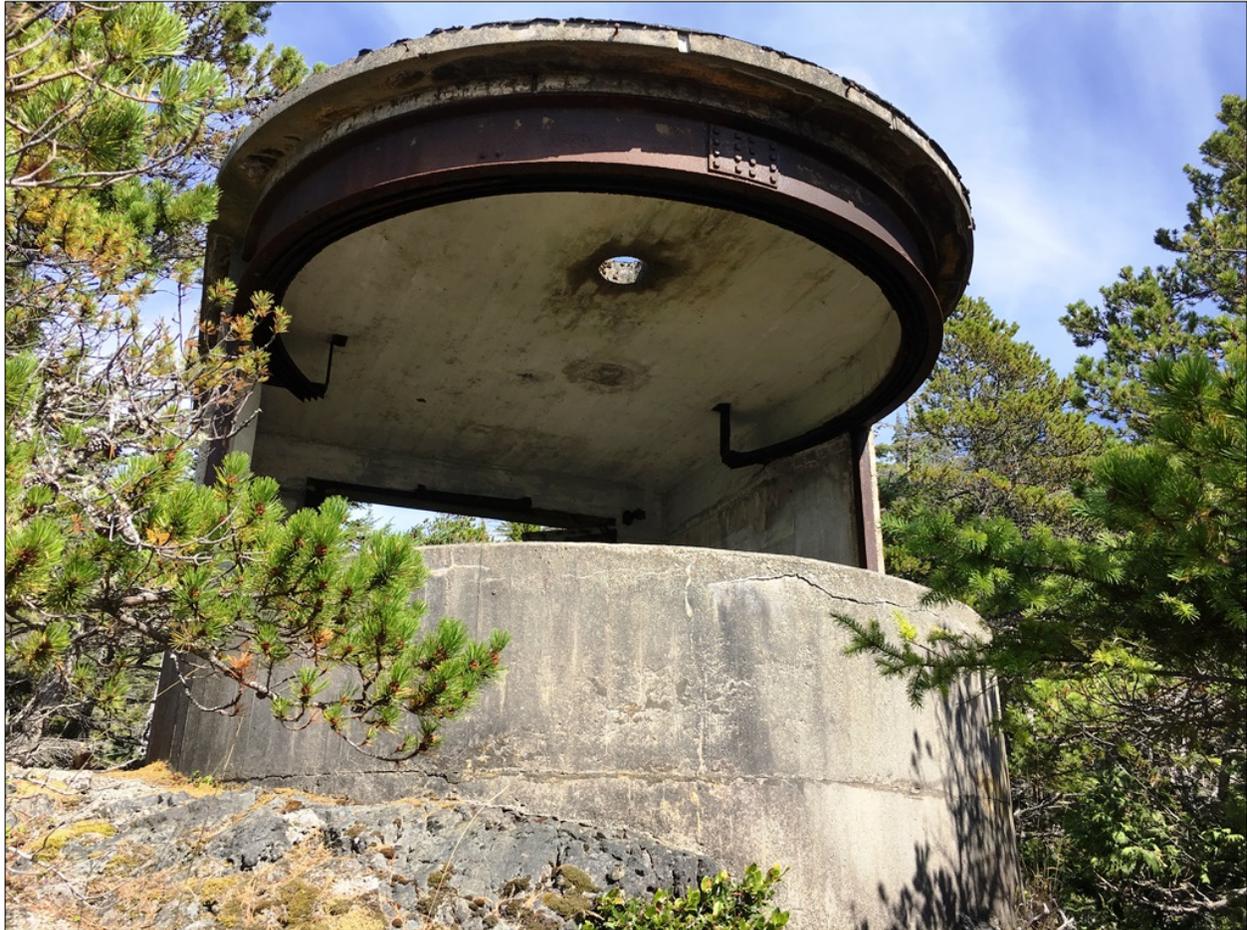
Northwest elevation

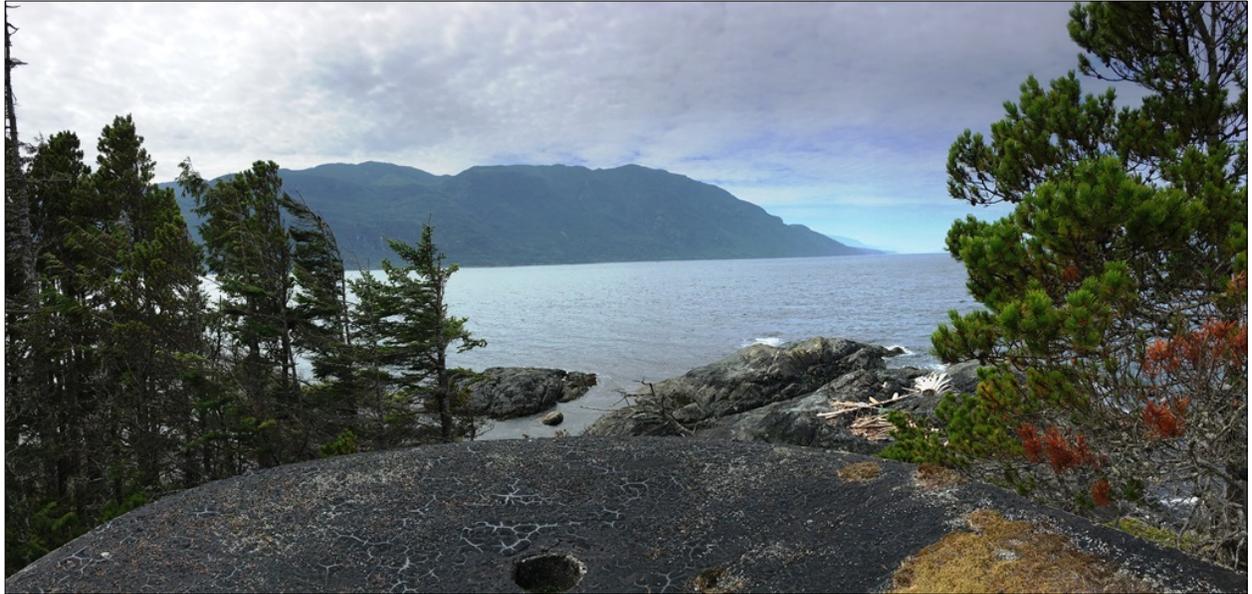
The roof is in fair condition.

Roof, view towards northwest
