Hənłəmdʒi Məkola Yorke Island Conservancy

As-found Survey and
Condition Assessment

March 2018

HERITAGEWORKS

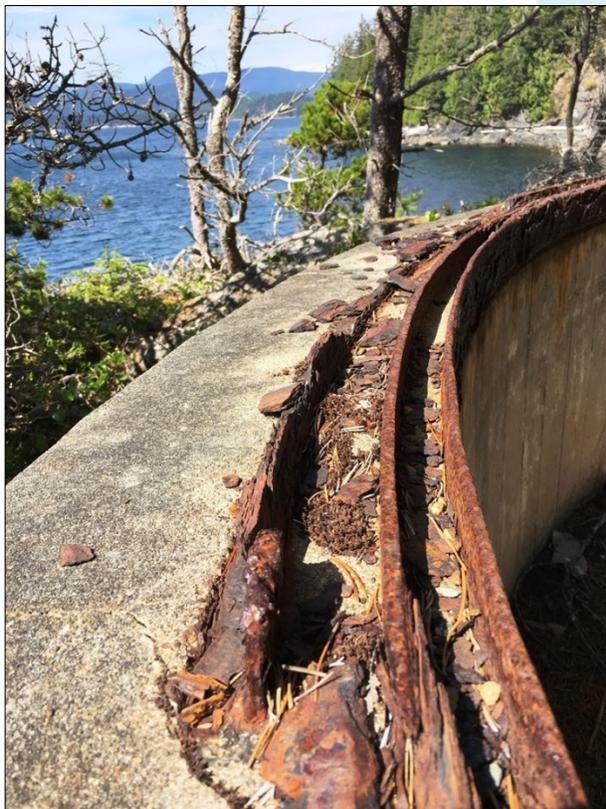
The metal tracks (cast in place) that support the steel shutters are badly corroded and continuing to decay. These are in extremely poor condition.

Left – Detail of shutter tracks

Right – Detail of shutter tracks

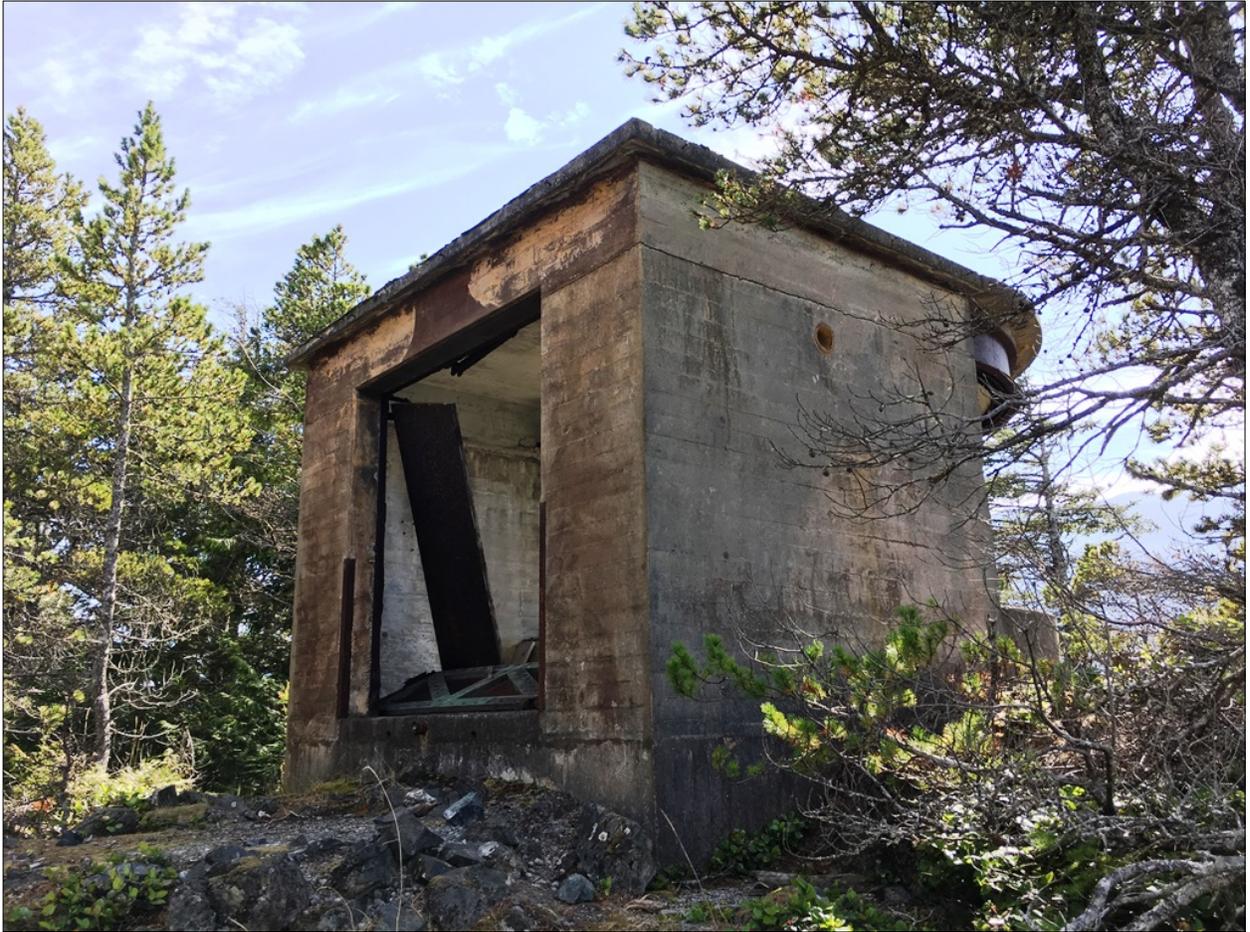
East corner

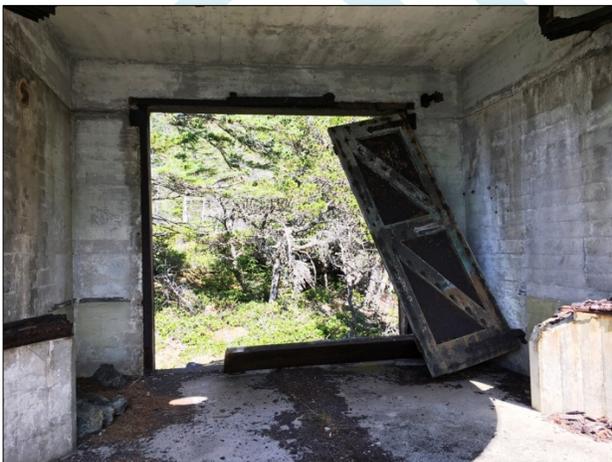
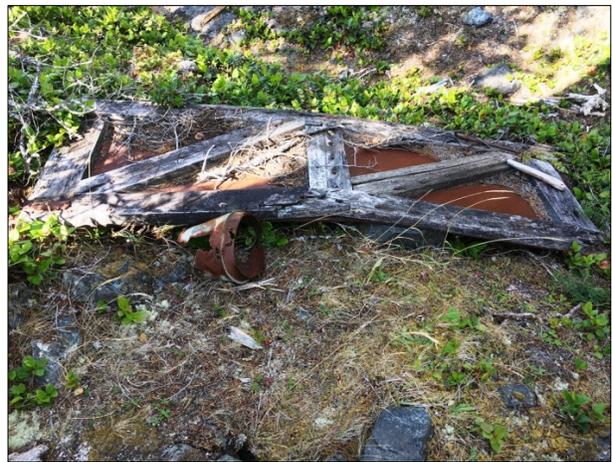
2 of the 3 original wood and steel doors are still inside the building and partially attached while the third panel is lying in the environs nearby. The tracks are in poor condition and badly corroded.

Left – Interior showing doors at southeast elevation **Right** – One of the doors in landscape north of light

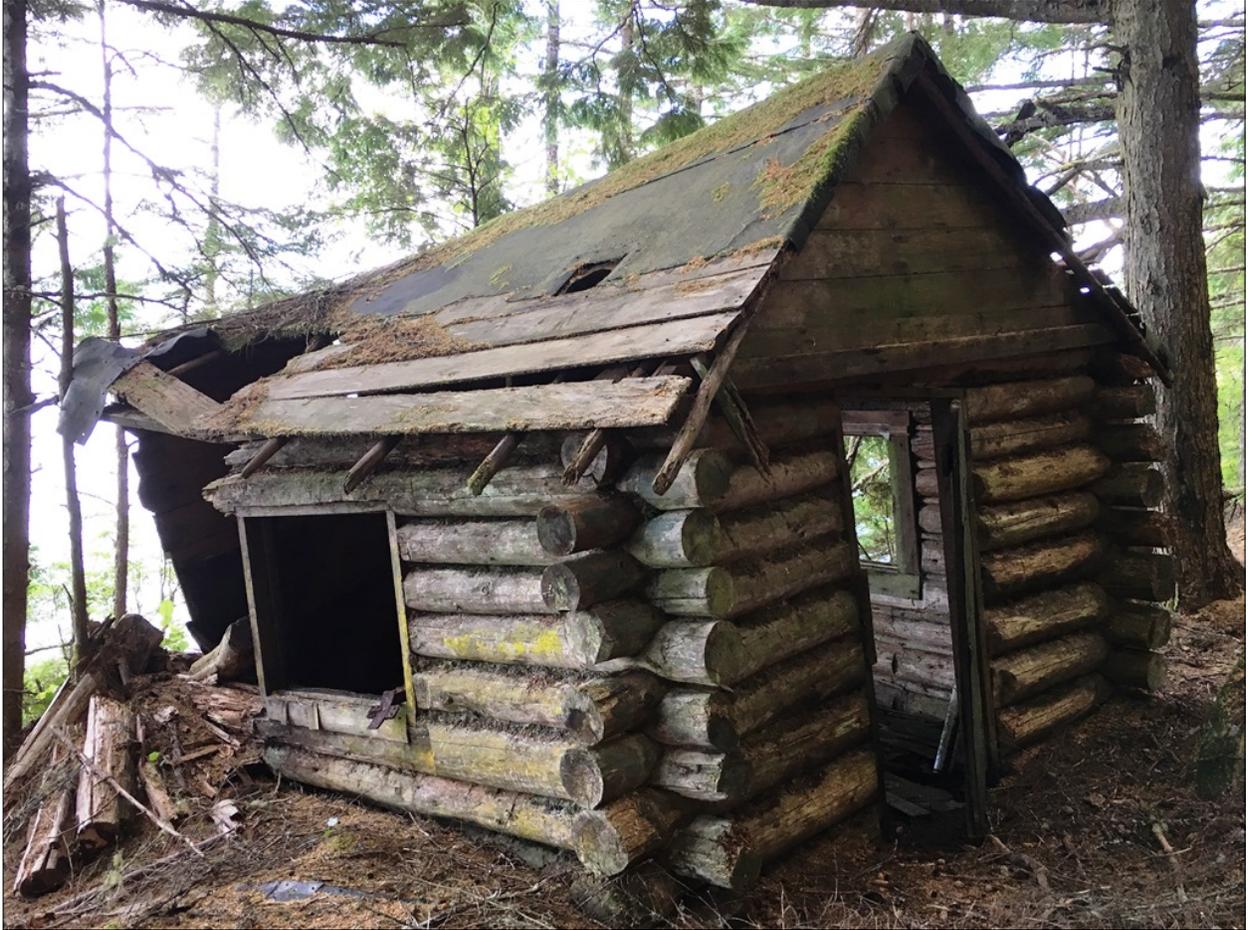
Northwest corner

The building is partially-collapsed and hazardous. Some of the logs are missing, and those that remain are generally soft, but the partially-collapsed roof is still providing some cover. Sufficient information currently exists in the building to understand and interpret all of the original building features. With an appropriate team the Sunderland Post can be repaired.

Building	Scope Ref	Action Required	Priority
Sunderland Post	14.1	<ul style="list-style-type: none"> Record the site; Repair the log structure; Repair the roof and make watertight; Carefully document and remove all contents; Repair/replace the floor; Repair the windows, doors and furniture. 	High
	14.2	<ul style="list-style-type: none"> Windsafe the adjacent forest. 	High
	14.3	<ul style="list-style-type: none"> Restore the historic sentry paths between building and the island perimeter trail. 	Medium
	14.4	<ul style="list-style-type: none"> Restore historic sightlines to ocean by selectively pruning/clearing shoreline trees. 	Low

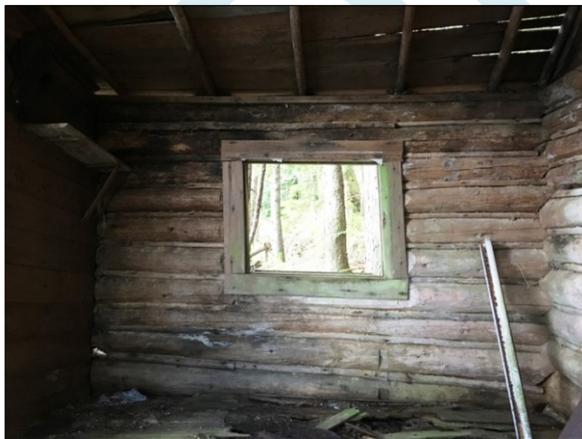
Left – Interior showing window at south wall

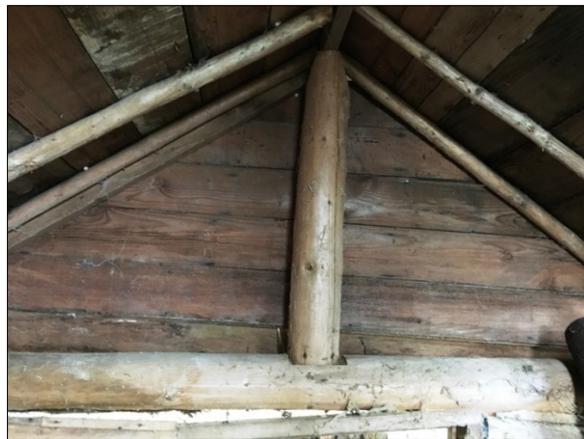
Right – Interior, simple roof truss at west wall

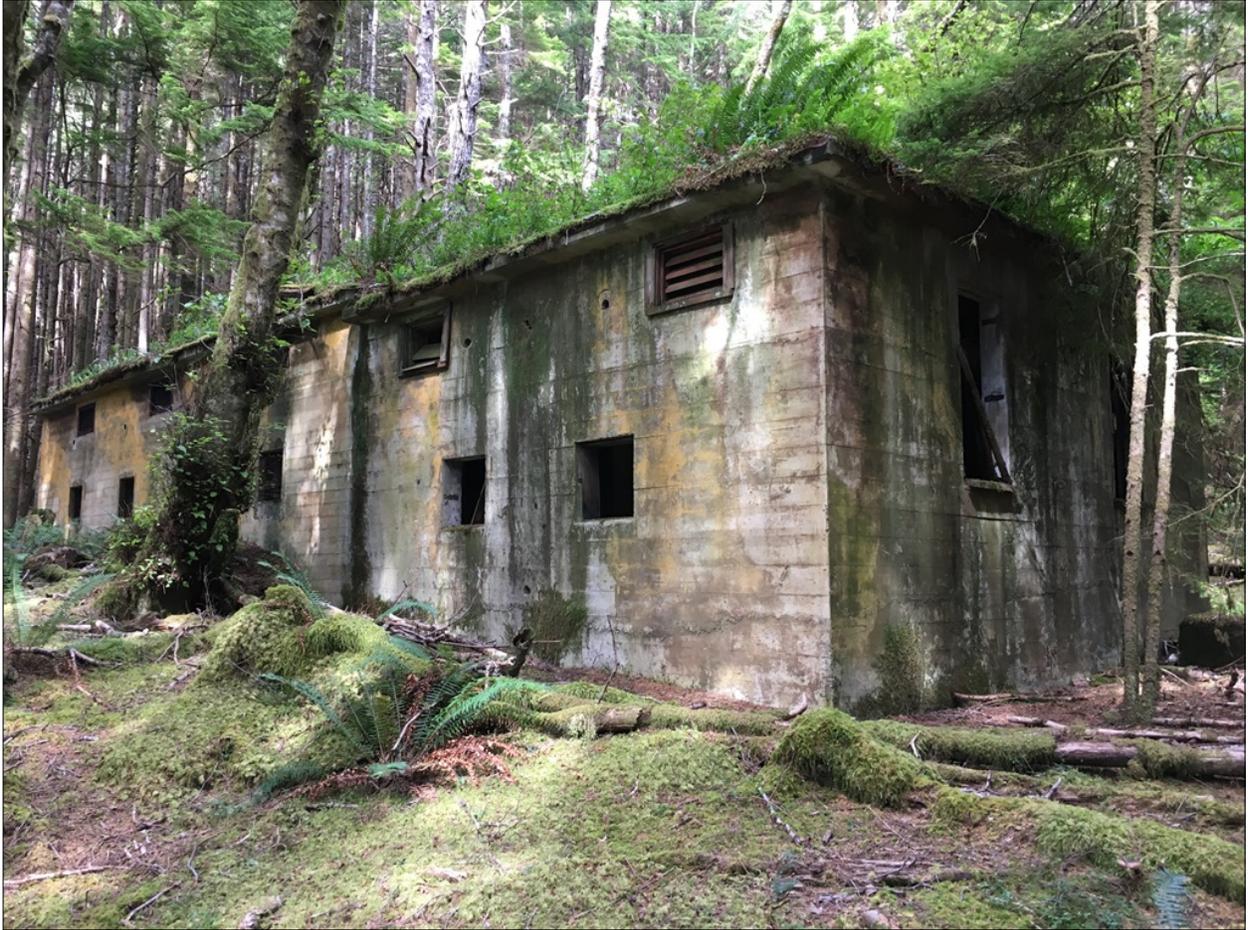
Southwest corner.

The structure is generally in very good condition though several trees have fallen against it. The large steel doors are still in place (or nearby) and they are in fair/good condition. The interior of the southern space has been damaged by vandals, and there is a lot of debris on the floor in this area.

17.2	<ul style="list-style-type: none"> Remove deadfall. 	High
	17.3	<ul style="list-style-type: none"> Repair the doors and fix in open position; Treat all exposed metal parts. 	Medium

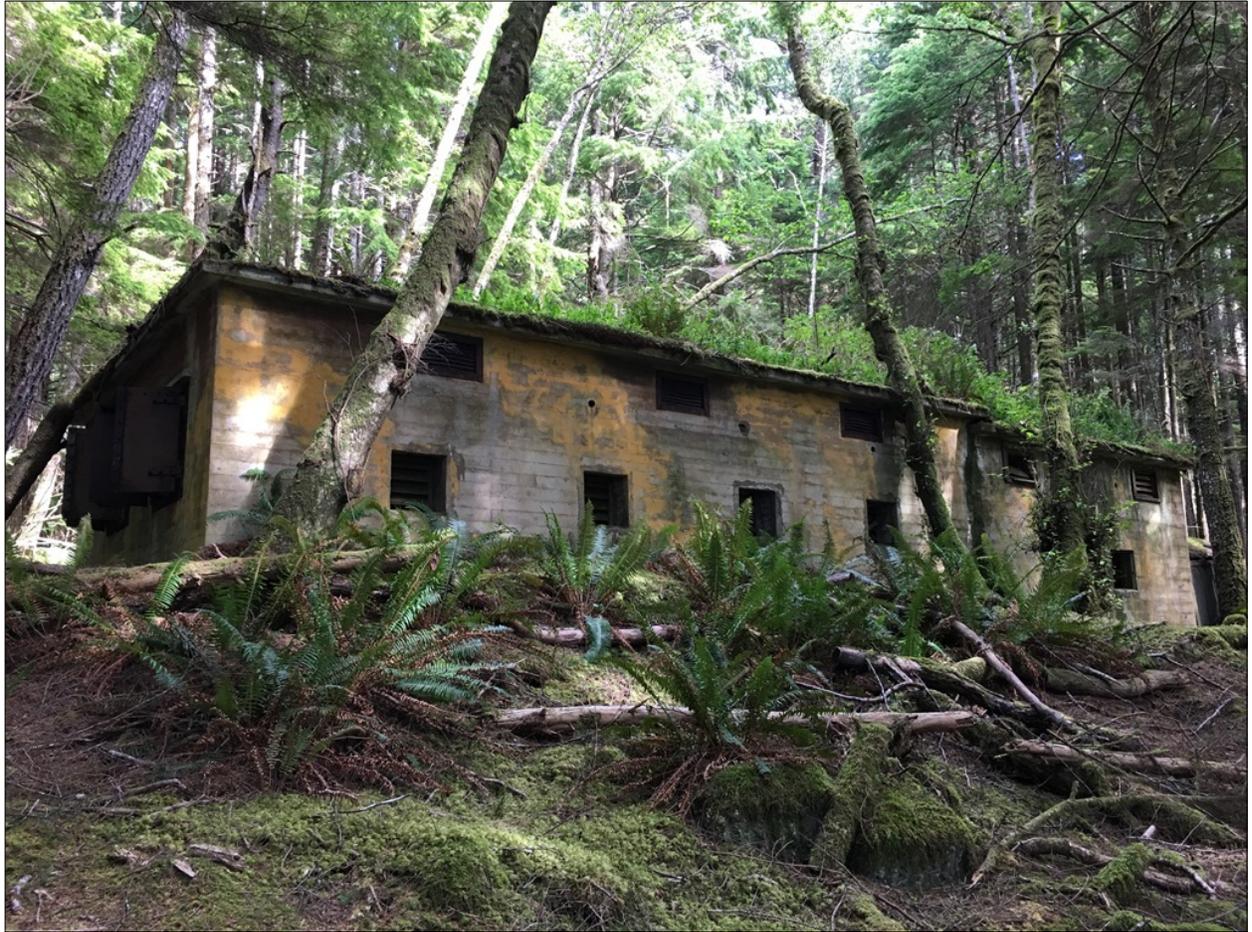
The camouflage paint is in fair condition on the west elevation, but remains vulnerable to damage.

West elevation. Note the camouflage paint.

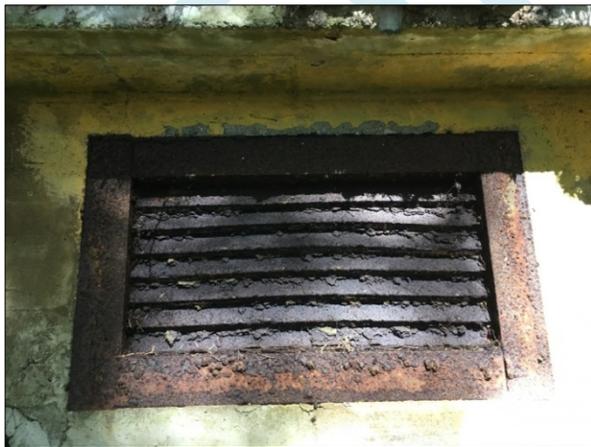
Left – Example of metal louver on west elevation

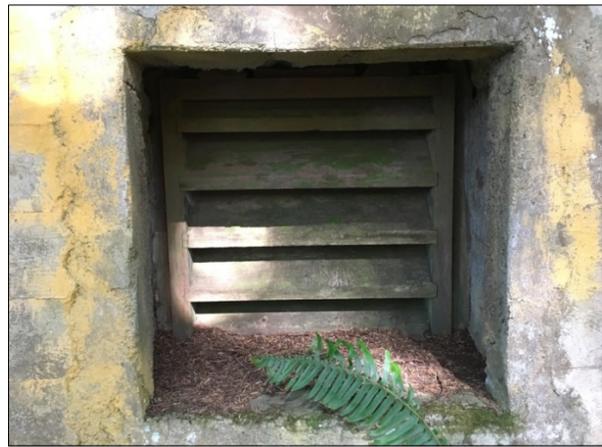
Right – Example of wooden louver on west elevation

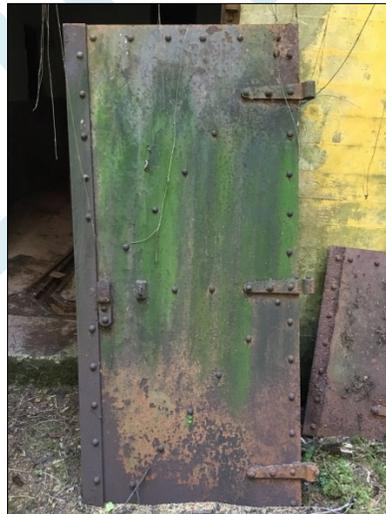
Doors to Generator Shed and Power Plant at east elevation.

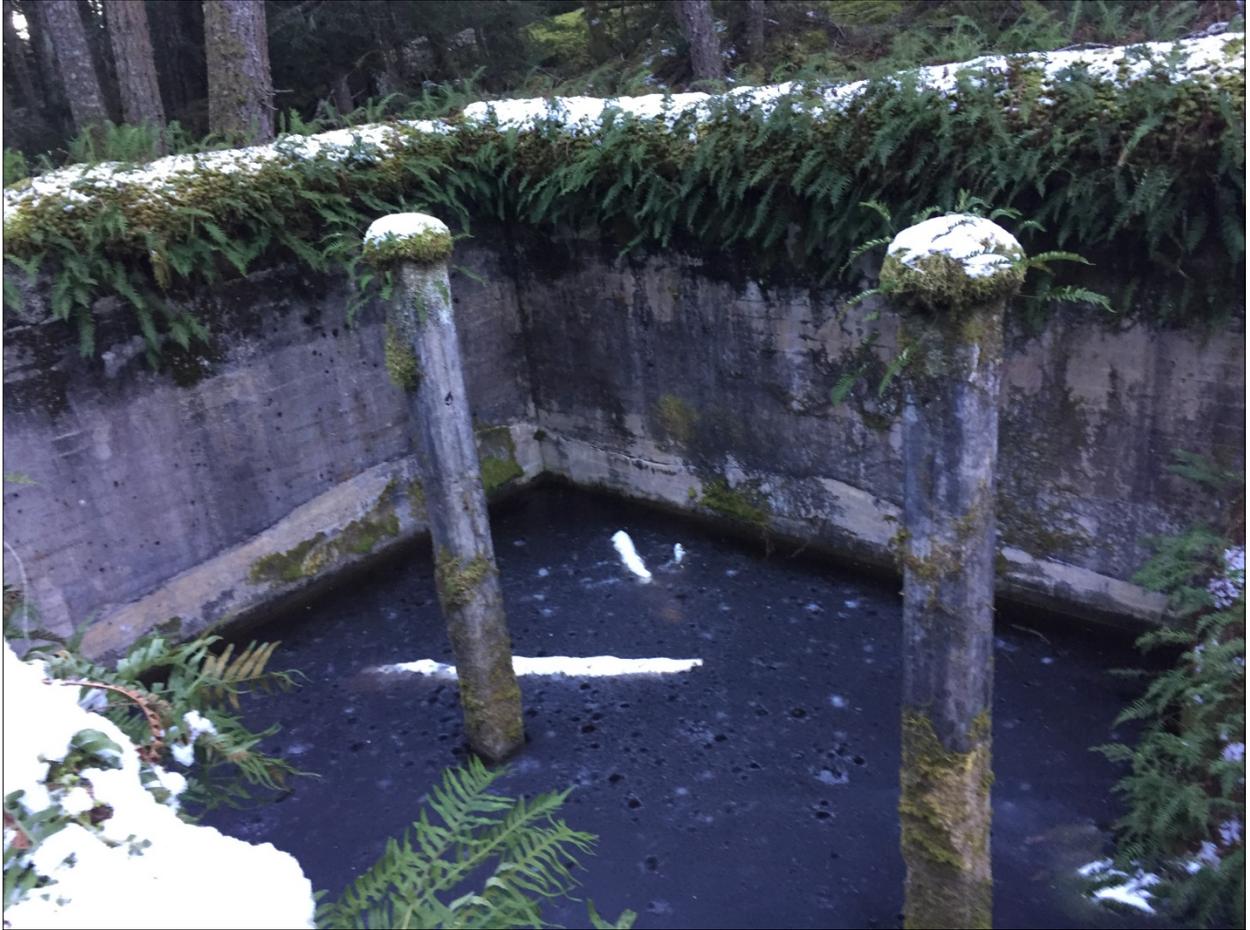
Interior of Water Tank

The Water Tank is heavily overgrown by salmon berry bushes around its base. Several trees have come down around the perimeter and at least two of these lean against the exterior of the west and east elevations. Vegetation has also established itself around the rim of the basin and there is a significant amount of debris and water on the bottom of the tank. The structure itself is very solid however, and the concrete in good condition. Conservation should be focused on management of vegetation around and on the structure. It may be desirable to control access to the tank with a ladder guard to reduce the risk of falls into the basin.

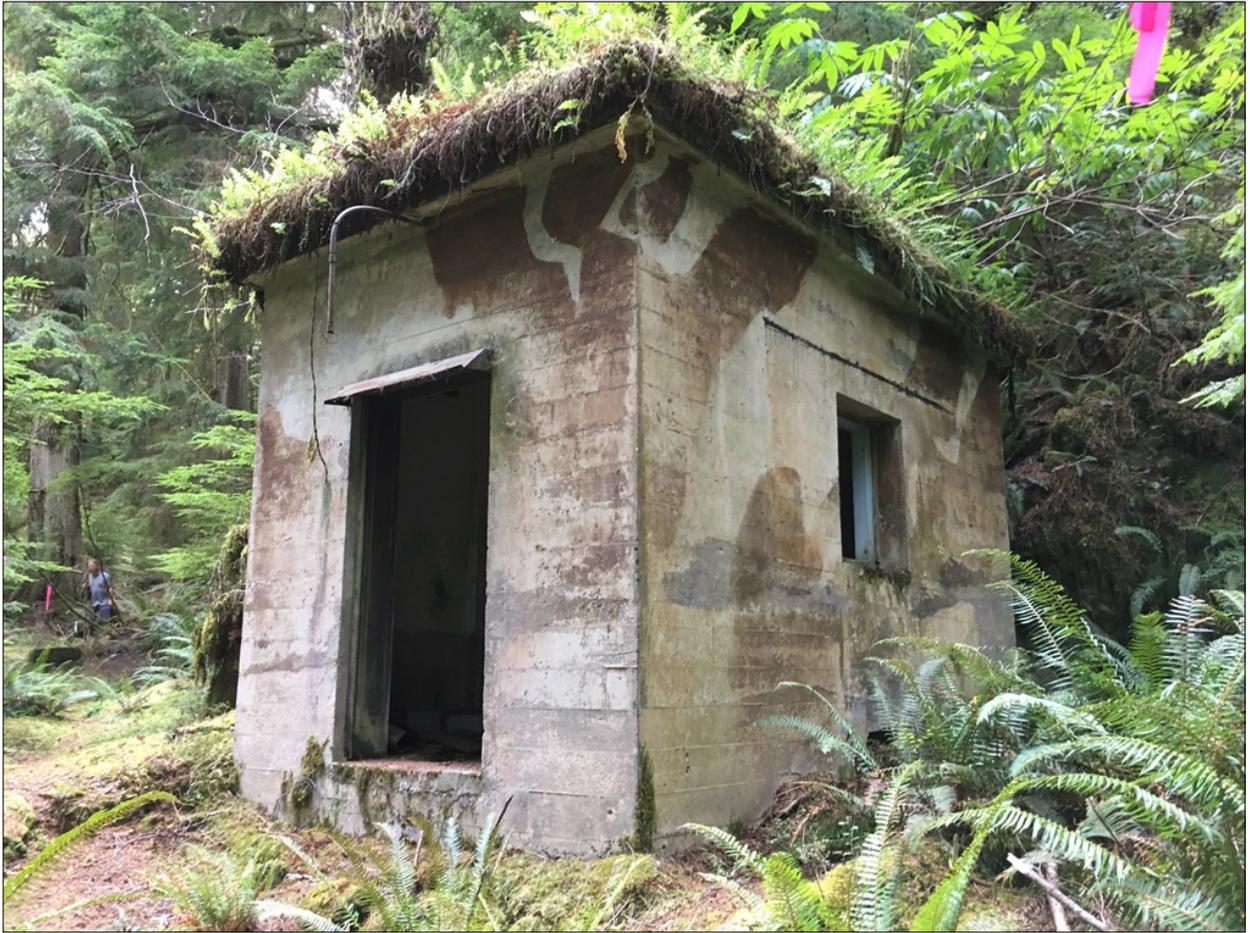
The condition of the Wireless Telegraph Station is stable. Internal finishes have been damaged and partially removed, but the structure is sound. The remaining joinery is in stable condition and reasonably well protected from the weather. The camouflage scheme is in the best condition of any on the island, and is perhaps the best known survival of a painted deception pattern in B.C. (R. Linzey, Pers. Comm). Together with the graffiti, is highly-significant as an example of the original appearance of these buildings. The good condition of the paint scheme is a result of the relatively sheltered situation of the building and maintaining its continued protection should be a priority.

Southeast corner of the Wireless Telegraphy Station

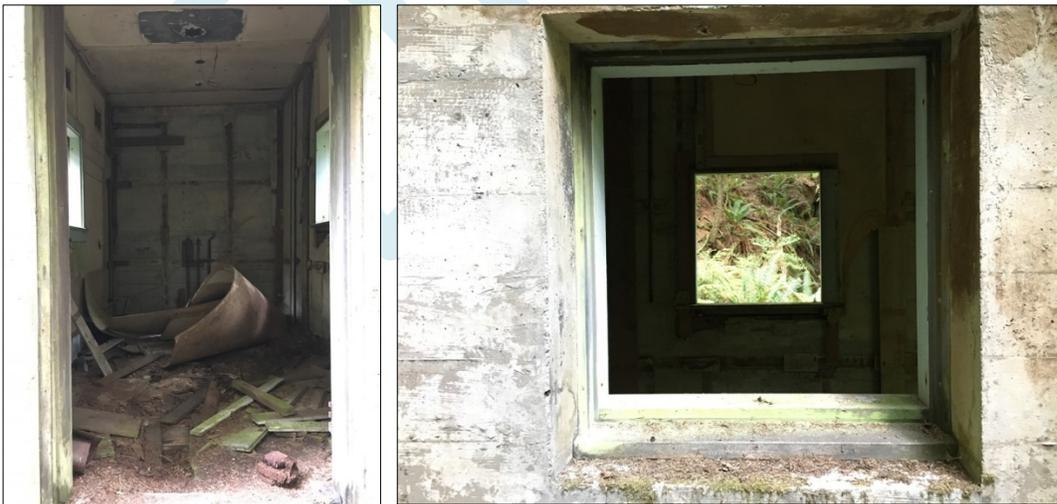
Details of the door and windows.

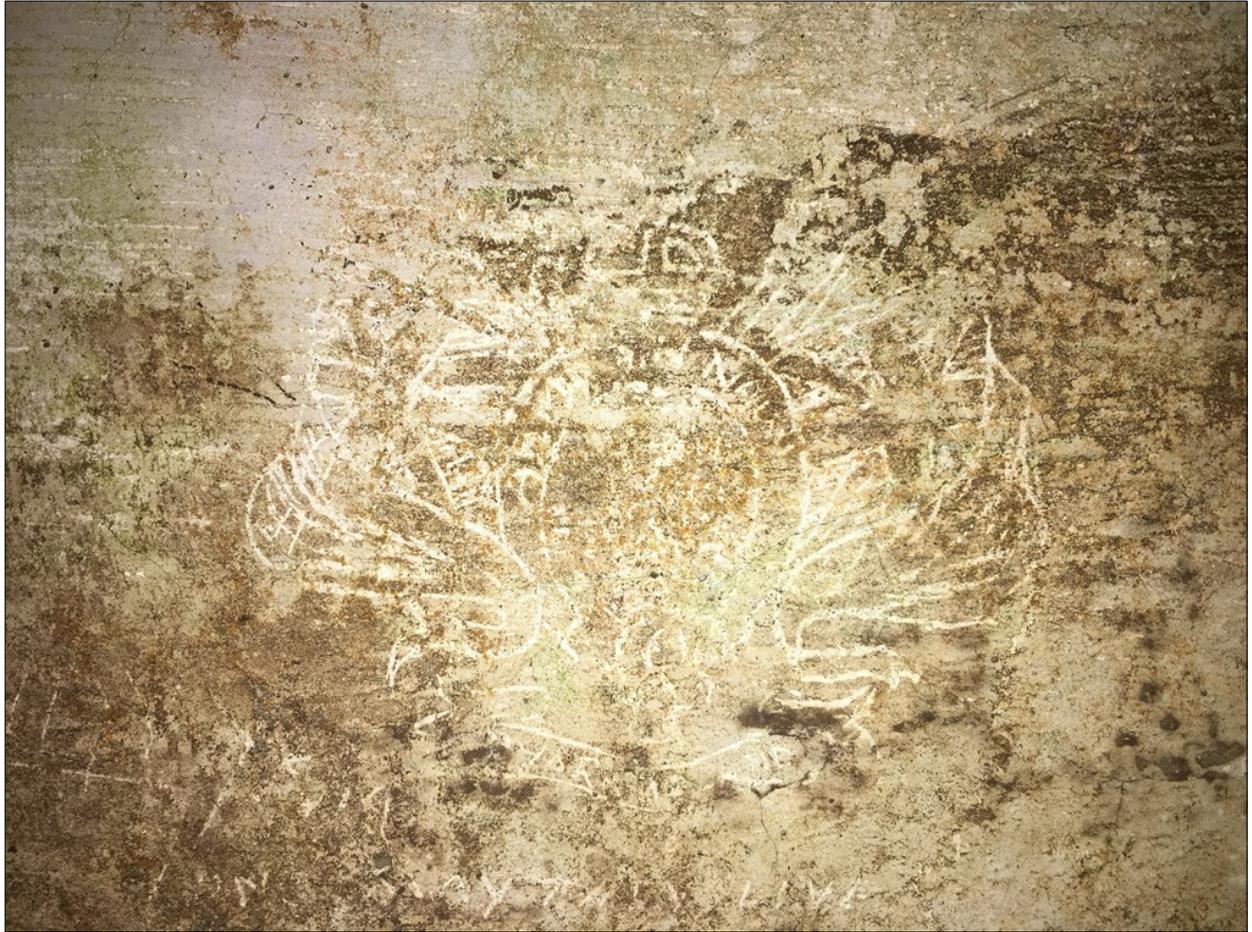
An important and highly significant example of regimental graffiti can be found on the east wall. Like the camouflage paint, this graffiti is extremely susceptible to damage.

Regimental graffiti on the exterior east elevation "Army and Navy, Yorke Island, Long May They Live"
